LINNTON MILL RESTORATION SITE (NWP-2014-477; 58909-RF; 59636-MBI)

YEAR 1 (2020) MONITORING REPORT

DECEMBER 18, 2020

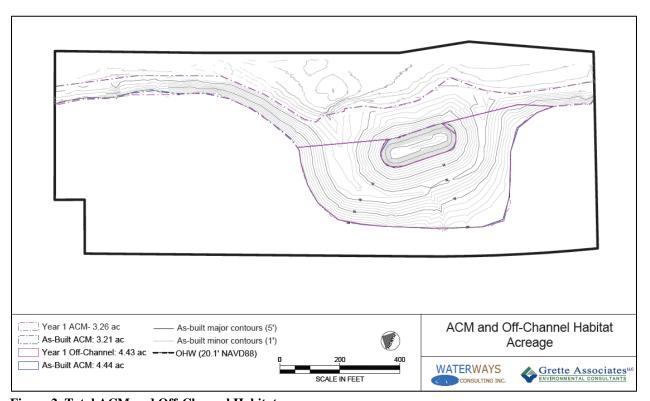
Using the same methods, Off-Channel habitat area in Year 1 monitoring was 4.43 acres, as compared to an as-built total using the same methods of 4.44⁵ acres (Figure 2). This represents a reduction by 0.2%.

The performance standard for these parameters was 10% change or less. Thus, both the ACM and Off-Channel habitat met this performance standard.

Figure 2. Total ACM and Off-Channel Habitat

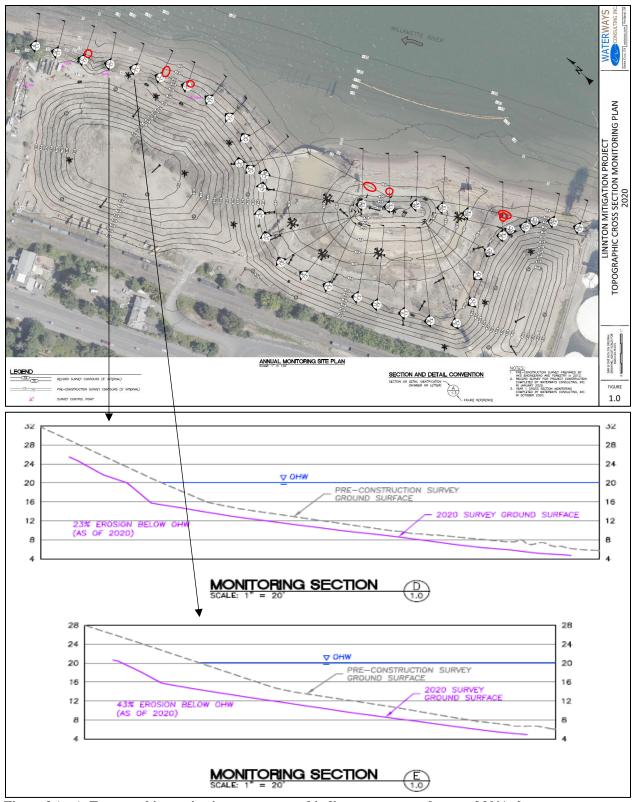
Both of these locations are near the mouth of the Off-Channel habitat where it interfaces with the Willamette River. Additionally, as with the ACM habitat, the exceedances are near the upper elevations of the cross sections, near OHW where the 20% threshold is lowest and changes are least impactful on the function of the habitat.

Based on sampling data, the elevation performance standard for the Off-Channel habitat was met.

Figure 3 (top). Topographic monitoring transects; red indicates spot exceedances of 20% change.

Figure 4 (bottom). Transects D and E, showing pre-construction ground surface and Year 1 ground surface (NTS).

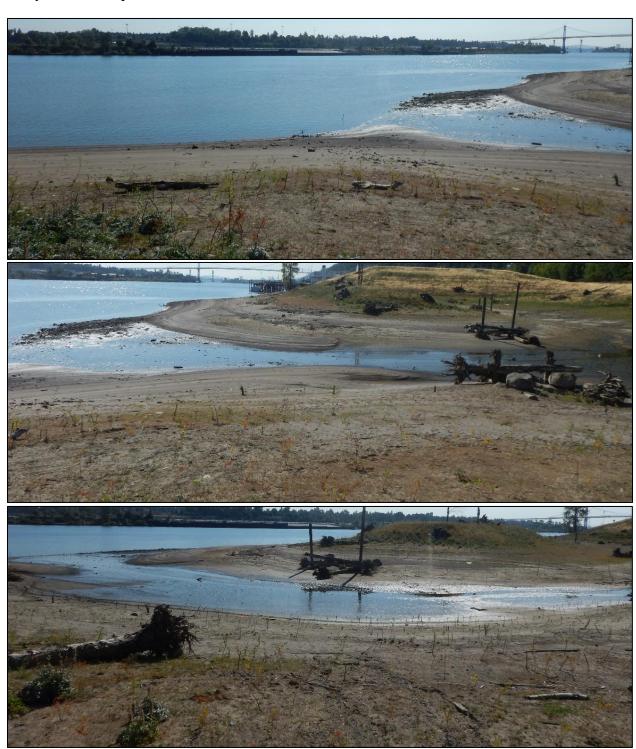
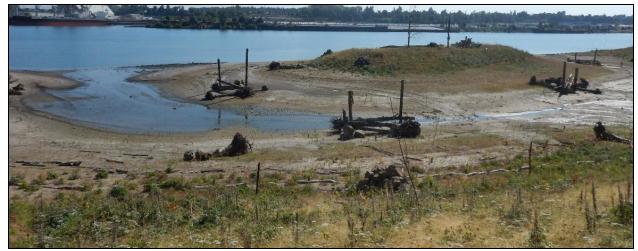
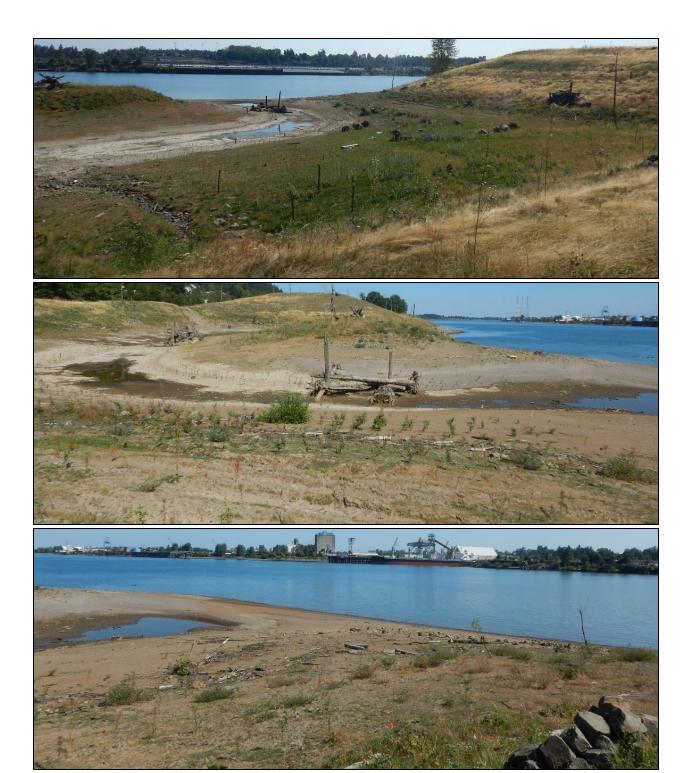
Based on a visual survey, no physical conditions exist that prevent fish access to the site. The photo series presented below (Photograph 1) illustrates that fish can access the site and leave the site freely, without impediments.

Photograph 1. Photo series: off-channel habitat fish access (river water level +6.2 ft)

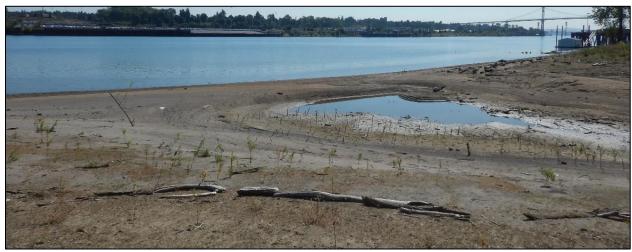
As part of fish access monitoring, potential stranding risks in the off-channel habitat were assessed visually. A potential risk was identified at the upstream mouth of the off-channel habitat (Photograph 2). A berm is present on the outer edge of the site, and immediately inward of the sand cap is a depression that retains water following dewatering of the off-channel habitat. This depression is approximately 1-2 feet deeper than the surrounding channel. As is visible in the

photo, water is retained in this depression after the water level recedes. This depression may pose a stranding risk to smaller fish using the off-channel habitat.

Photograph 2. Sand berm at the upstream mouth of the site

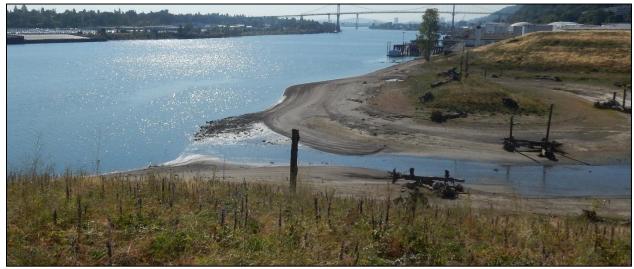
Additionally, sand appears to be accumulating at the mouth of the off-channel habitat, forming a small berm that extends a portion of the way across the channel (Photograph 3, Photograph 4). Though this does not constitute a stranding risk, if it continues to extend and connects across the mouth, this could cause an additional stranding risk. This is unlikely though, as continual outflow from the off-channel habitat due to year-round Linnton Creek flow as well as seeps from the hillside will likely keep this outlet open.

Photograph 3. Emerging berm on the downstream end of the off-channel habitat, facing southeast.

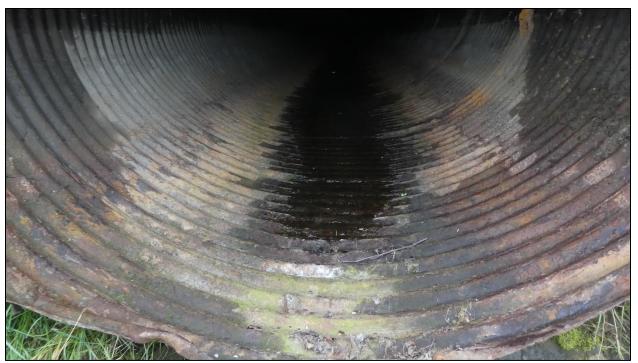
The northeast-facing photo at photo point 12 is consistently the clearest view of flow in Linnton Creek¹. Flow is difficult to observe from a distance due to the fact that the culvert is rusted, and low flows fall out of the culvert through a rust hole before the end of the pile; this is shown in Photograph 8 from October 29.

Photograph 8. Flow in Linnton Creek October 29, 2020

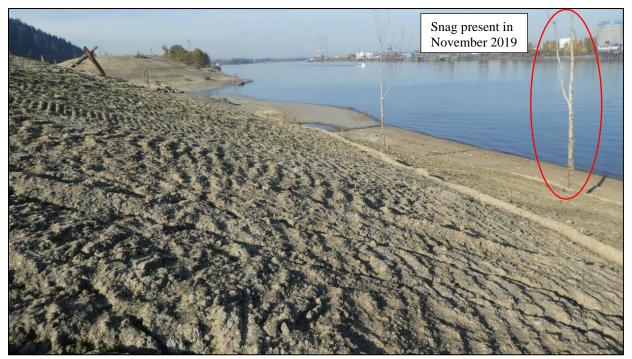
As discussed in the as-built report, 65 habitat structural features were installed. Based on a Year 1 survey of these features, 64 features are present with one snag missing. The missing snag was located on the far southern end of the site along the shoreline, just above OHW. This snag was removed by a beaver in mid-January 2020 (Photograph 15). Photos from photo point 23 in November 2019 versus August 2020 show the snag was installed, but is no longer present.

Photograph 14. Facing north from Photo Point 23, November 2019

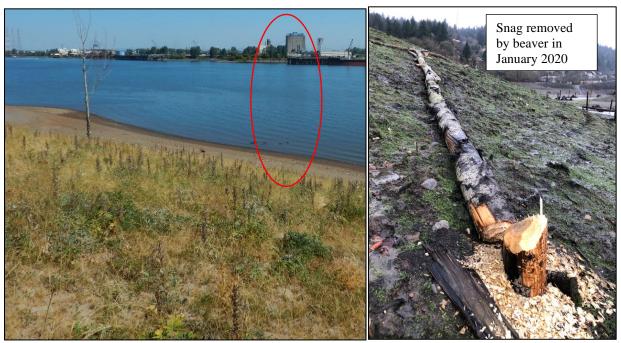
Photograph 15. Facing north from Photo Point 23, August 2020; snag removed in January, 2020.

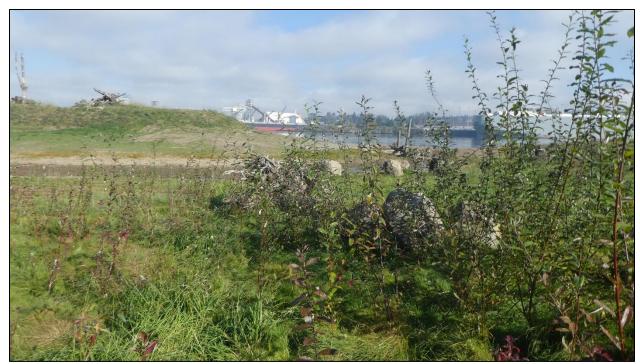
Photograph 16. Substantial shrub growth in the southwestern portion of the off-channel habitat, facing ENE

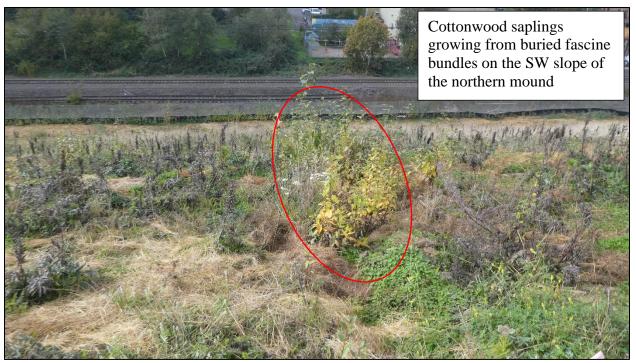
watering and weed maintenance, and remedial actions such as installation of supplemental plantings and cottonwood fascine bundles within rills that formed from runoff (these bundles have sprouted very successful; Photograph 19), and spreading seeded straw as a mulch/seed for the herbaceous layer. The planting contractor expresses utmost confidence in the success of the site, in large part due to their ongoing oversight and care of the site.

Photograph 19. Cottonwood establishment from fascine bundles placed in rills, west-facing slope of the northern mound
