i. MITIGATION MONITORING REPORT COVER SHEET
CORPS OF ENGINEERS

Corps Permit Number: 2011-100

2. WALN CREEK/BATTLE CREEK MITIGATION PLAN PURPOSE AND OVERVIEW

Wain Creek/Battle Creek riparian mitigation area in Salem, Oregon.

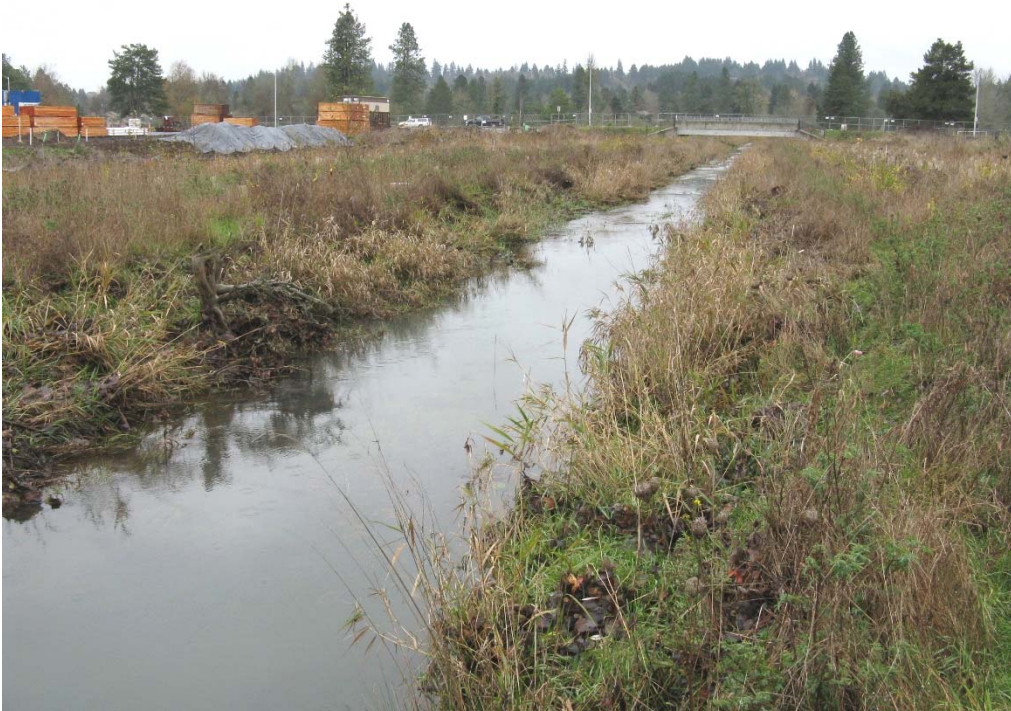
Photo A:

Looks south from northern
boundary of mitigation area

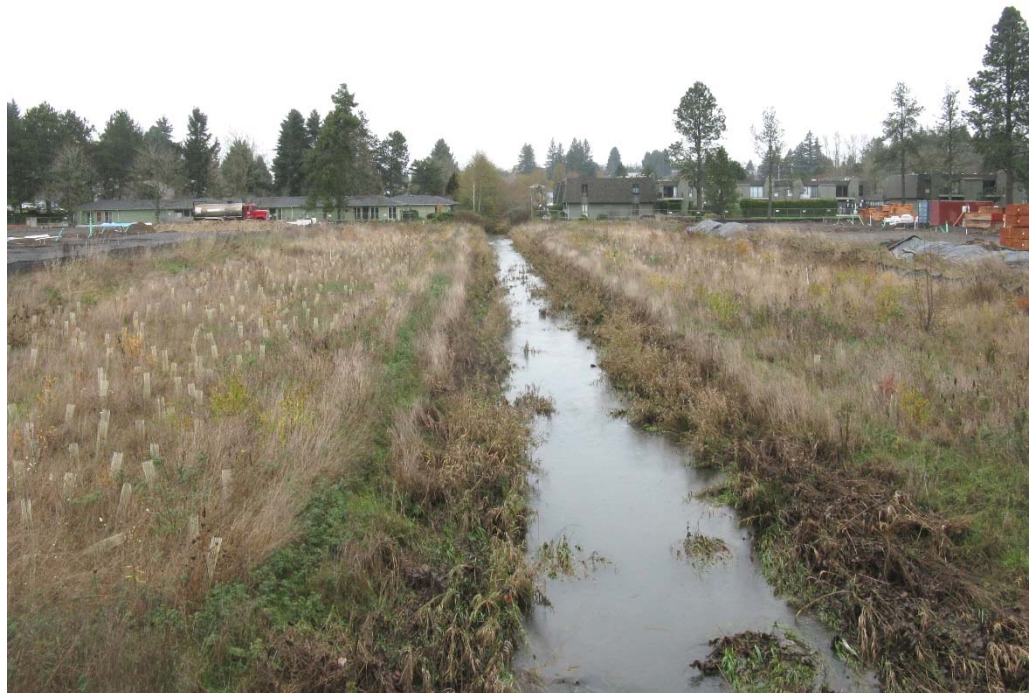
Photo B:

Looks north from bridge
at Wain Drive SE

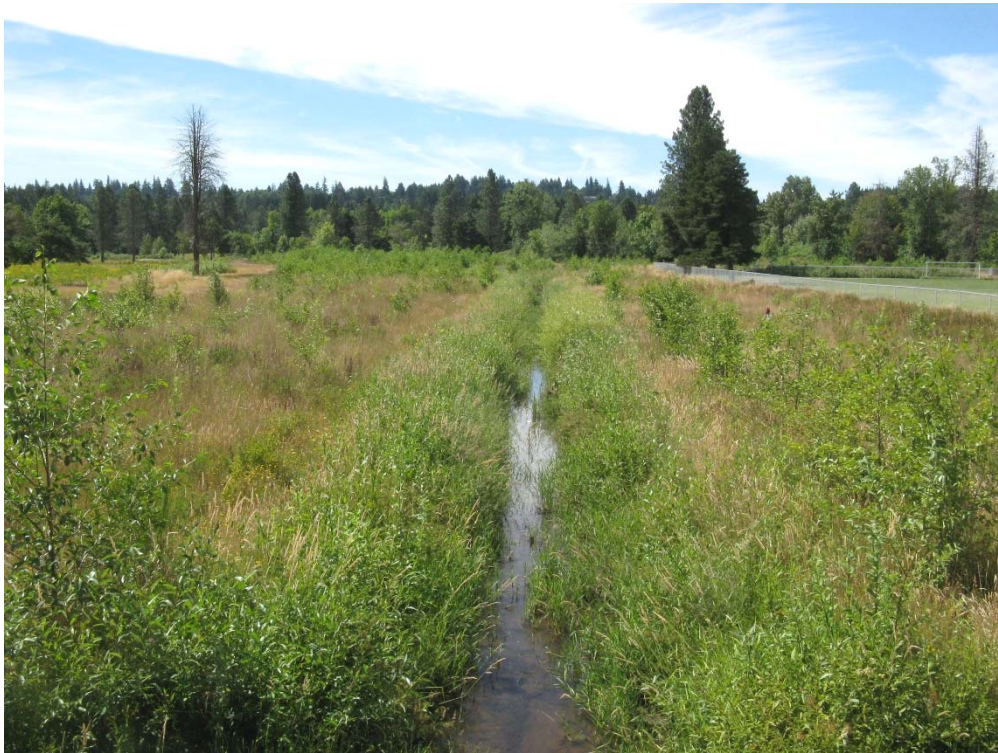
Photo C:

Looks south from Wain Drive SE bridge

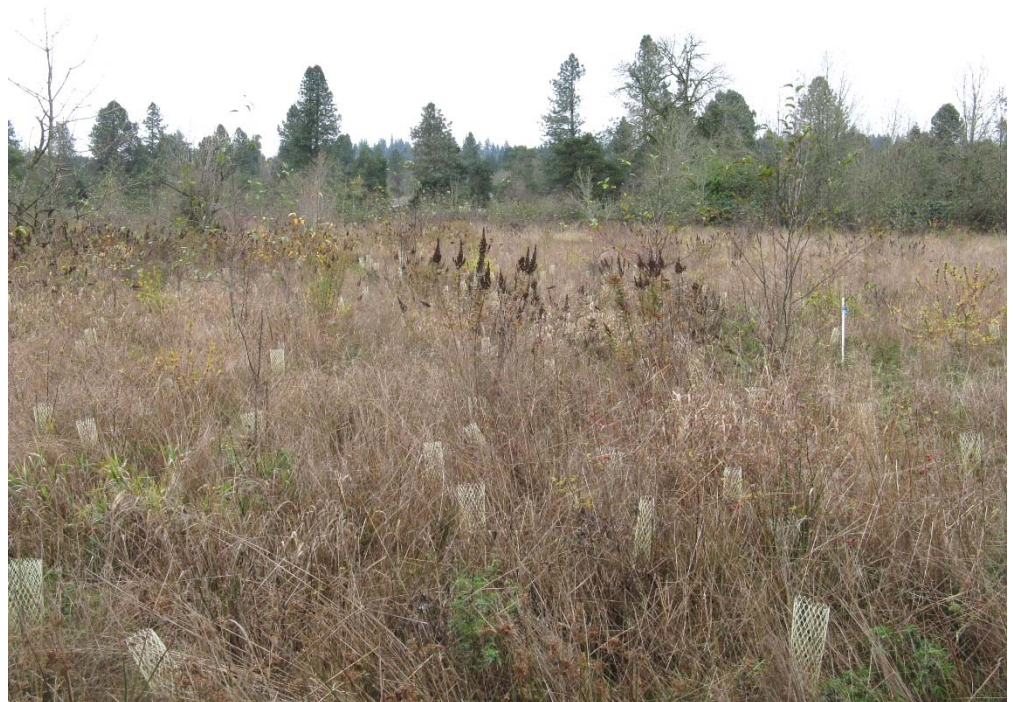
Photo D:

Looks south from west side of mitigation area.

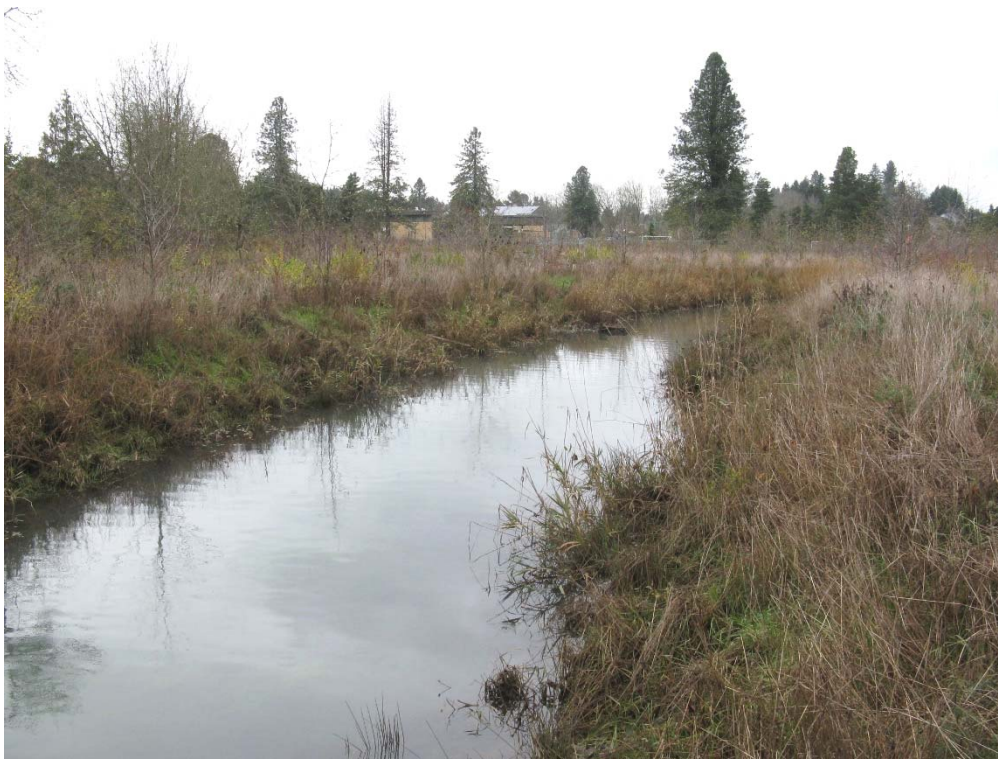
Photo E:

Looks northwest from southern portion of mitigation area

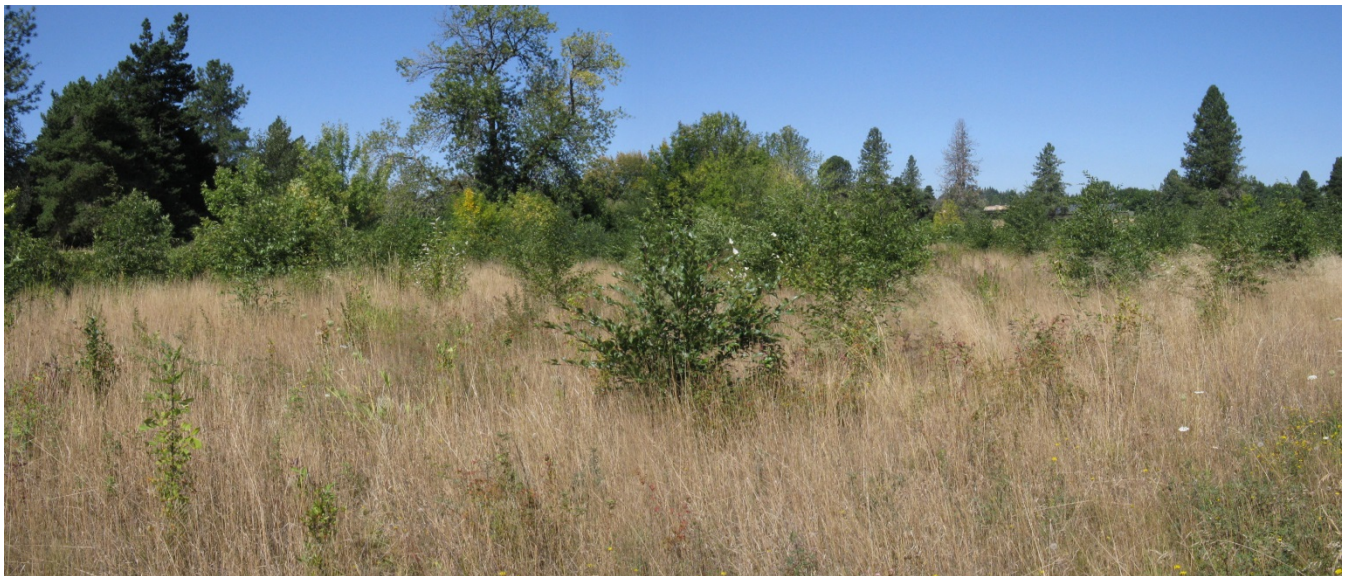
Photo F (below):

Looks northwest from southeast edge of mitigation area

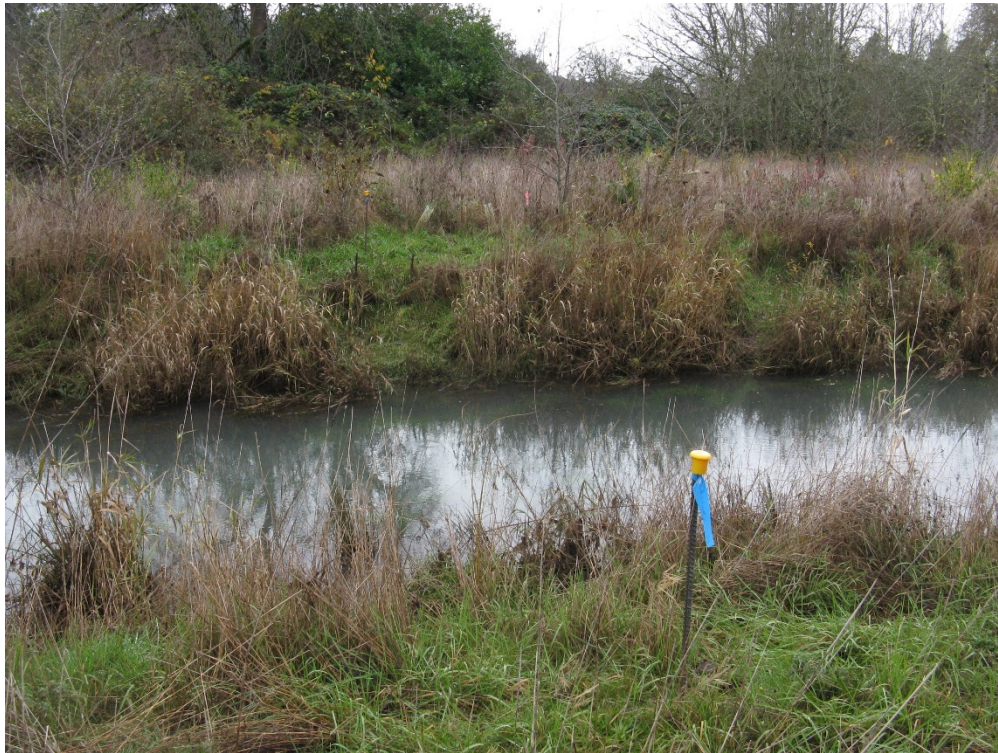
Photo shows X-section D from east bank of Wain Creek.

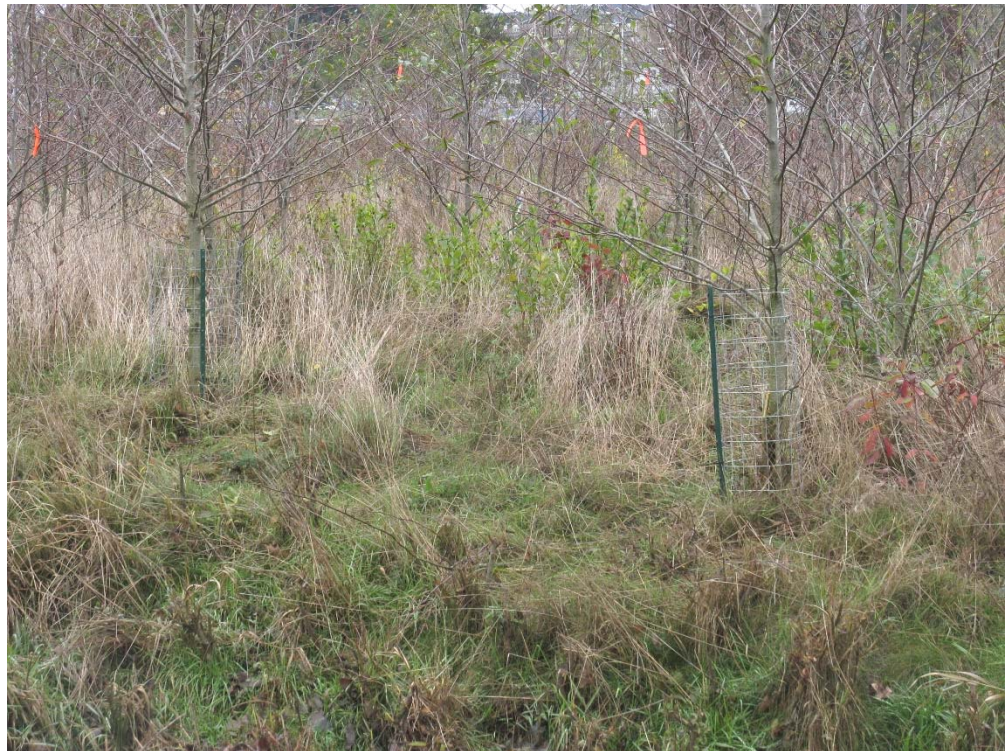
While previous attempts at reducing beaver use in Waln Creek primarily involved installation of a beaver deceiver in 2015, this action was insufficient to deter recolonization of the channel. This year in particular has seen a marked increase in beaver activity, with several new dams being established, despite the functioning deceiver.

Photo shows recently installed beaver protection cages on two alders.

A program to protect existing priority plantings was implemented in November 2016, in which at least 100 plants at higher risk of loss were protected using galvanized wire fencing. This initial program will be observed through the next year to determine whether further protective measures will be necessary to preserve the developing riparian plant community.

Further measures that may be implemented during the winter and spring of 2016-17 and beyond include (1) the planting of willow and cottonwood stakes on the channel banks and on adjacent terraces in order to enhance beaver-impacted areas, and (2) the protection of additional trees with exclusionary fencing.

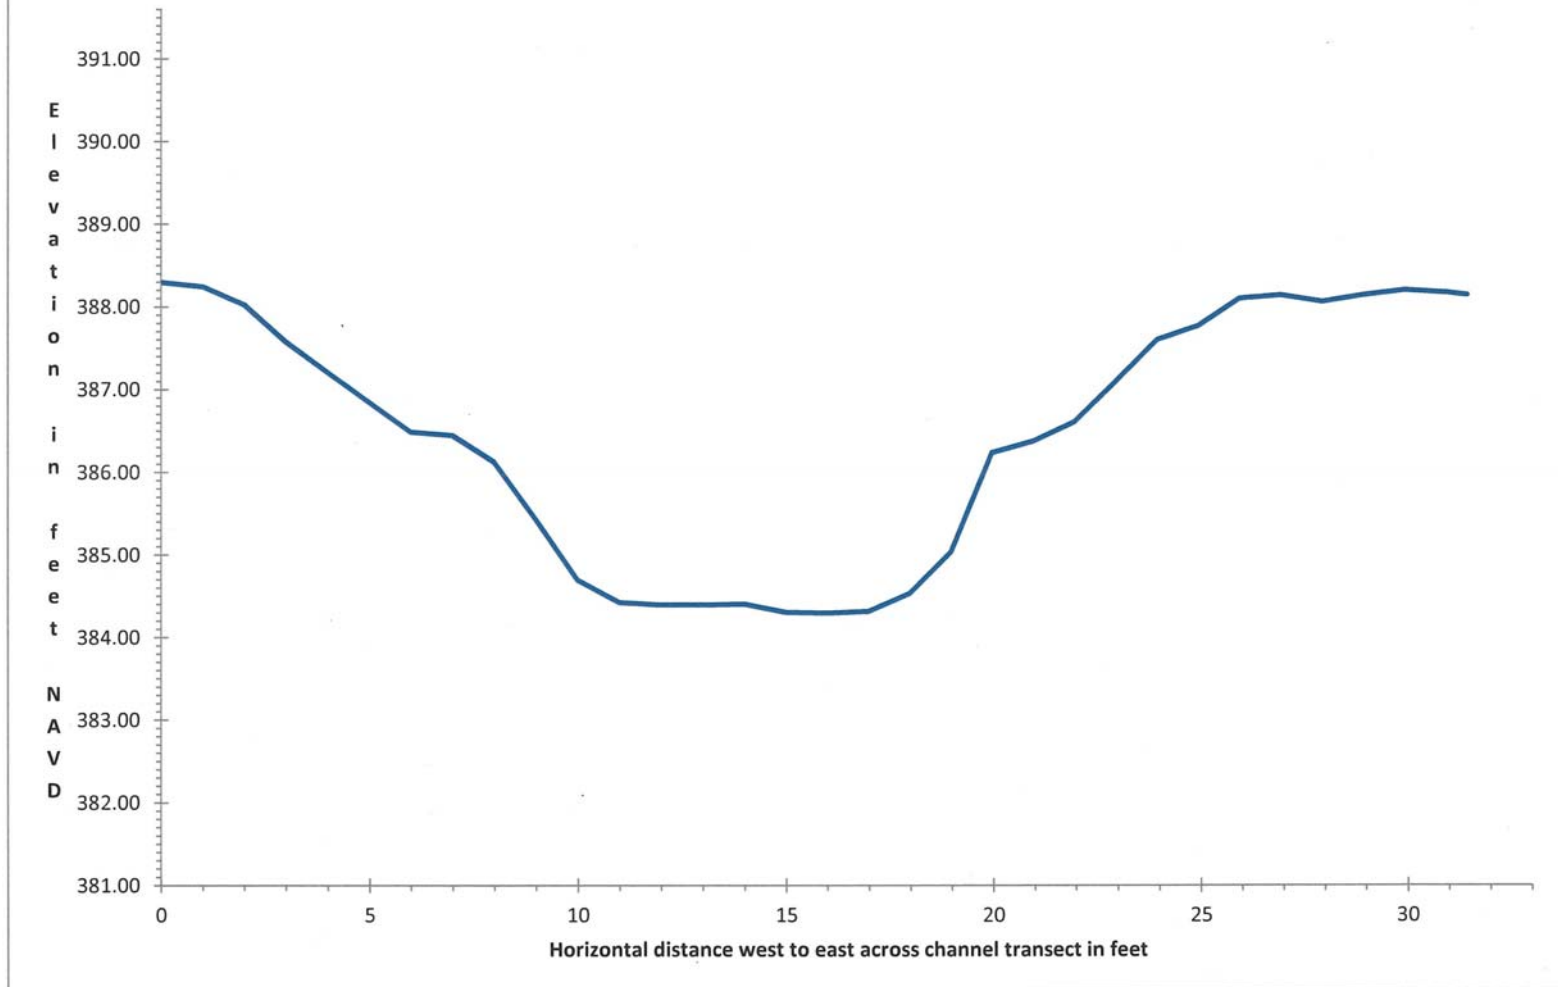
Stream Channel Cross Section A, 2016
Waln Creek Stream Mitigation Bank site, Salem, Oregon

As mentioned above, the lack of comparative data from previous years precludes a current analysis of channel changes over time. Nevertheless, the calculations for the Bank Erosion Hazard Index (BEHI) at each cross section indicate that the stream channel currently has an overall low level of susceptibility to erosion (BEHI index ranges from 19 to 20.5). This measure is based on multiple factors, including bank height and angle, root depth and density, bank material, and surface protection. Given the relatively low gradient, low velocity channel as well as its relatively well vegetated banks, the BEHI index is unlikely to appreciably change over time.

Channel section A vertical exaggeration x2

Very Low	Low	Moderate	High	Very High	Extreme	Adjective Rating and Total Score
5 - 9.5	10 - 19.5	20 - 29.5	30 - 39.5	40 - 45	46 - 50	<u>Low</u> <u>18</u>
