**i. MITIGATION MONITORING REPORT COVER SHEET**  
**CORPS OF ENGINEERS**

**Corps Permit Number:** 2011-100

<b>Permittee:</b> <u>City of Salem</u>	<b>Consultant:</b> <u>Pacific Habitat Services, Inc.</u>
<u>Attn: Patricia Farrell</u>	<u>9450 SW Commerce Circle, Suite 180</u>
<u>555 Liberty Street SE, Rm. 325</u>	<u>Wilsonville, OR 97070</u>
<u>Salem, OR 97301-3513</u>	<u>503-570-0800</u>

**Name:** Pacific Habitat Services (Fred Small) **Date(s):** July 7 and 14, 2017

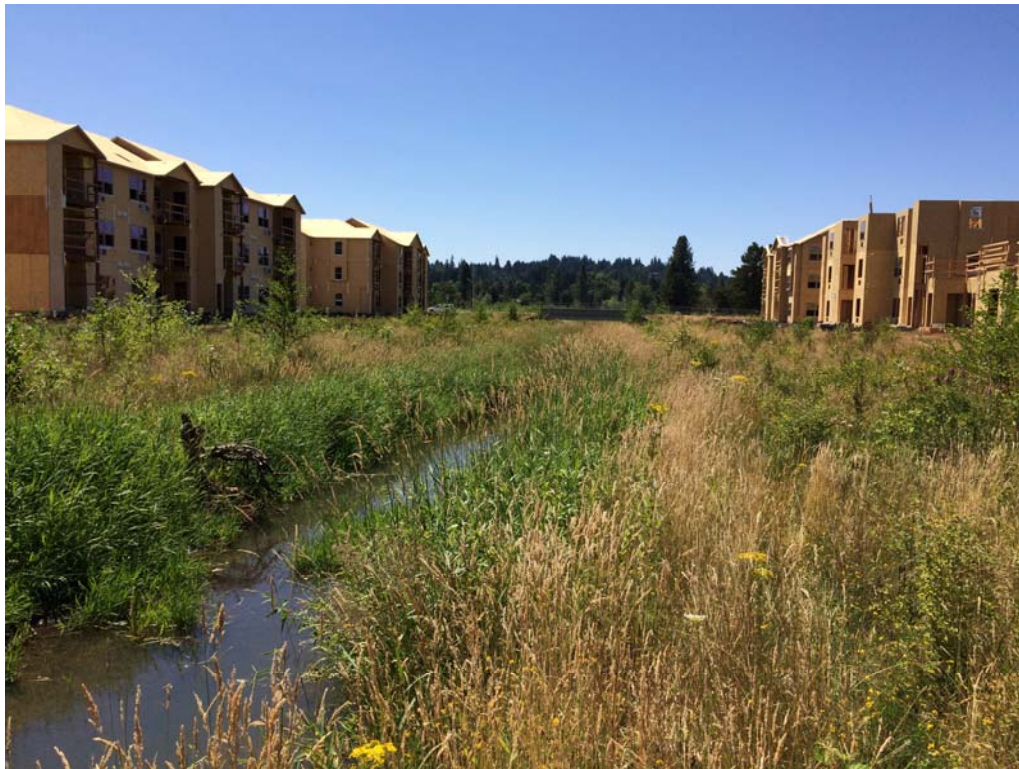
**Photo A:**

Looks south from northern boundary of mitigation area

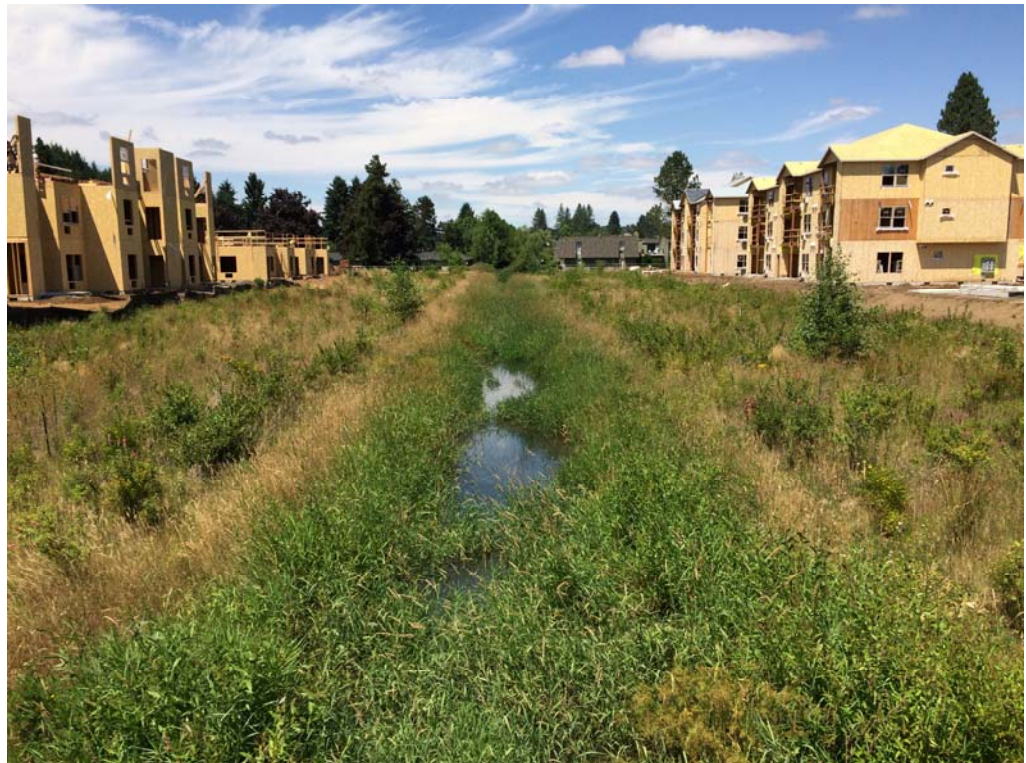
**Photo B:**

Looks north from bridge at Wain Drive SE

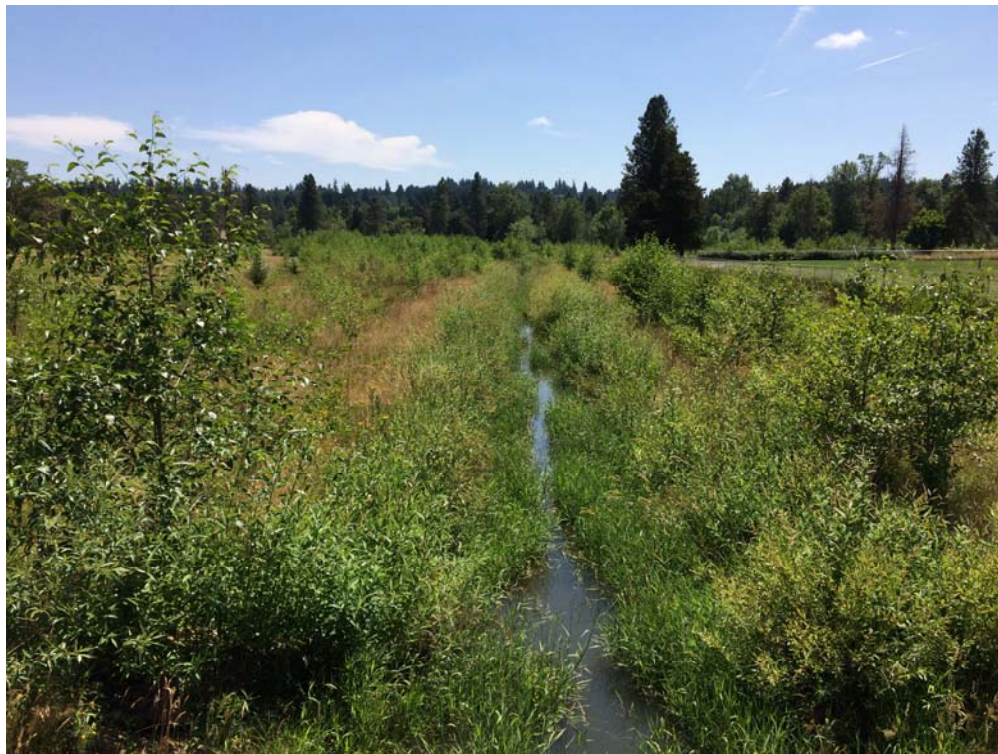
**Photo C:**

Looks south from Wain Drive SE bridge

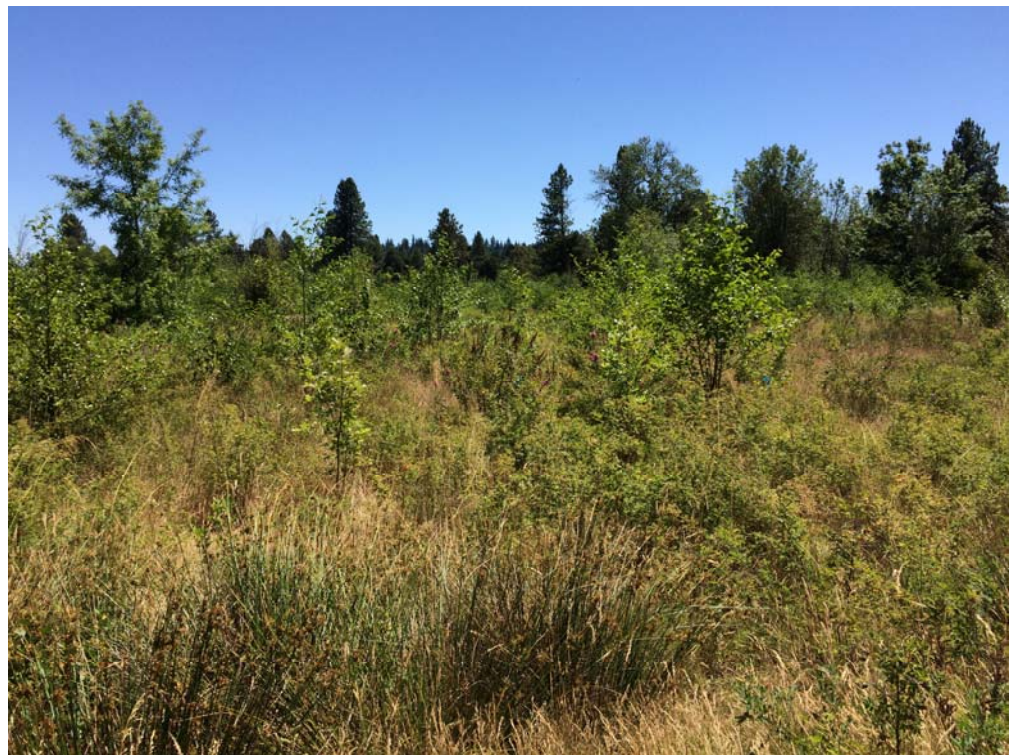
**Photo D:**

Looks south from west side of mitigation area.

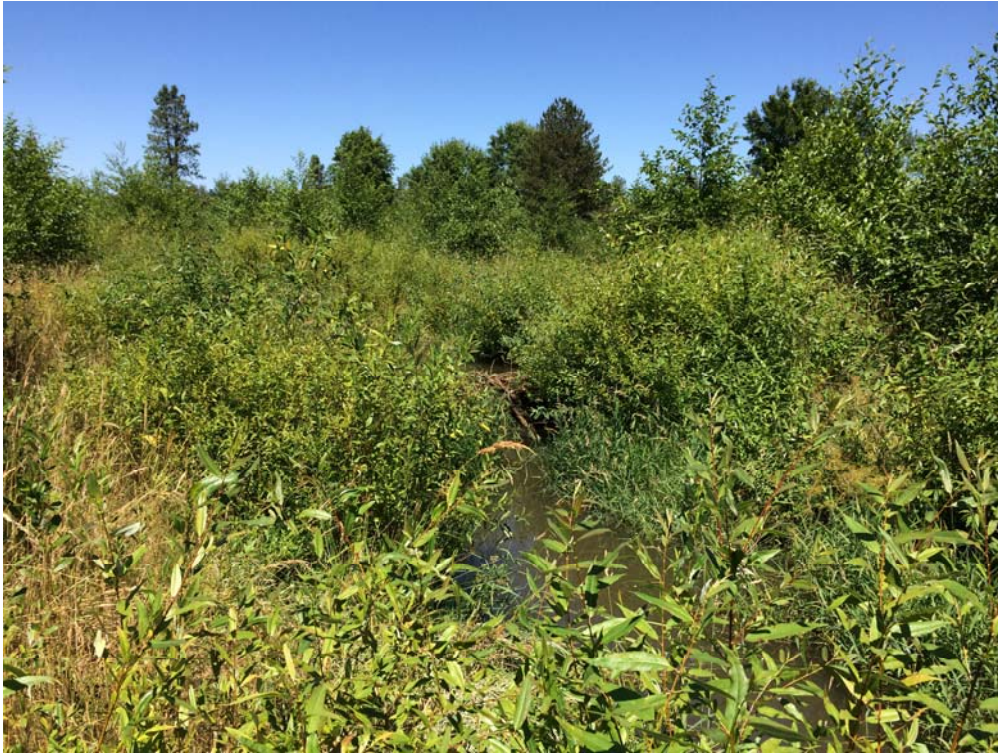
**Photo E:**

Looks north along channel in southern portion of mitigation site, toward active beaver dam.

The potential for plant losses due to beaver activity remains a valid concern. With beaver losses significant along streambanks and also farther from the channel, steps were taken this past winter and spring to offset those losses. Several hundred willow and red-osier cuttings were installed along the channel, and over 100 tree saplings were protected using wire mesh guards.

Further measures that may be implemented during the winter and spring of 2017-18 and beyond include (1) the planting of additional willow and cottonwood stakes on the channel banks and on adjacent terraces in order to enhance beaver-impacted areas, and (2) the protection of additional trees with exclusionary fencing.

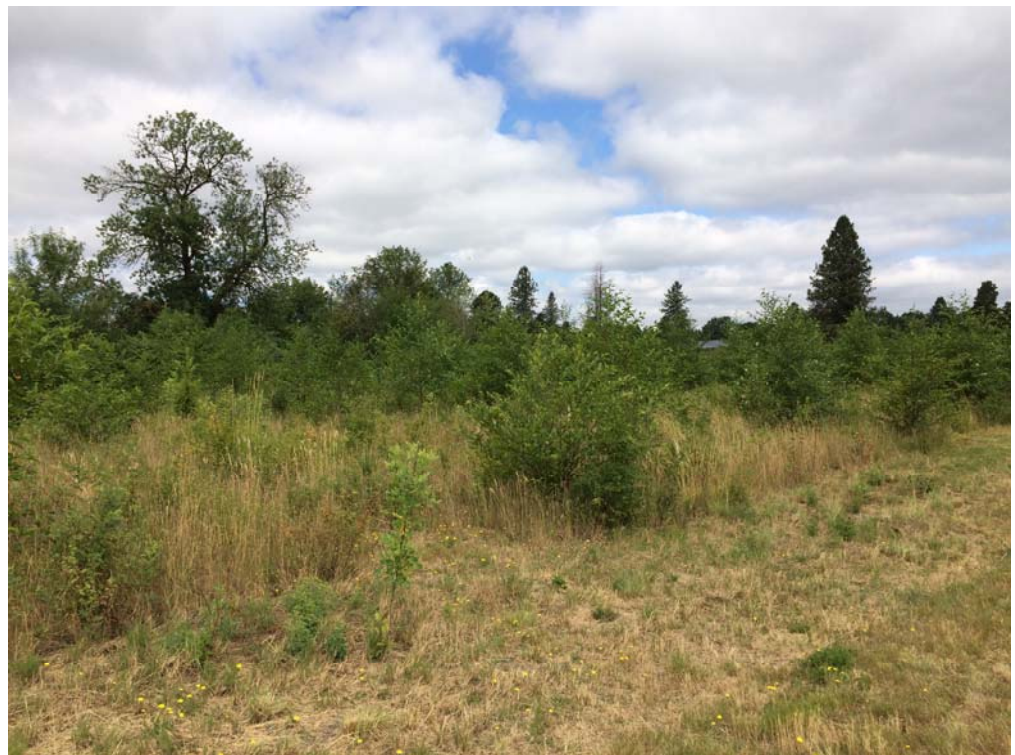
**Photo F:**

Looks northwest from southeast edge of mitigation area

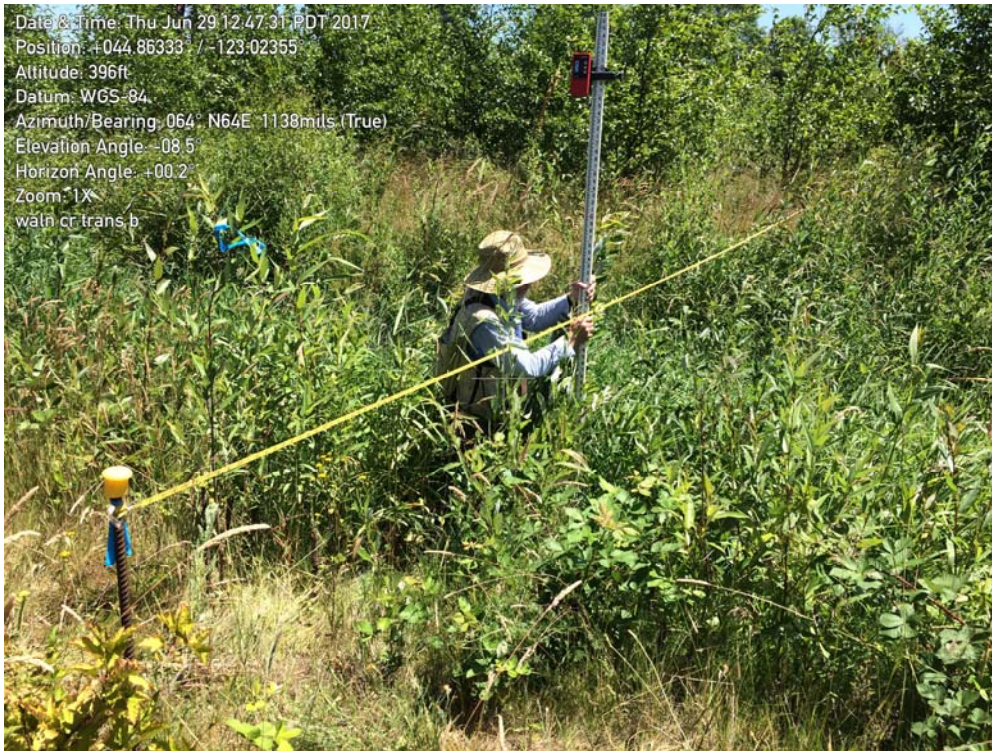
Photo shows obtaining measurements at channel section B, from west bank of Wain Creek.

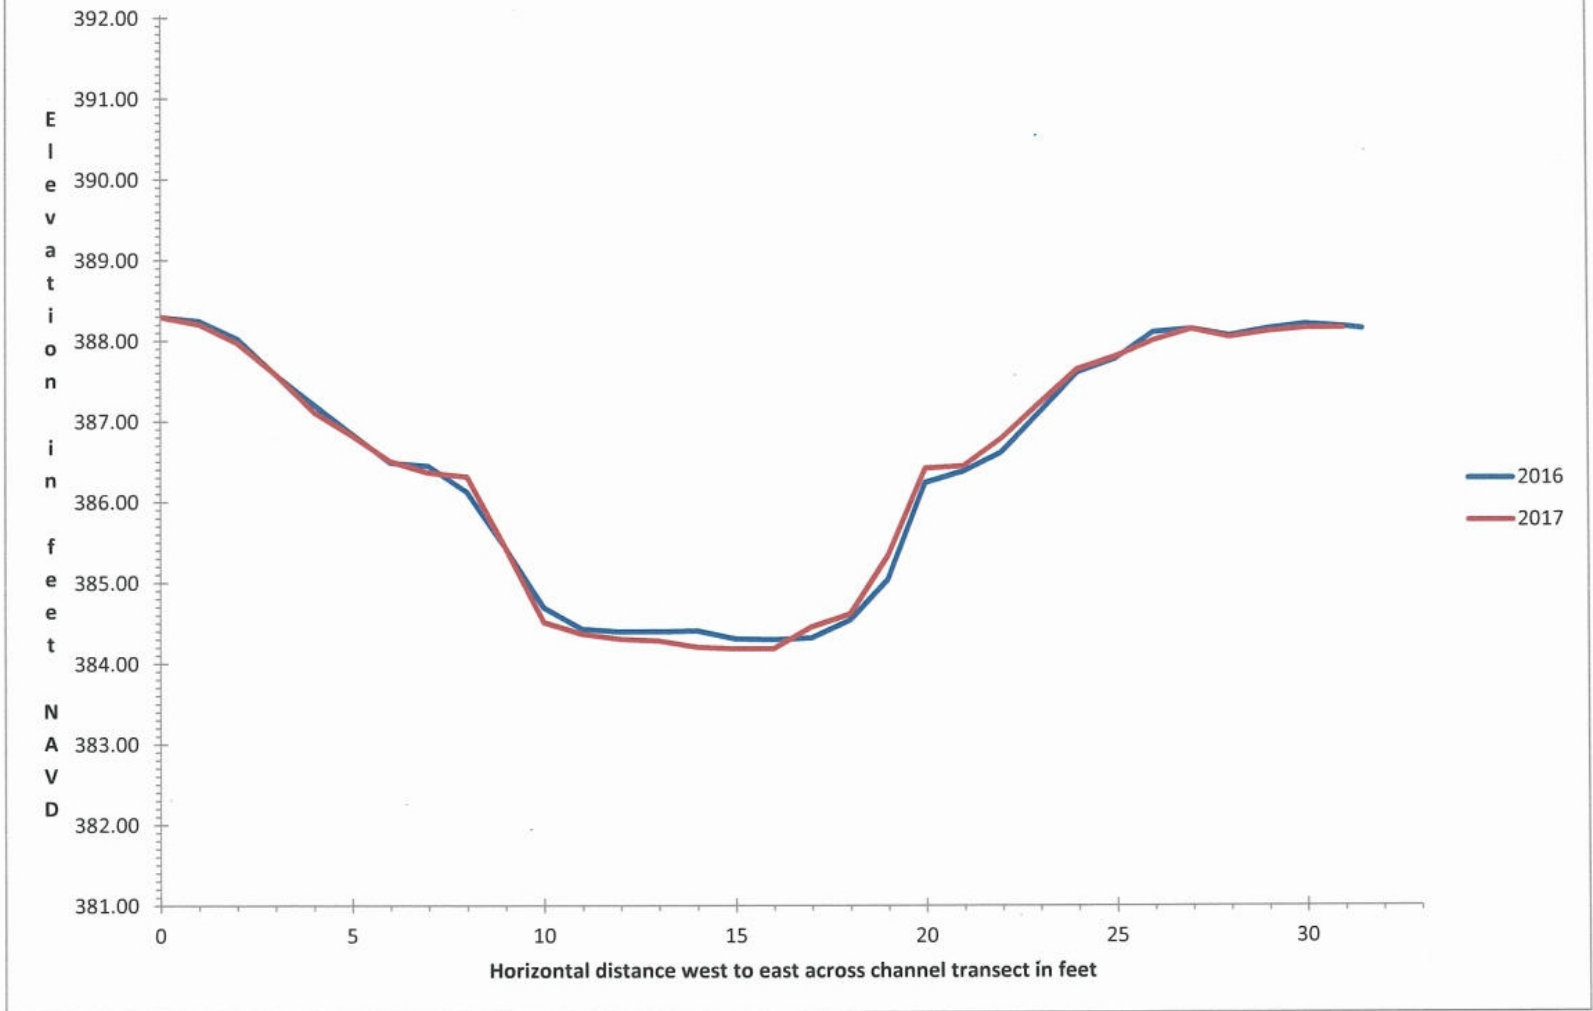
### Channel section A vertical exaggeration x2

Virtually no distinctions can be made between the two years for Channel Sections A, C, and D; however, the bed and banks at Channel Section B have been modified somewhat during this time. One side of the channel has been broadened by up to 2 feet while the other side appears to have been built up by 0.5 feet or more. However, please note that there has been beaver dam activity in the vicinity, with increased water depths at different times of year. This factor appears to have resulted in significant siltation, some minor local bank slumping, and expanded reed canarygrass growth along the banks. The poorly consolidated silts and developing root mats have likely contributed to bottom dimension changes as well.

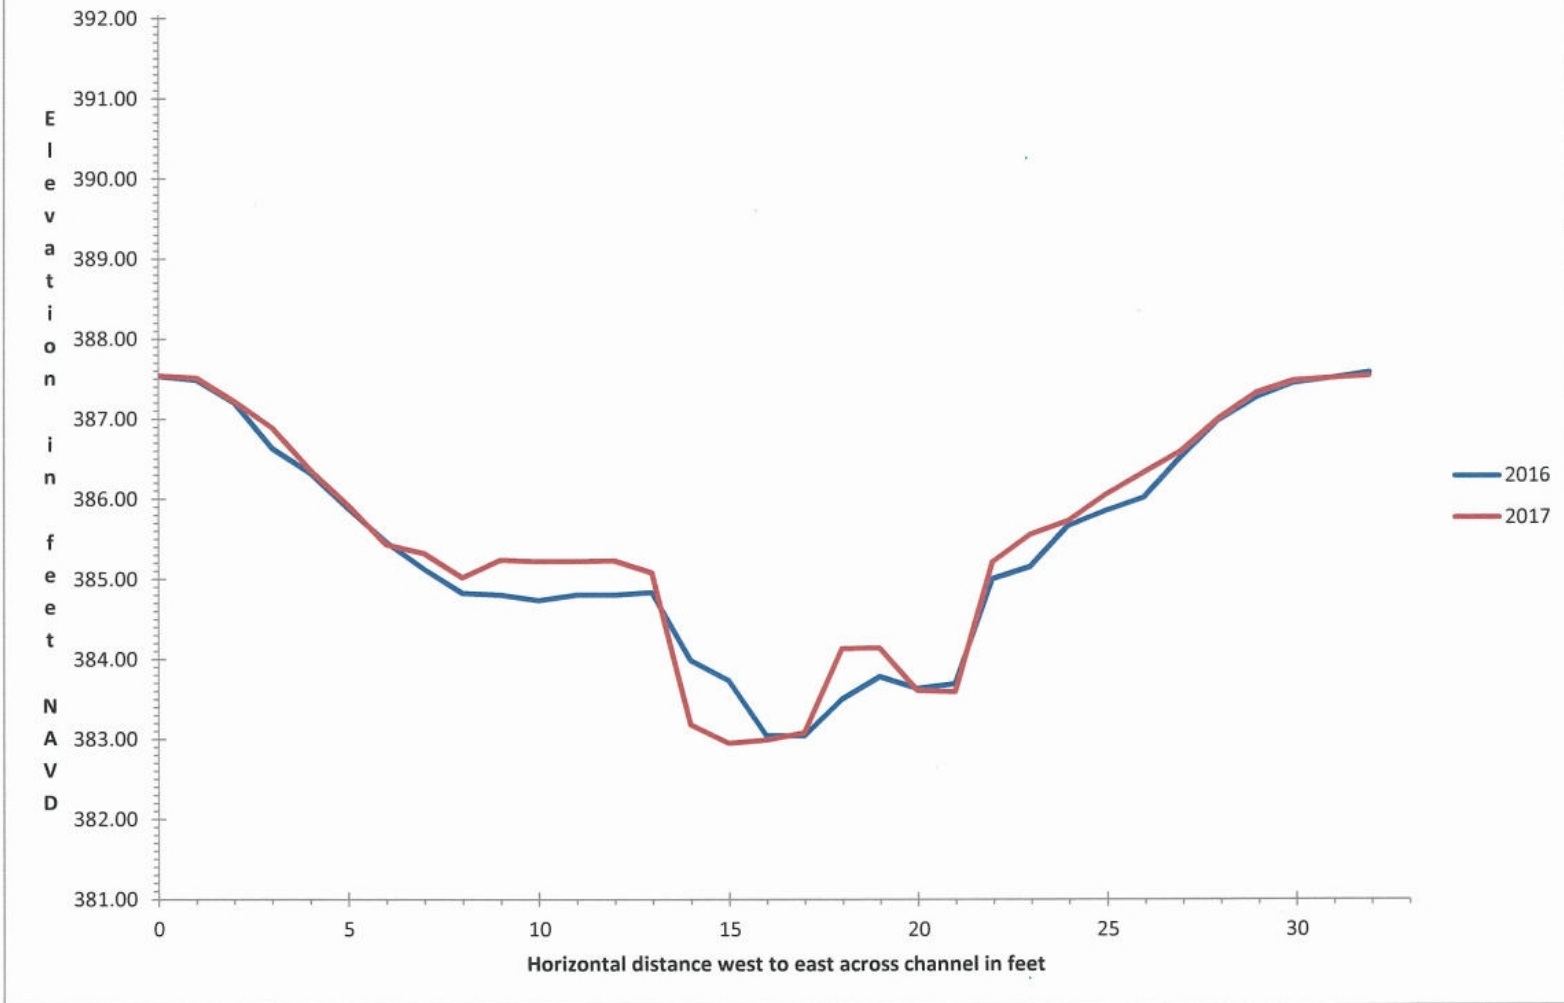
### Channel section B vertical exaggeration x2

With regard to the two stream channel success criteria, only Criterion VI.b.ii (Lateral Stability and Bank Erosion/Migration) appears to be significant with Channel Section B showing evidence of such changes. However, given the lack of changes at other sections, it is highly unlikely that channel modifying instabilities are occurring.

As mentioned above, a comparison of channel section measurements for 2016 and 2017 indicated minimal changes, except in the case of Channel Section B. At this location, the apparent bottom and bank changes are most likely explained by the ongoing beaver activity (water ponding behind dams, sediment accumulations, bank slumping, an increase in reed canarygrass along the banks). In addition, the calculations for the Bank Erosion Hazard Index (BEHI) at each cross section again indicate that the stream channel has an overall low level of susceptibility to erosion (BEHI index ranges from 19 to 20.5), with bank/height ratio remaining at 1.0. This index is based on multiple factors, including bank height and angle, root depth and density, bank material, and surface protection. Given the relatively low gradient, low velocity channel as well as its relatively well vegetated banks, the BEHI index is unlikely to appreciably change over time. In fact, none of the measures used to determine the BEHI index have changed during the past year.
