**MITIGATION BANK INSTRUMENT FOR THE DAIRY CREEK MITIGATION BANK**

Located in Banks, Washington County, Oregon

Sponsored by: DCMB LLC  
6770 Canyon Drive  
Portland, Oregon 97225

Prepared by: C. Jonas Moiel, Senior Ecologist  
Green Banks LLC  
14200 SE McLoughlin Blvd, Suite A  
Milwaukie, Oregon 97267  
(503) 477-5391

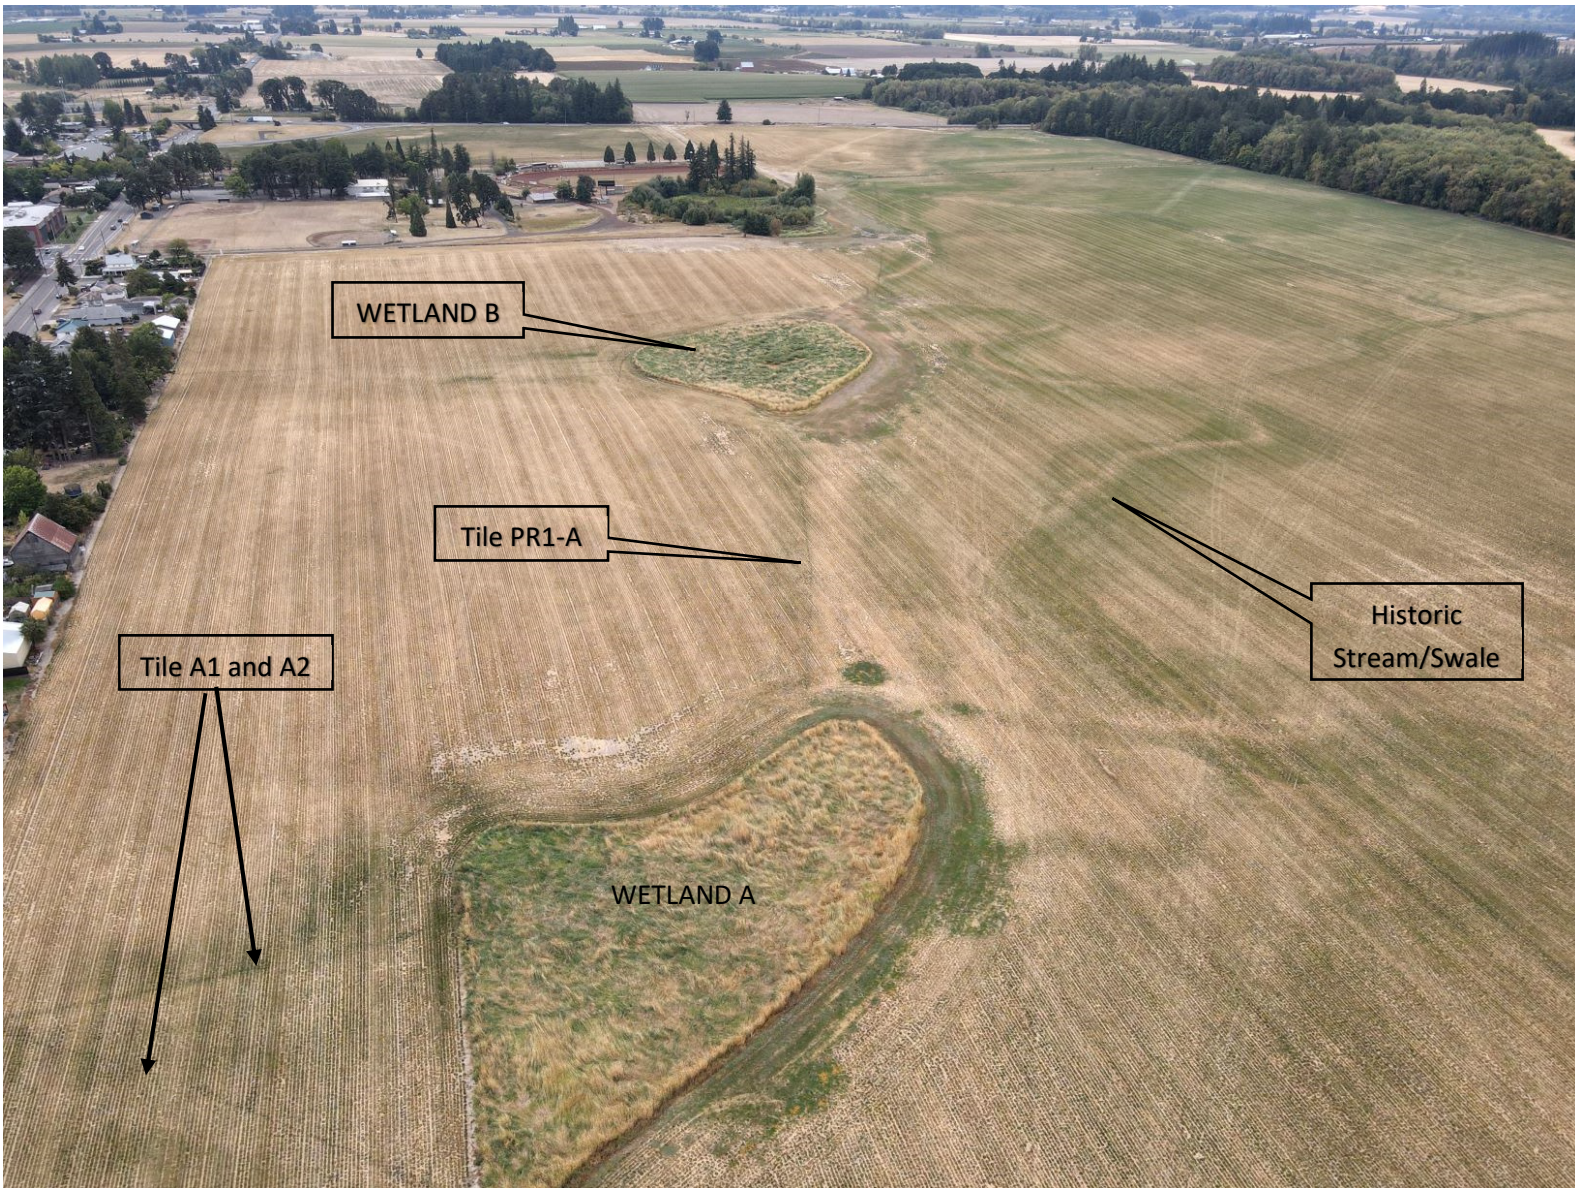
DPP1- Drone PP1 displays Wetlands A and B and active tile lines A1, A2, and PR1-A. It also displays the historic stream/swale flowing to the southwest. Photo was taken facing south/southwest from an altitude of 120m on 9/5/20.

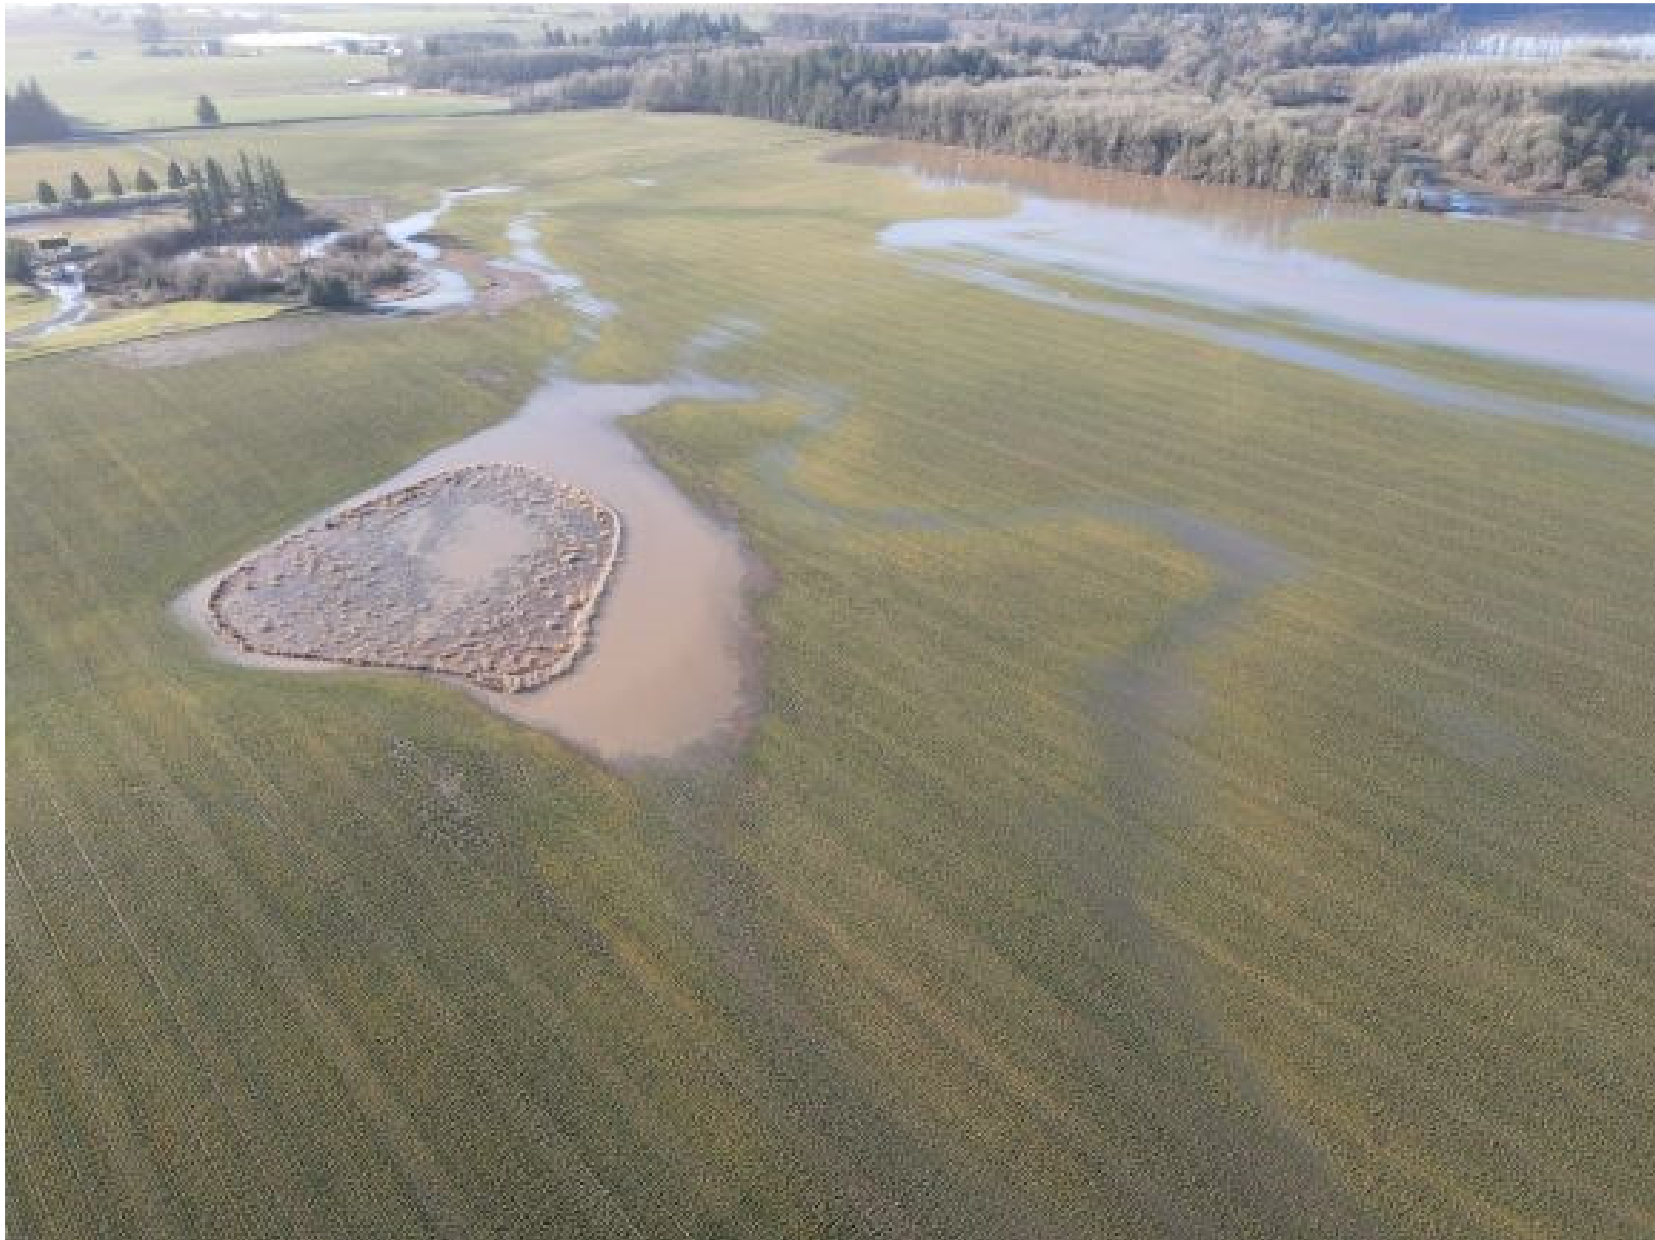
Drone Photo 13: View of Wetland B, historic swale, and flooding on January 13, 2021 facing southwest.

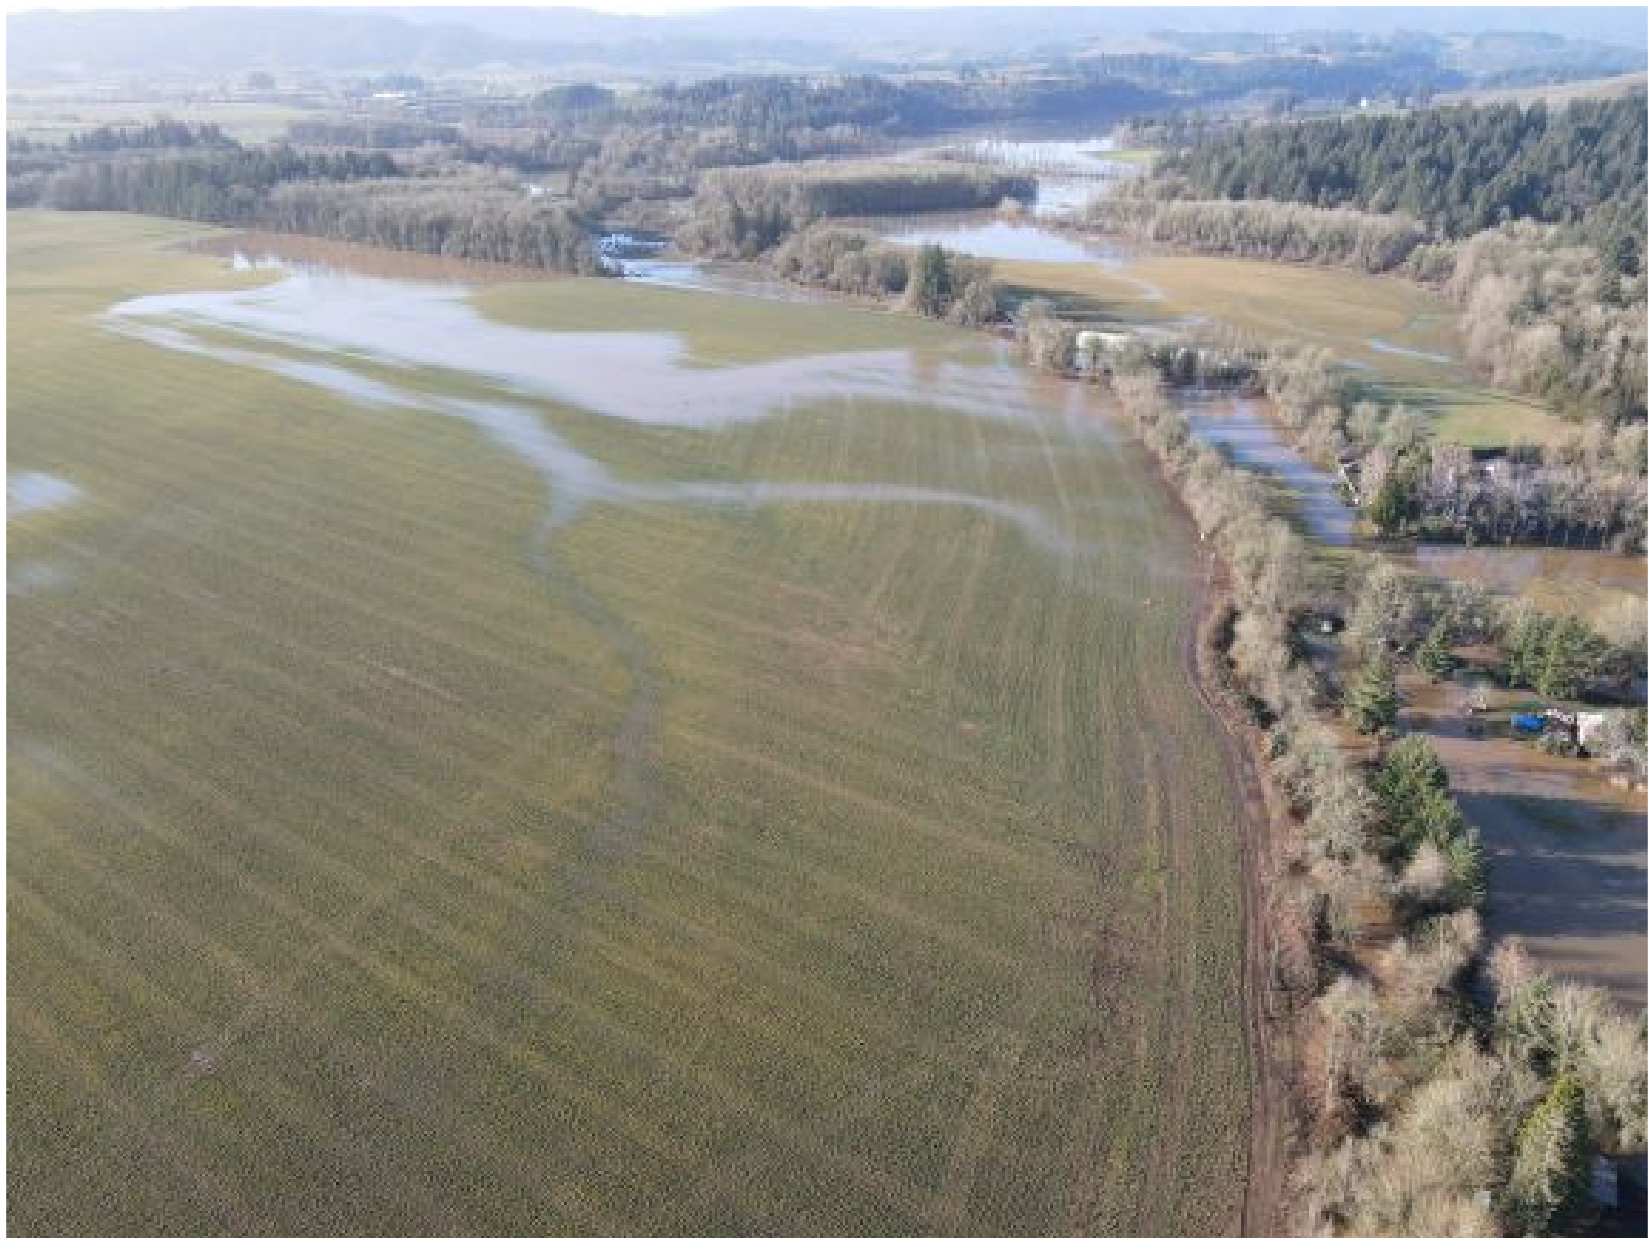
Drone Photo 14: View of W. Fork Dairy Creek and Straight Channel flooding into site on January 13, 2021, facing west.

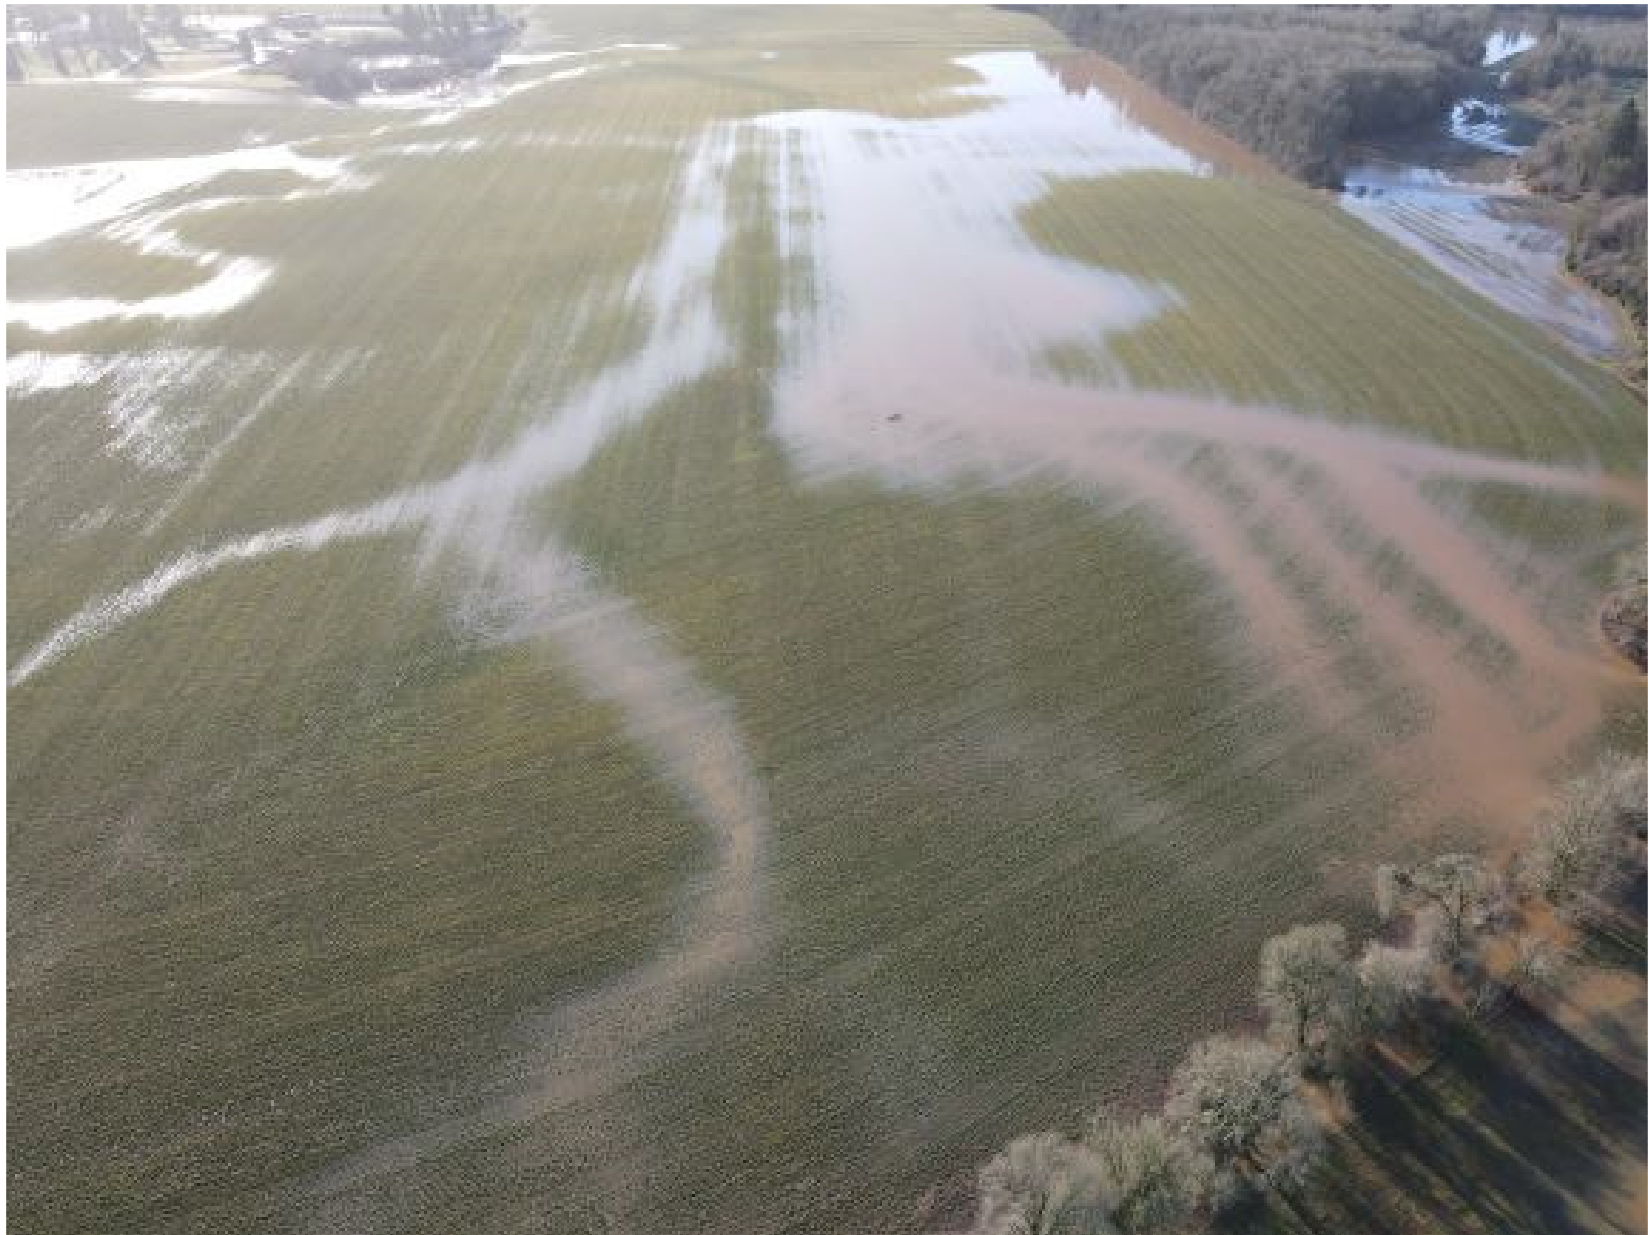
Drone Photo 16: View of flooding into DCMB from W. Fork Dairy Creek and Straight Channel in approximate location of proposed channels. Photo taken on January 13, 2021, facing south.

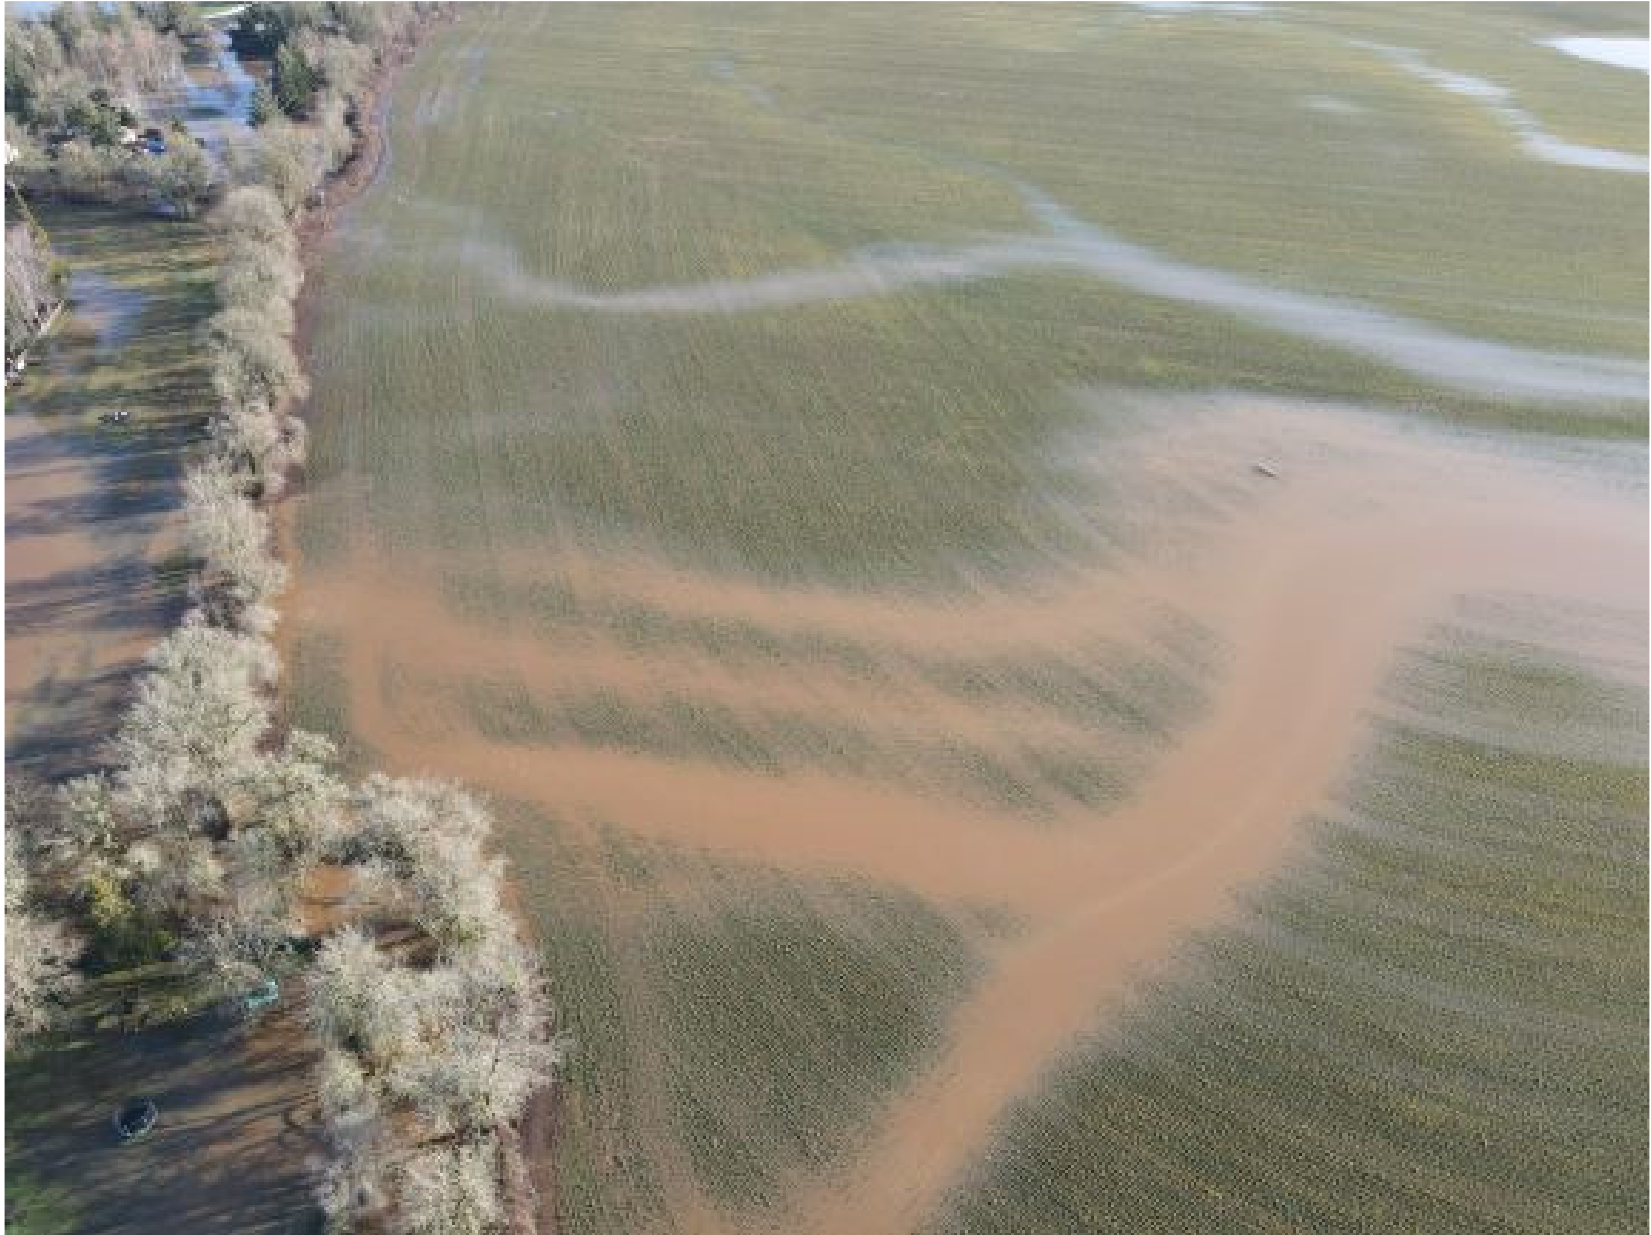
Drone Photo 17: View of flooding from W. Fork Dairy Creek and Straight Channel into DCMB on January 14, 2021, facing east.

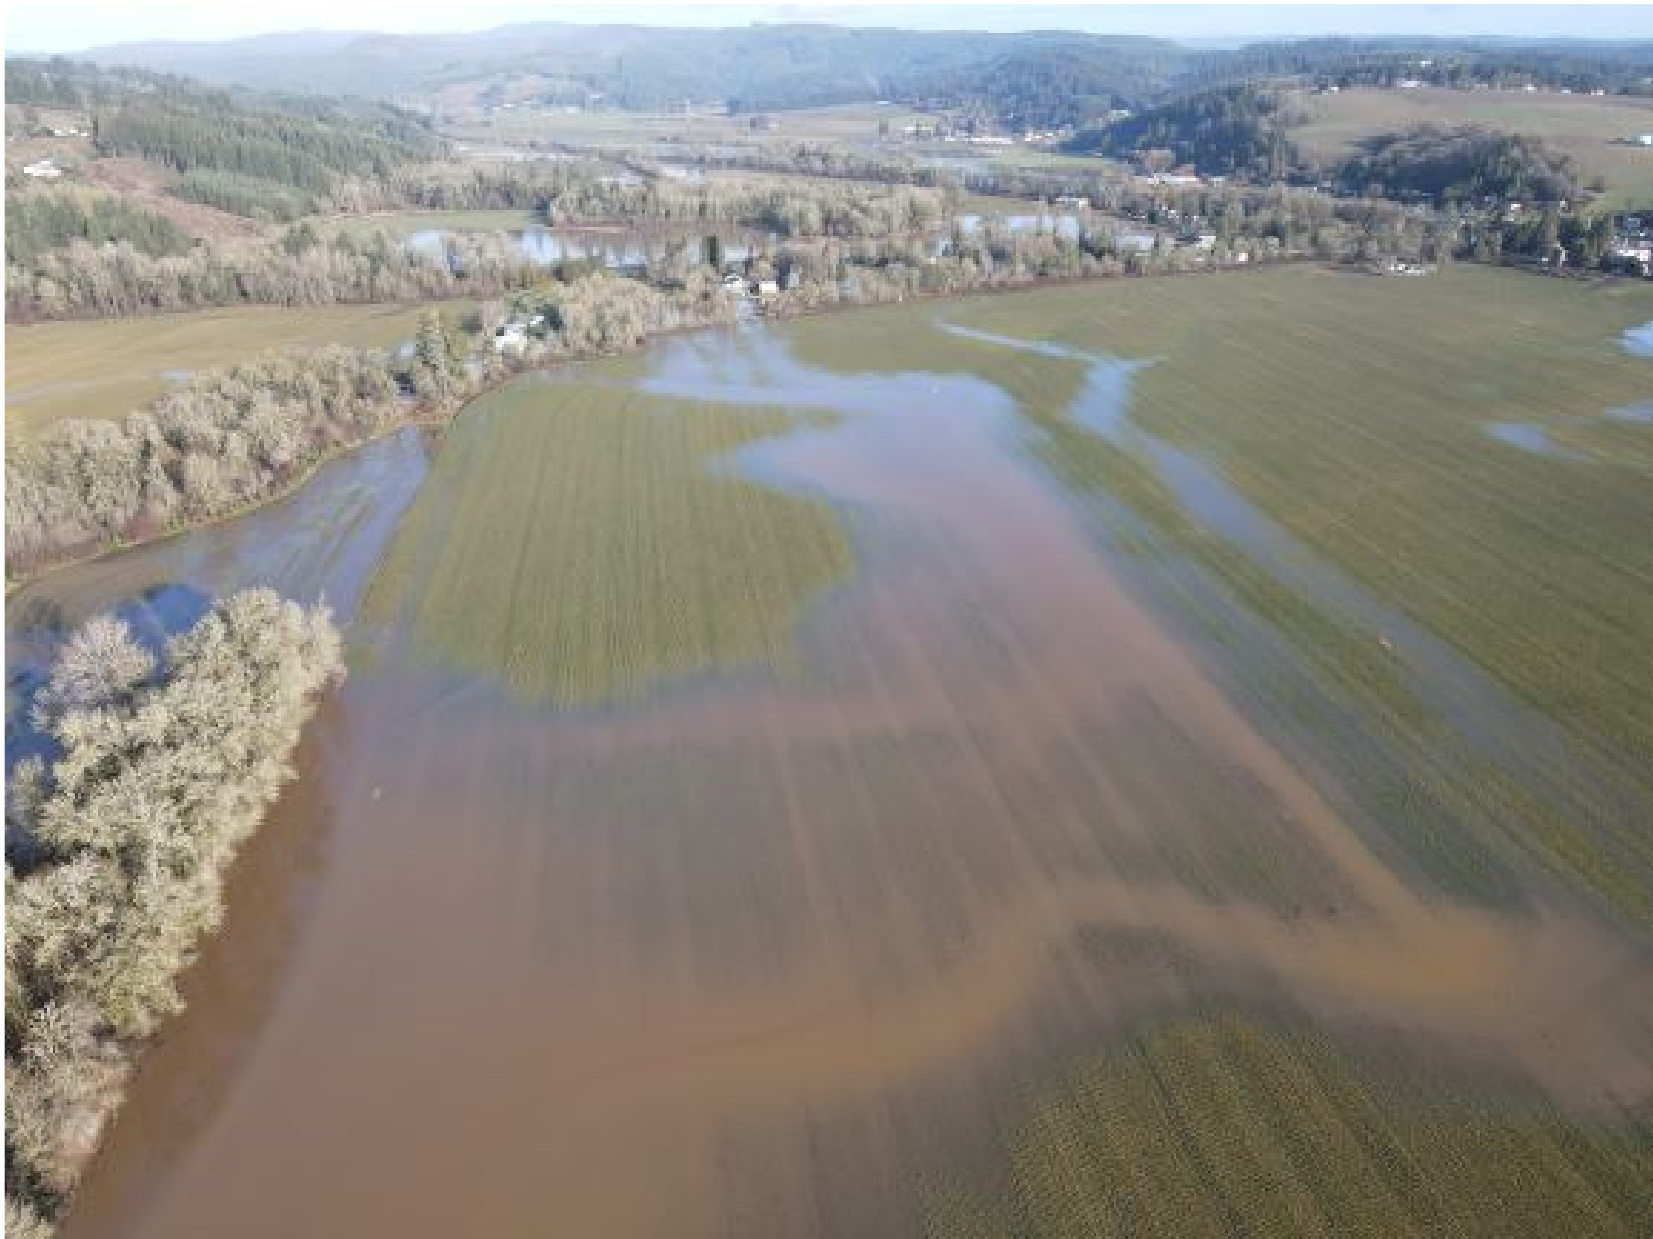
Drone Photo 18: View of approximate 2-Year flood event extent on January 13, 2021, facing north.

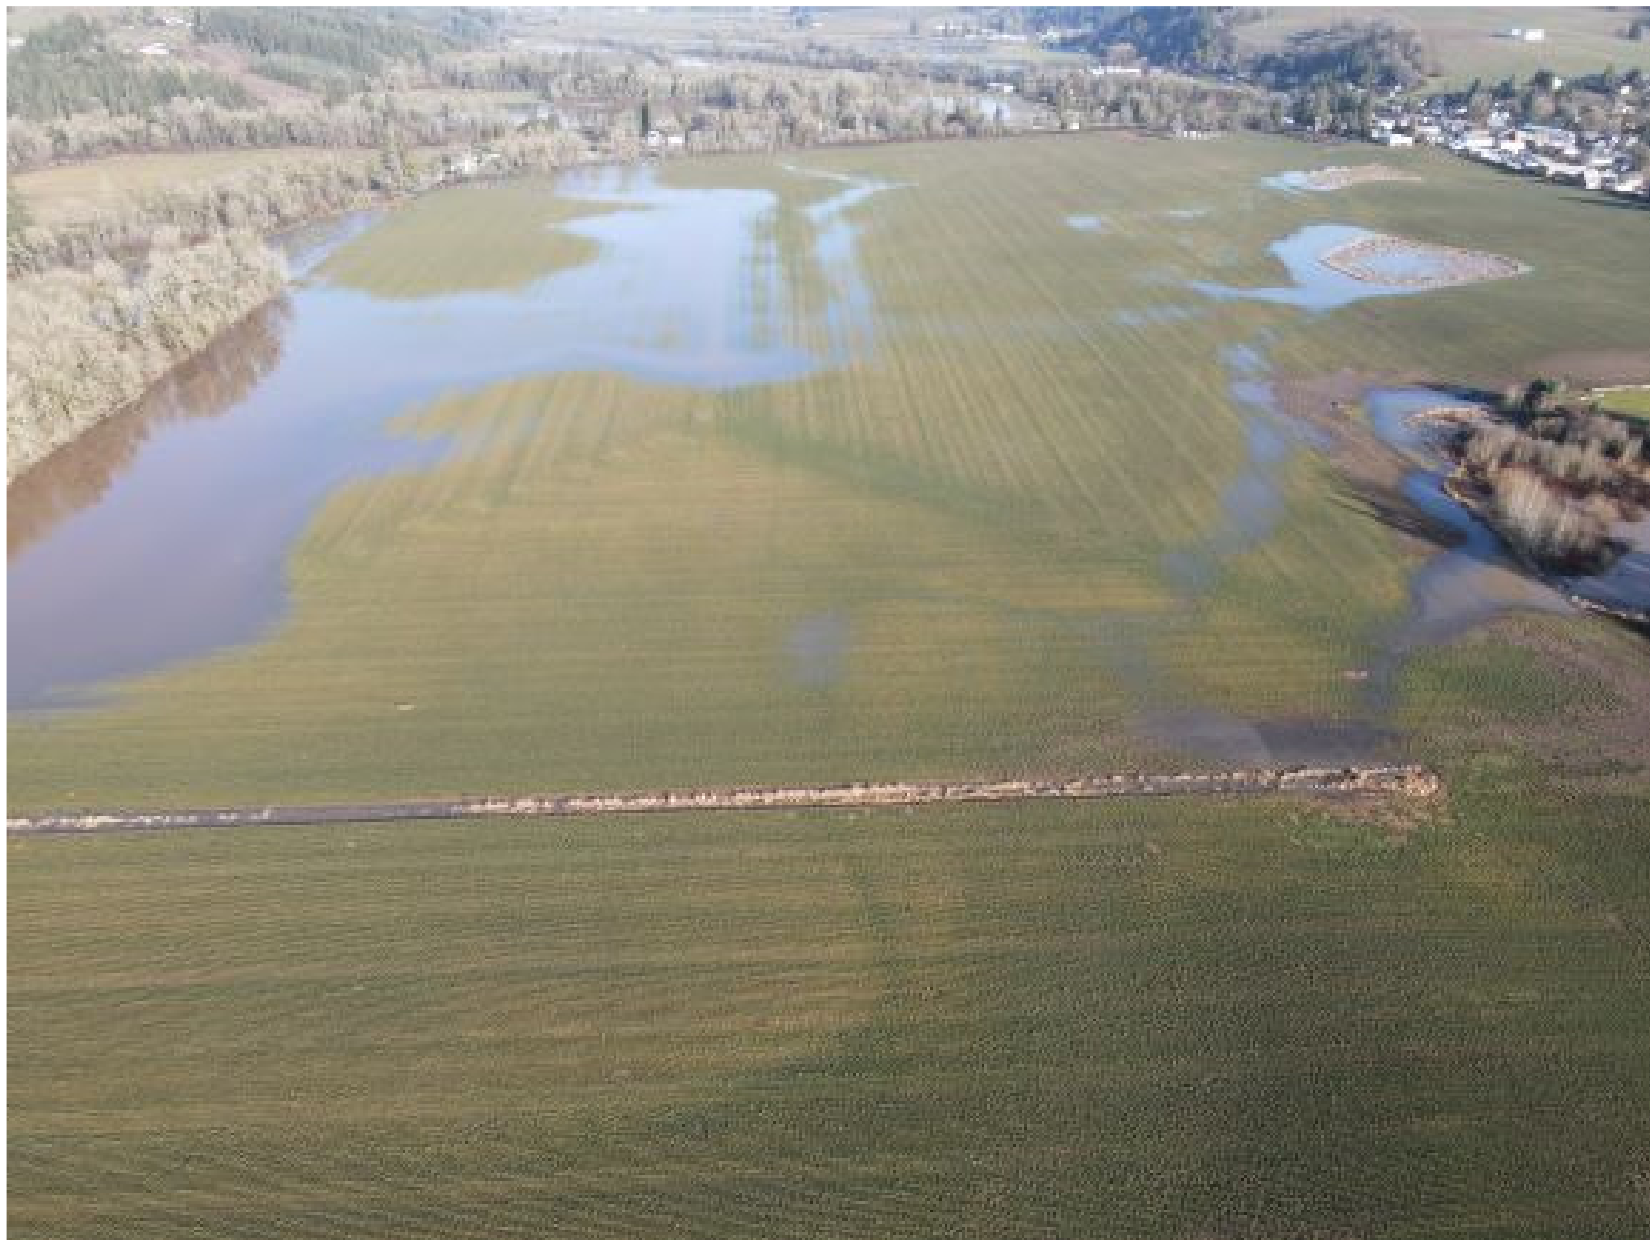
Drone Photo 19: Overview of 2-Year flood extent on January 13, 2021, facing north. Photo taken from Phase 2 area and displays E-W ditch.

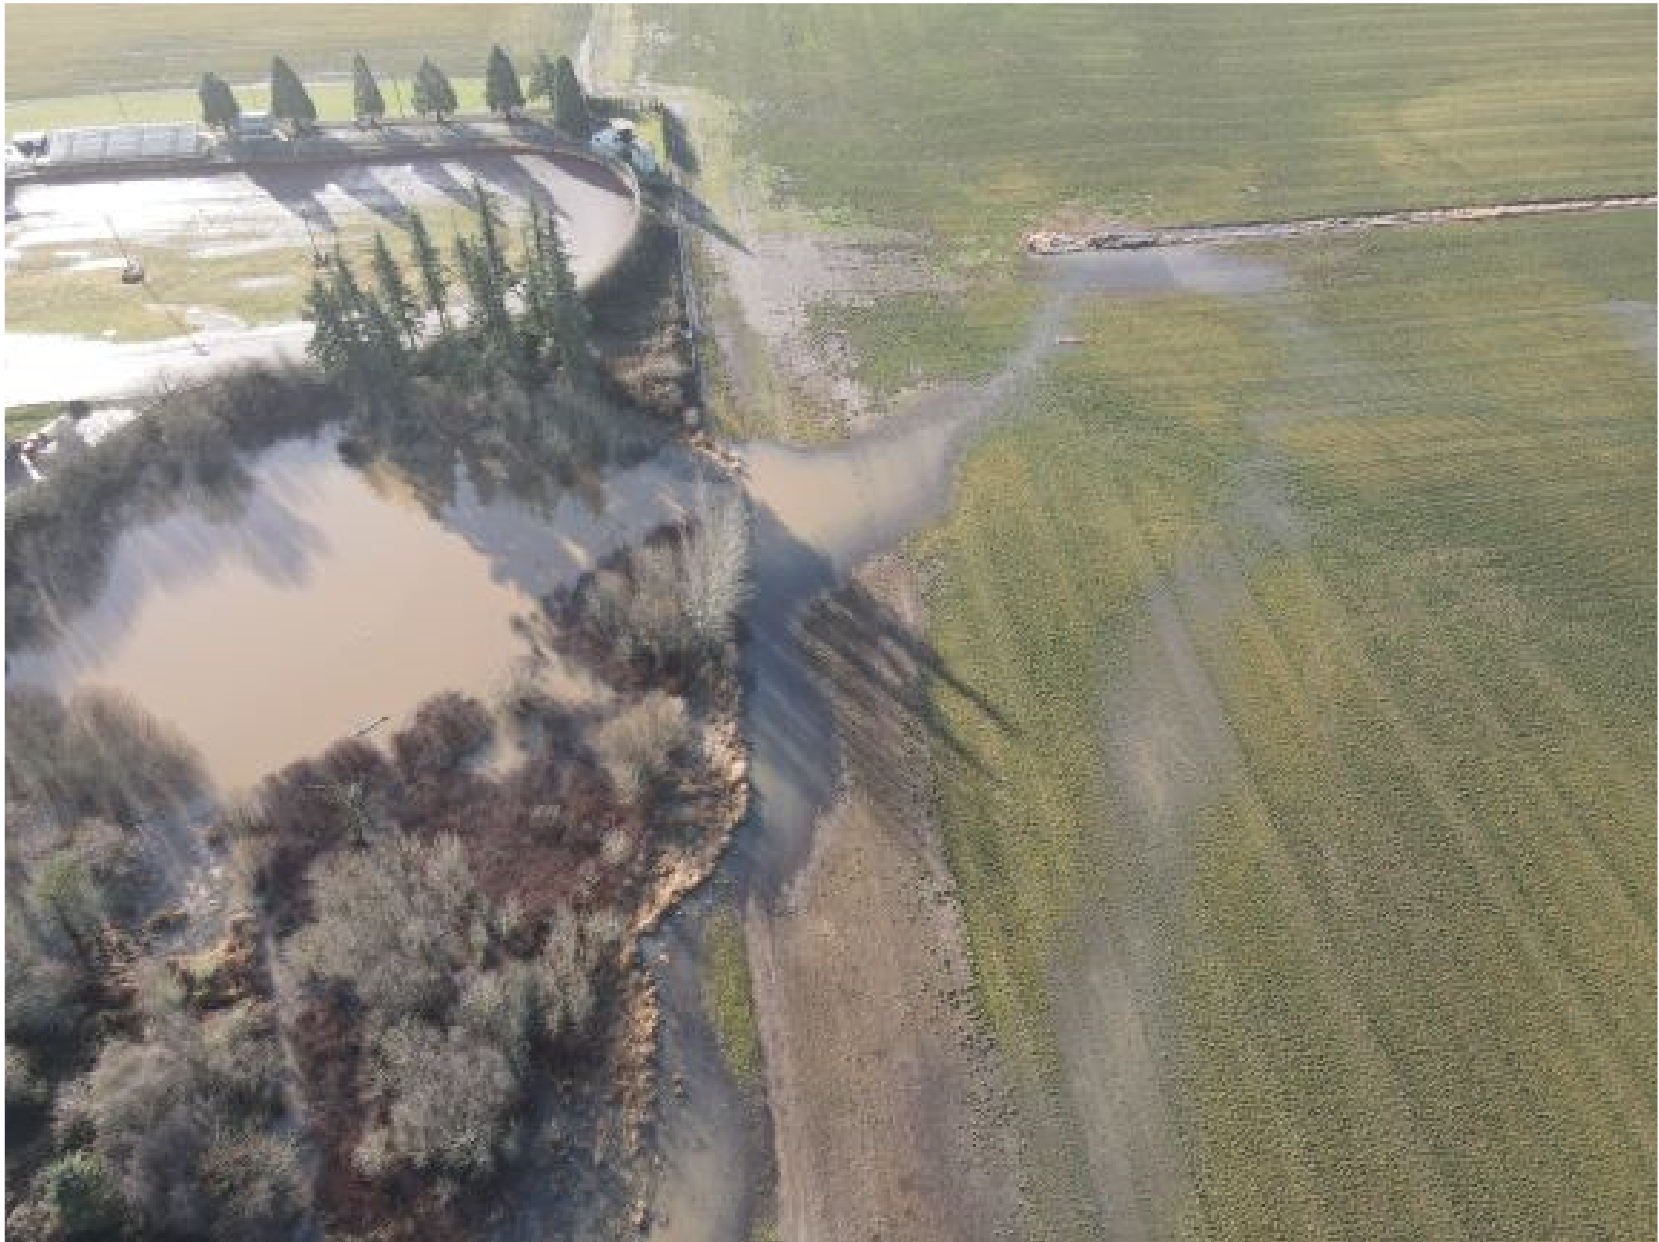
Drone Photo 20: View of offsite wetland east of Phase 2 project area overflowing into the DCMB on January 13, 2021, facing south.
