**MITIGATION BANK INSTRUMENT  
FOR  
GARRET CREEK WETLAND MITIGATION BANK**

# Wetland Mitigation Plan

Garret Creek Mitigation Bank ■ Garret Creek Mitigation Bank, LLC ■ July 2008

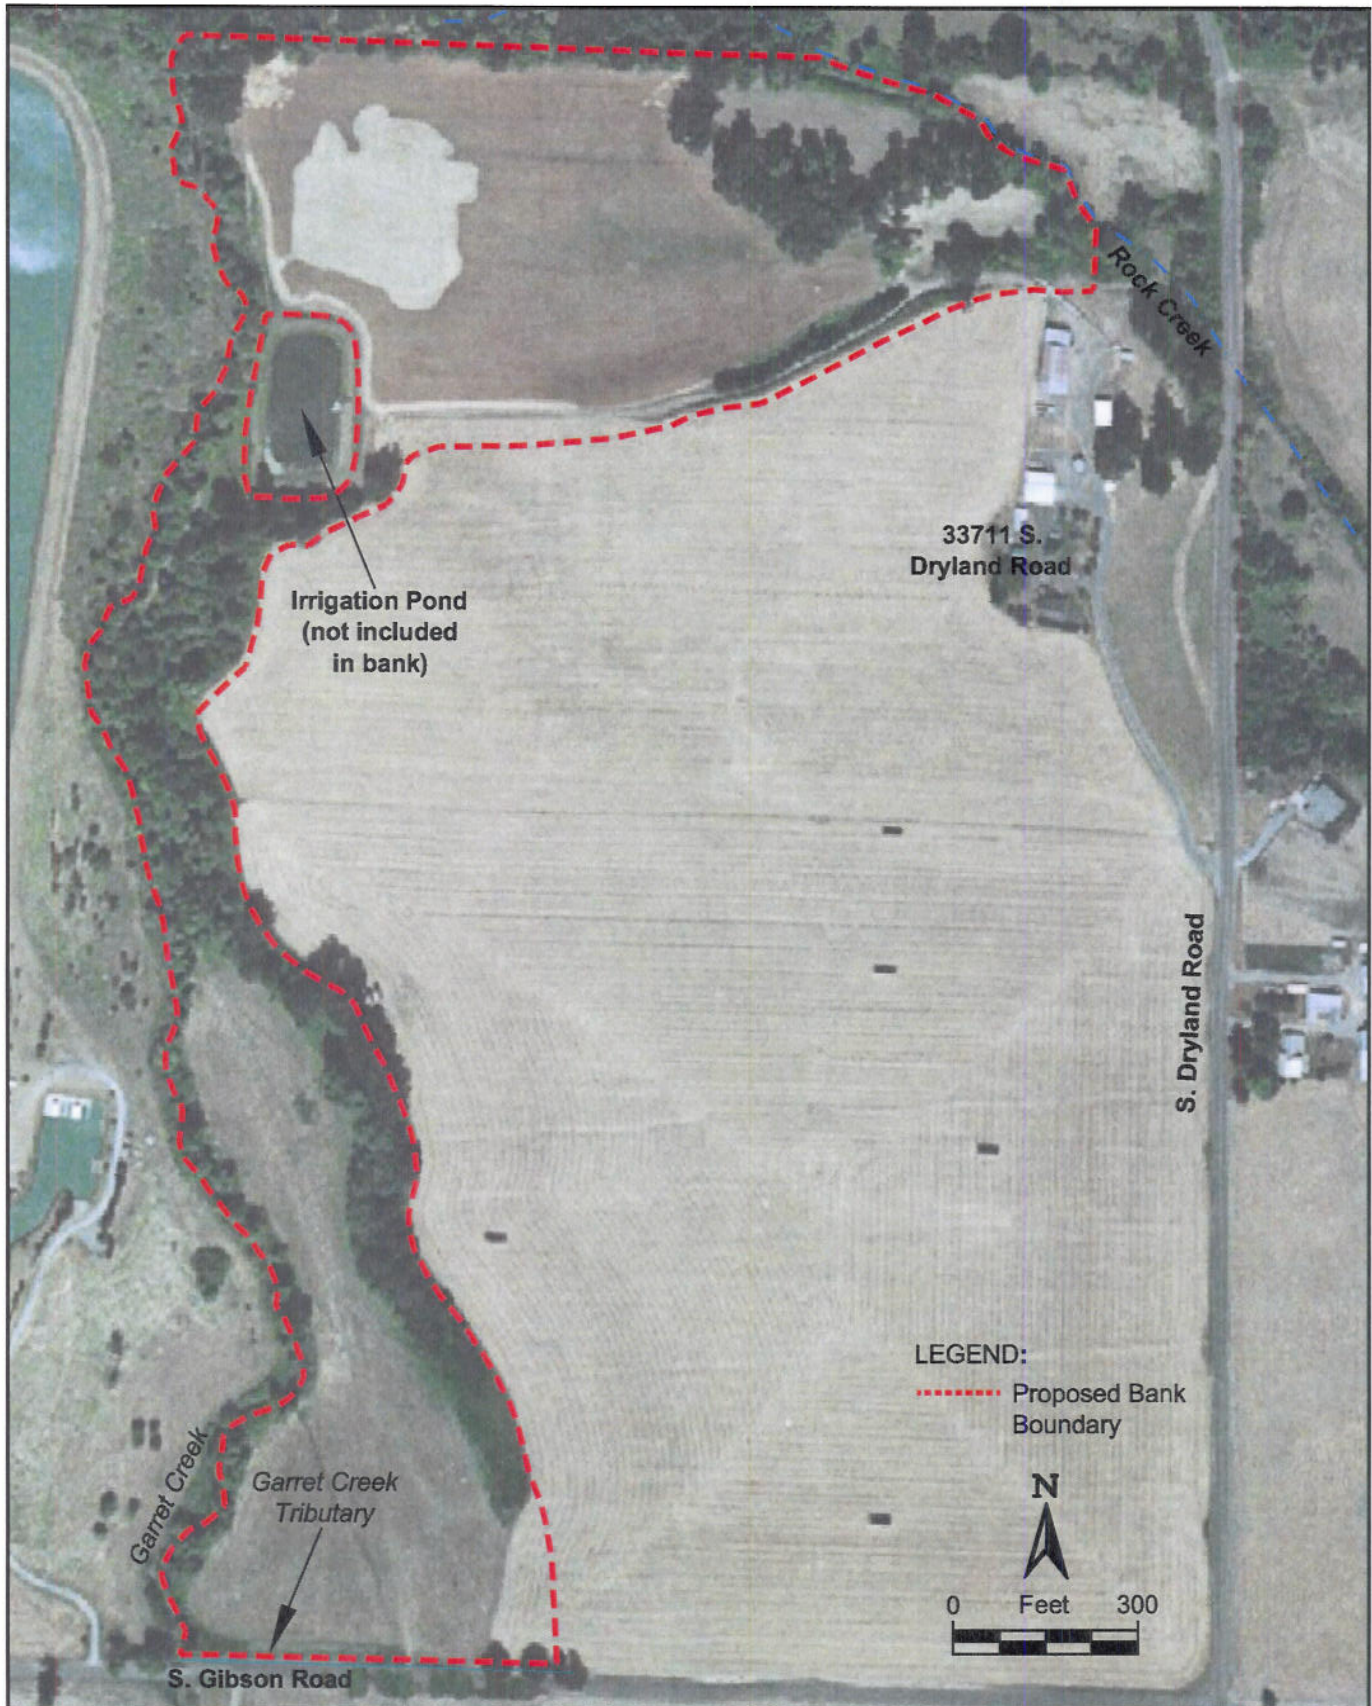
The wetland forest separates the northwestern and southern cropland, and is too wet to be farmed. The property owner constructed an informal roadway through the forested wetland to provide direct access between the two croplands. The roadway was roughly graded by Mr. Kemnitz without surfacing with roadbed material. The roadway is partially vegetated by native and pasture grasses, allowing vehicular access between May and October in most years.

Gibson Road runs south of the southern cropland, and the county right-of-way creates the southern border of the site. Gibson Road connects S. Dryland Road to Barlow Road, providing access primarily to local residents.
