# Oregon Department of State Lands Statewide Fee-In-Lieu Instrument Modification Proposal

Mitigation Plan for: Half Mile Lane Project

January 28, 2010

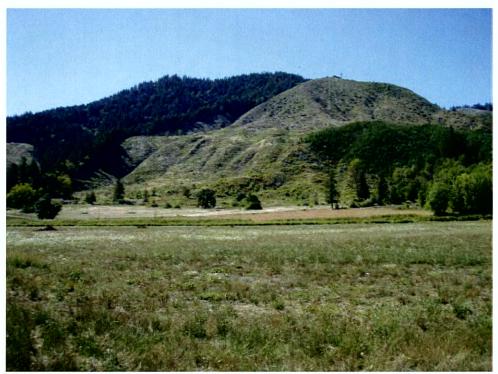
Photo 1. View looking west of site from Half Mile Lane. Photo CMW 9/08/08

The study area on tax lot 700 is undeveloped and consists of an actively managed wheat crop located in a valley (Photo 1). A rural residential home exists in the northeast portion of tax lot 600 with fenced pasture dominated by a grazed non-native facultative grass community to the west.

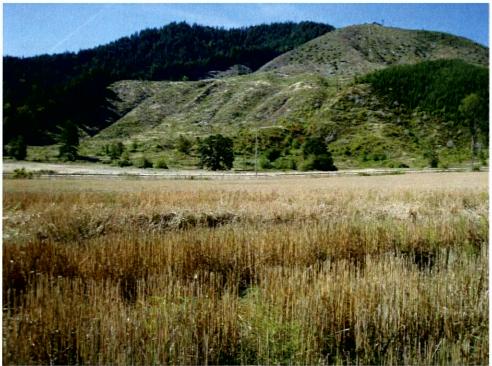
Photo 2. View looking west of site from wetland west of Roderick Creek. Photo CMW 9/05/08

Roderick Creek, a perennial tributary to the Gales Creek, flows southeasterly through the southern portion of the study area (Photo 2). Gales Creek is located within 500 feet off-site to the east.

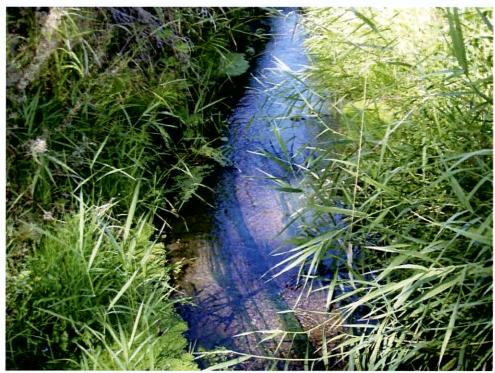
Photo 3. View looking north of Roderick Creek from culvert under road at south end of site. Photo CMW 9/08/08

Roderick Creek enters the study area from the northwest and flows in a southeasterly direction through tax lot 700 (approximately 1300 linear feet and 0.52 acre within the study area). It leaves the site via a 43-inch corrugated metal culvert under a farm road along the southern property boundary. A second culvert is present to the south to accommodate overflow conditions. The creek joins Gales Creek through a ditch that extends east to the south of the property. On-site, the creek lacks sinuosity with on average ditched 4-5 foot tall banks and an approximate average 10 foot wide bed (Photo 7) with portions of the right bank at approximately 10 feet in height. The channel bed generally lacked vegetation with dominant substrate consisting of small gravels. Approximately 6 inch+ deep flow was observed in the channel during the September 2008 site visits and approximately 8 inches+ during the April 10, 2009 site visit. On-site the channel contains regular repeating sequences of riffle and deeper pool complexes. A green plastic pipe was observed extending from approximately 3 feet above the water on the right bank, upstream of the wetland located west of the creek, with flow draining into the creek during the April 29, 2009 site visit.

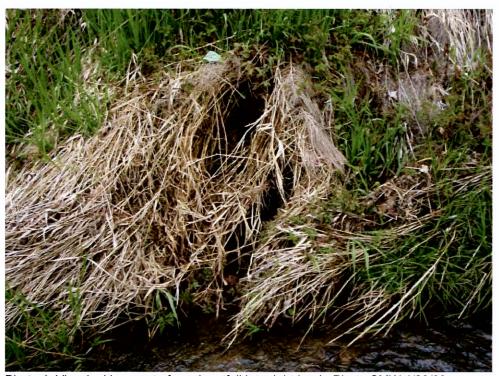
Photo 4. View looking west of creek outfall into right bank. Photo CMW 4/29/09

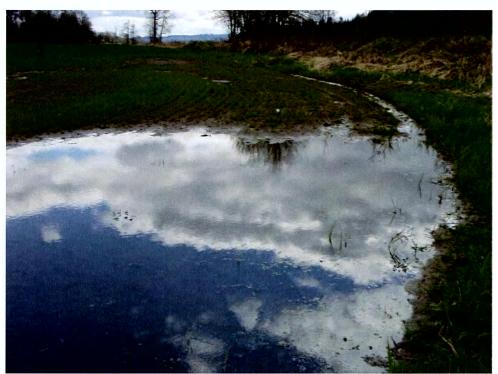
Photo 5. View south of ponding in wetland delineated on eastern side of creek. Photo CMW 4/10/09

Soils documented in wetland plots met Redox Dark Surface (F6) hydric soil indicator. Gley and depleted matrix surface profiles were also documented in the wetland on the eastern side of the creek (plot 24). Scattered shallow ponding ranging from 1 to ½-inch deep was observed in both wetlands during the April 10, 2009 site visit. A larger pool of up to 4-inch deep ponding was observed in the lowest elevational portions of the wetland on the eastern side of the creek (Photo 5).

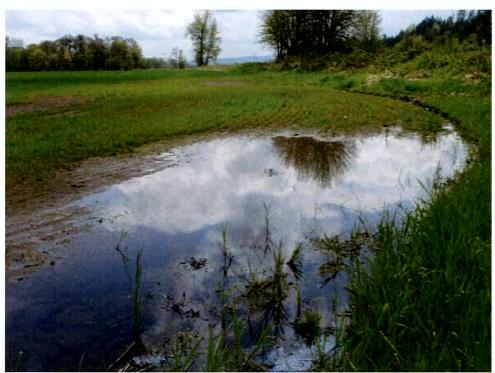
Photo 6. View south of ponding in wetland delineated on eastern side of creek. Crop stress visible in wheat. Photo CMW 4/29/09

Wetland conditions were determined by the presence of hydric soils and wetland hydrology indicators during the April 10, 2009 site visit. The wetland boundary was defined by a slight topographic increase to the adjacent uplands along with the lack of wetland hydrology indicators on April 10, 2009 (Photo 6).

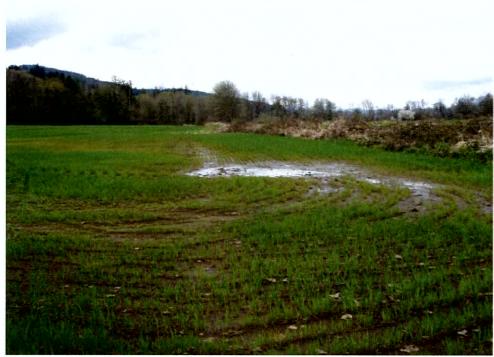
Photo 7. View looking north of wetland delineated on western side of creek. Photo CMW 4/10/09

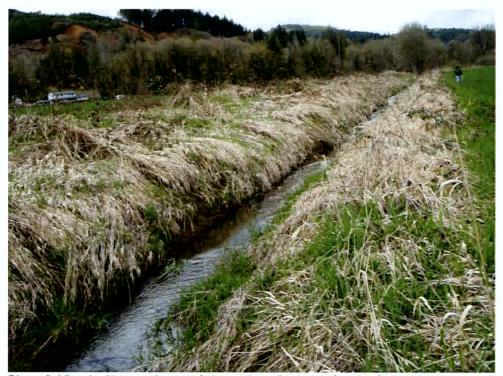
Photo 8. View looking northwest of channelized Roderick Creek. CMW 4/10/09

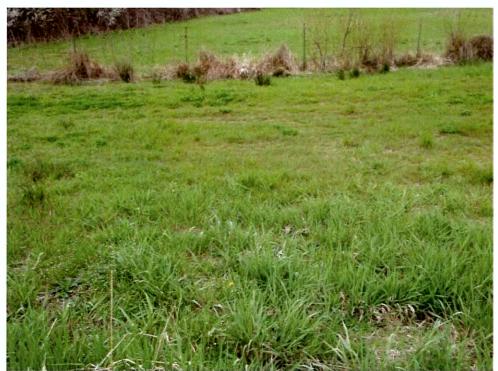
Photo 9. View looking east of vicinity of ds-1 in northern portion of study area. Photo CMW 4/10/09

The wetland boundary to the east was documented by the lack of wetland hydrology indicators (as documented at upland plot ds-1 and ds-3; Photo 9). The east top of bank associated with the eastern ditch defined the eastern wetland boundary (Photo 10).

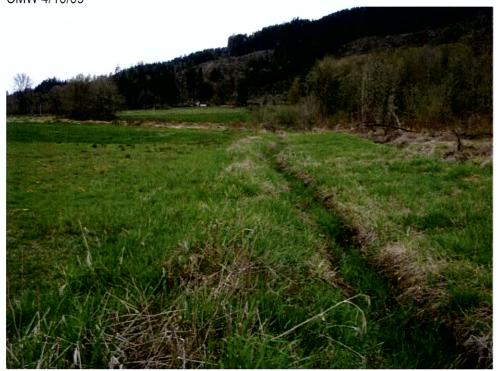
Photo 10. View looking southwest of ditch / eastern wetland boundary in northern portion of study area. Photo CMW 4/10/09
