RINEARSON NATURAL AREA RESTORATION MONITORING REPORT **YEAR 3 (2021)**

Prepared for
Columbia Restoration Group, LLC

Submitted January 2022;
Revised September 2022

Rinearson Natural Area Restoration Monitoring – Cover Sheet

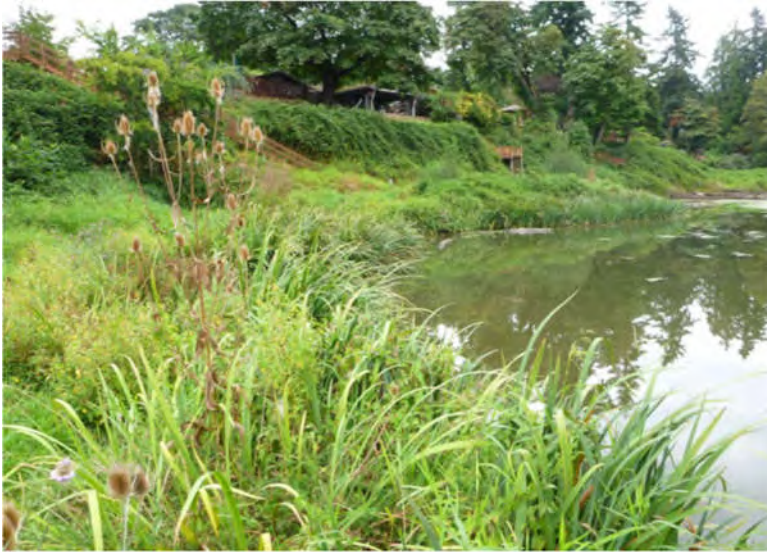
Figure 1-2: PP2 baseline, north shore of pond.

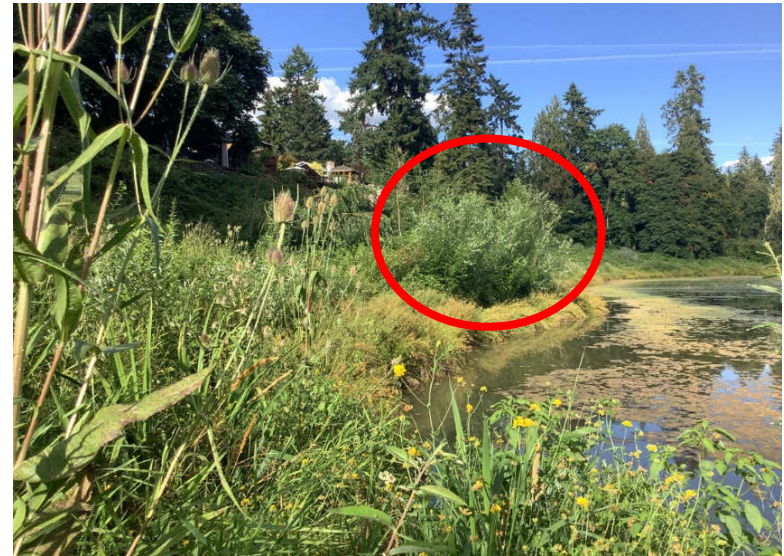
Figure 1-3: PP2 2021, note dense willow growth on north bank.

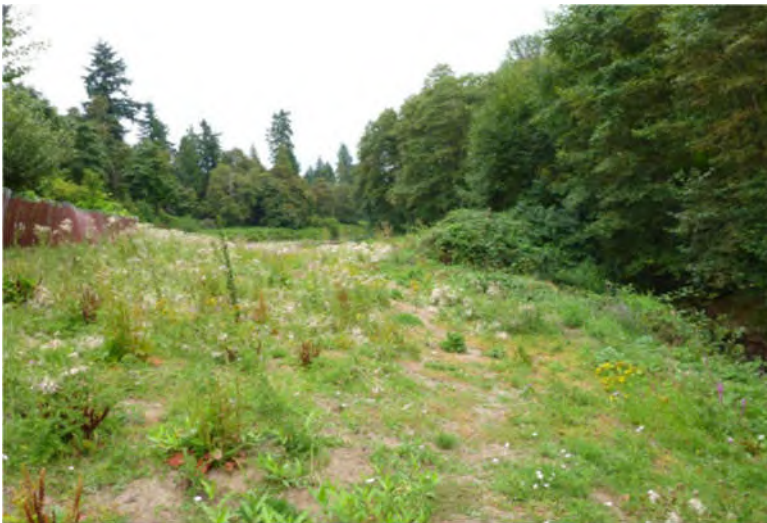
Figure 1-4: PP3 baseline, ruderal, weedy area near dam.

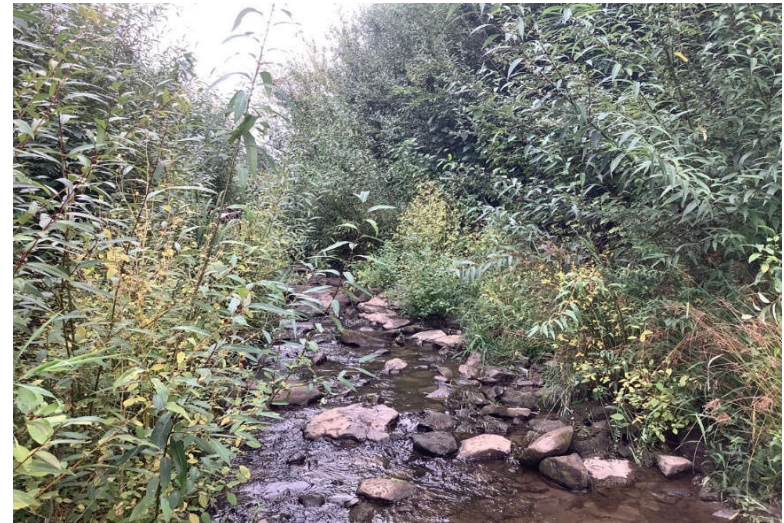
Figure 1-5: PP3 2021, dense willow thickets on streambanks.

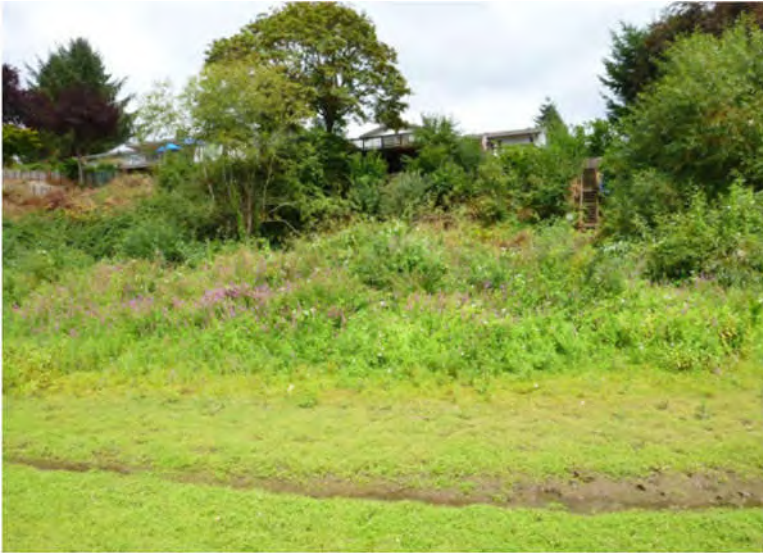
Figure 1-6: PP4 baseline, looking north.

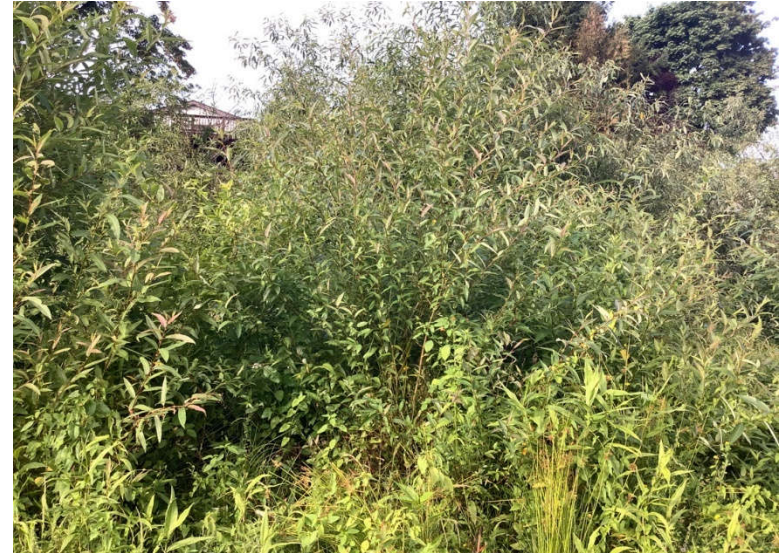
Figure 1-7: PP4 2021, looking north with dense willow growth.

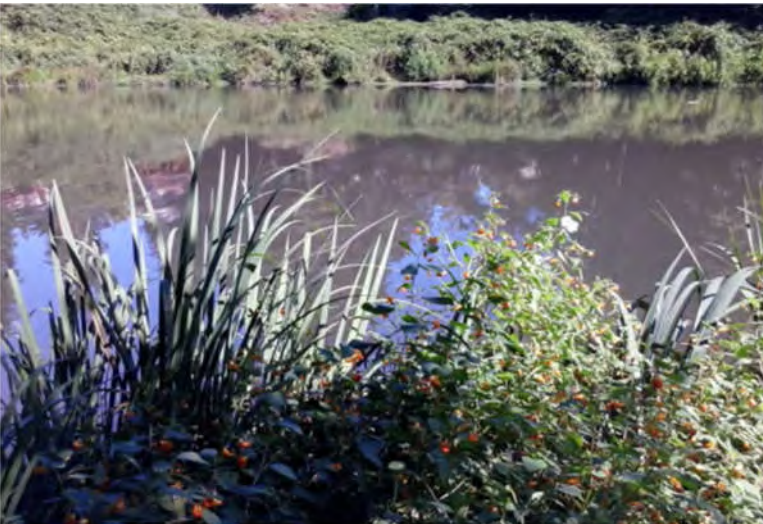
Figure 1-8: PP9 baseline, yellow flag iris and jewelweed.

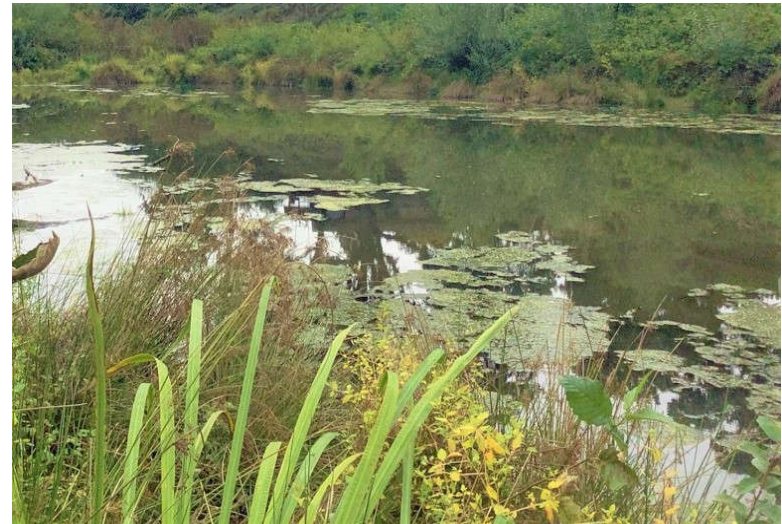
Figure 1-9: PP9 2021, yellow flag iris and jewelweed remain.

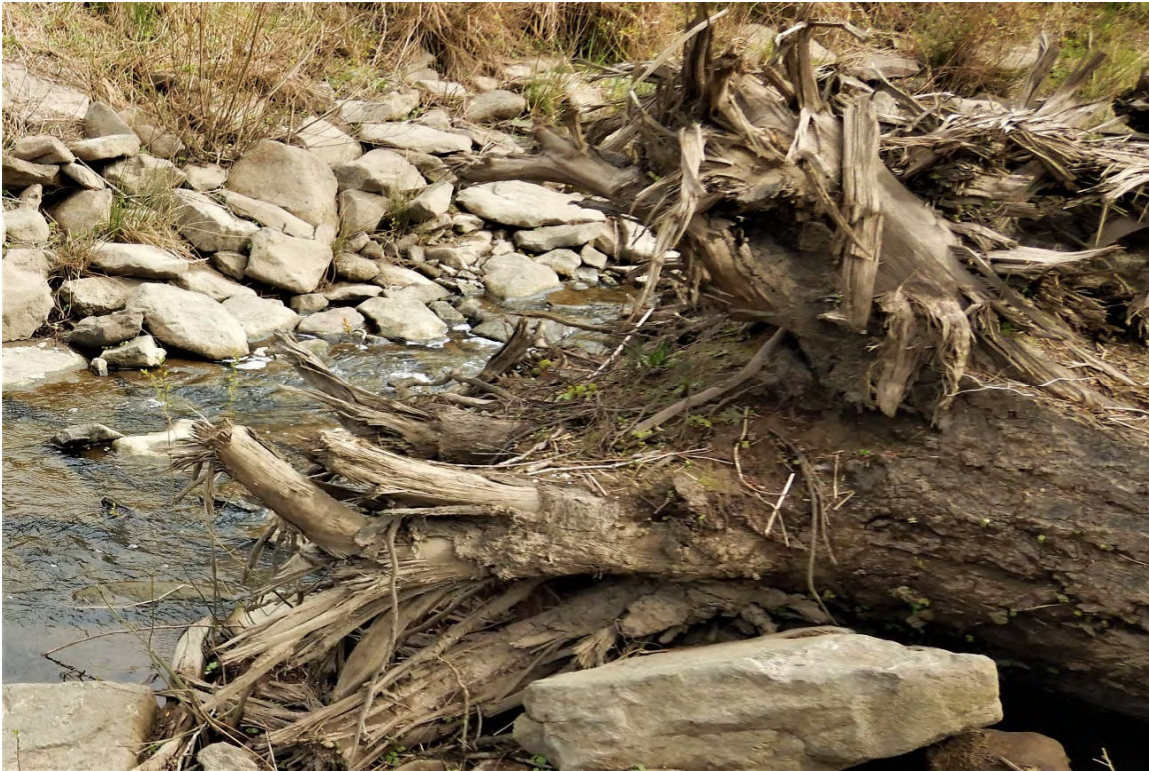
Four log structures were installed in the roughened channel downstream of the remnant pond outlet, and all four were recorded in 2021, indicating that the site requirement of 100% of as-built structures to remain, was met. A typical log structure is shown in **Figure 2-2**.

Figure 2-2. Typical Log Structure Installed and Retained Downstream of the Remnant Pond Outlet

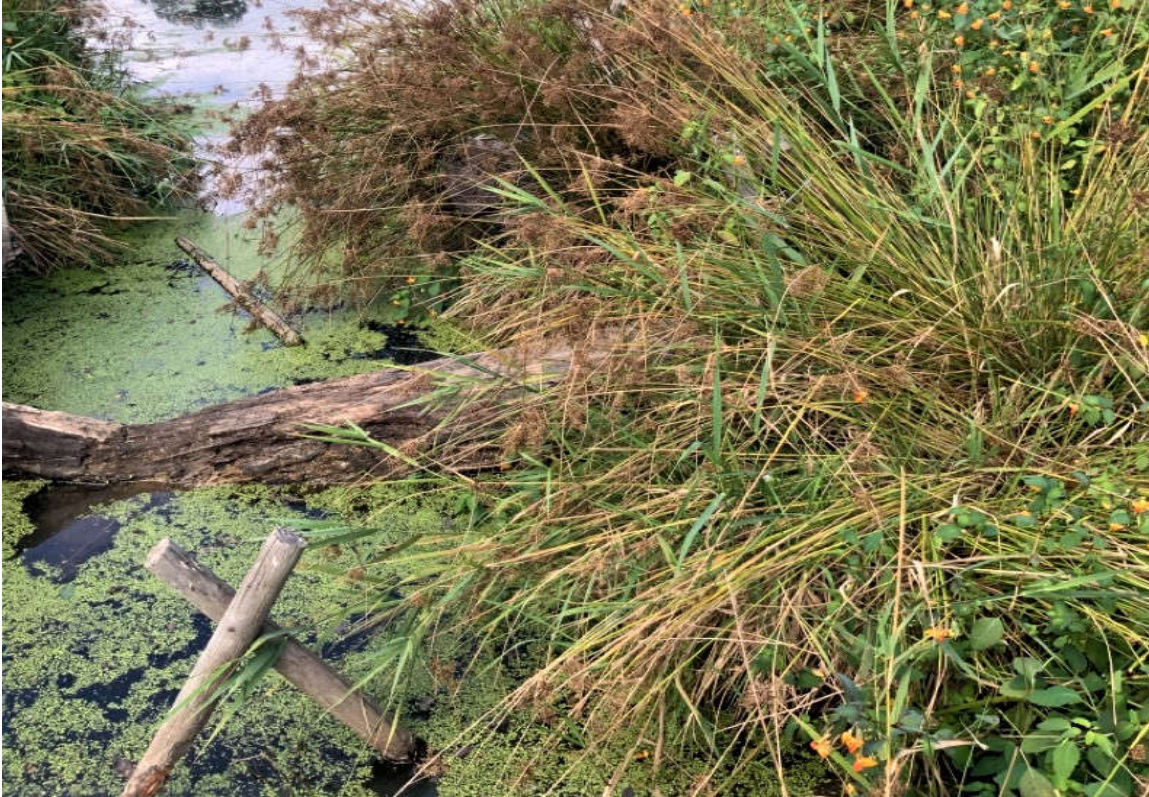
Figure 2-3. Typical Wood Structure Installed Upstream of the Remnant Pond Outlet

Both aquatic and terrestrial wood structures in the upstream area of the remnant pond were surveyed (**Figure 2-3**). As-built plans show 13 floodplain structures, 12 meander channel structures as well as 3 trees tipped into the remnant pond. All but two large wood structure was located, indicating the site requirement of 80% of as-built structures to remain was met. One floodplain log was not located and a second structure was in poor condition, considered absent. A third floodplain log shifted location and is considered present. Refer to **Appendix B** for photo documentation and data sheets of aquatic and terrestrial wood structures.

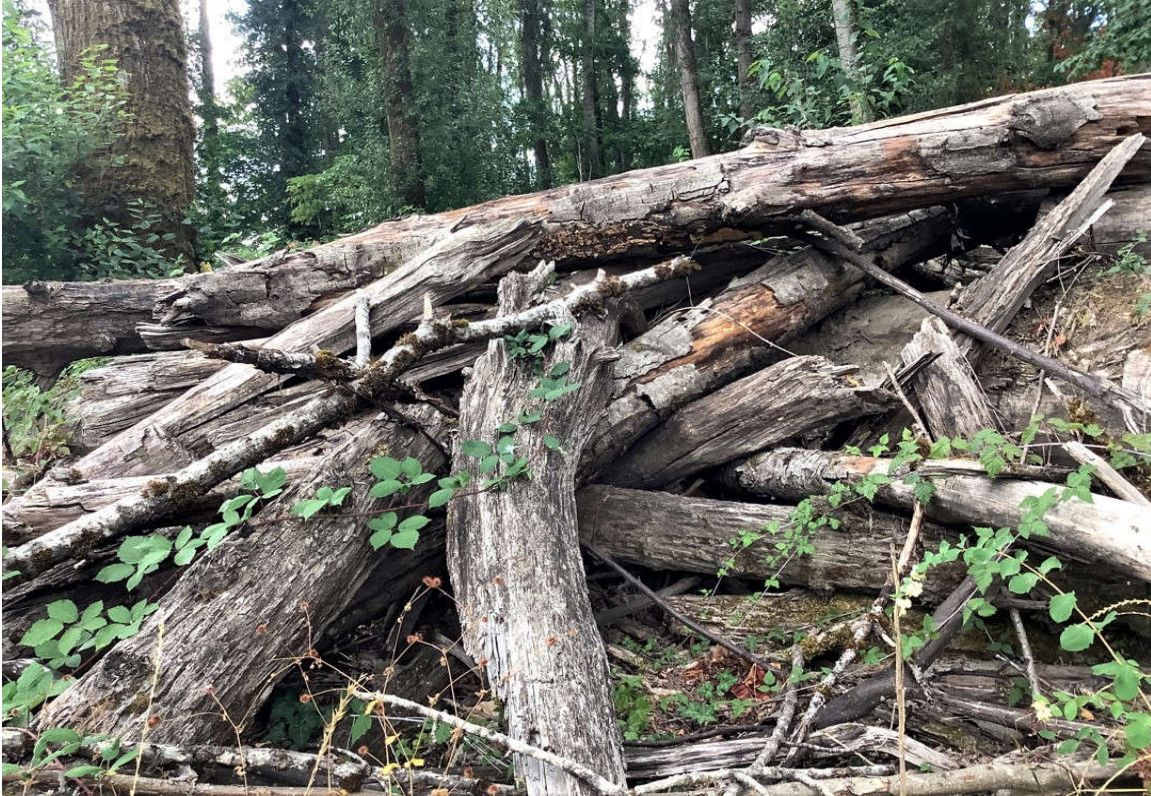
Figure 2-4. Typical Upland Wood Structure

Upland habitat structures were monitoring according to the HDP. As-built plans show 11 upland log structures, 13 debris piles, 7 small rock piles, 4 large rock piles, and 8 snags for a total of 43 features. All but 6 features were located, indicating greater than 80 percent retention was achieved and the performance standard met (**Figure 2-4**). Features that were not located due to extensive blackberry cover or in poor condition due to either being dismantled or degraded were considered absent.

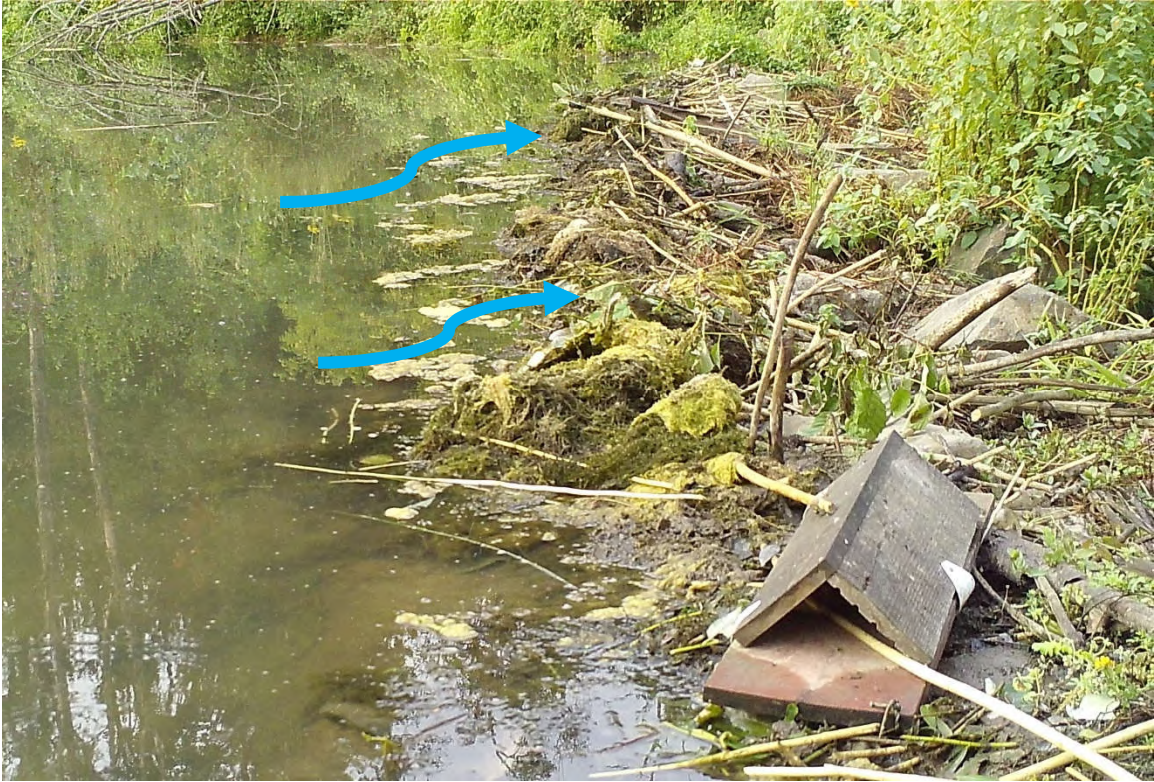
The beaver dam documented in the previous year's monitoring report (Cardno 2020) is still in place with water draining through the dam during low water (**Figure 2-5**).

Figure 2-5: Water trickles through the beaver dam at the remnant pond outlet, August 3, 2021.

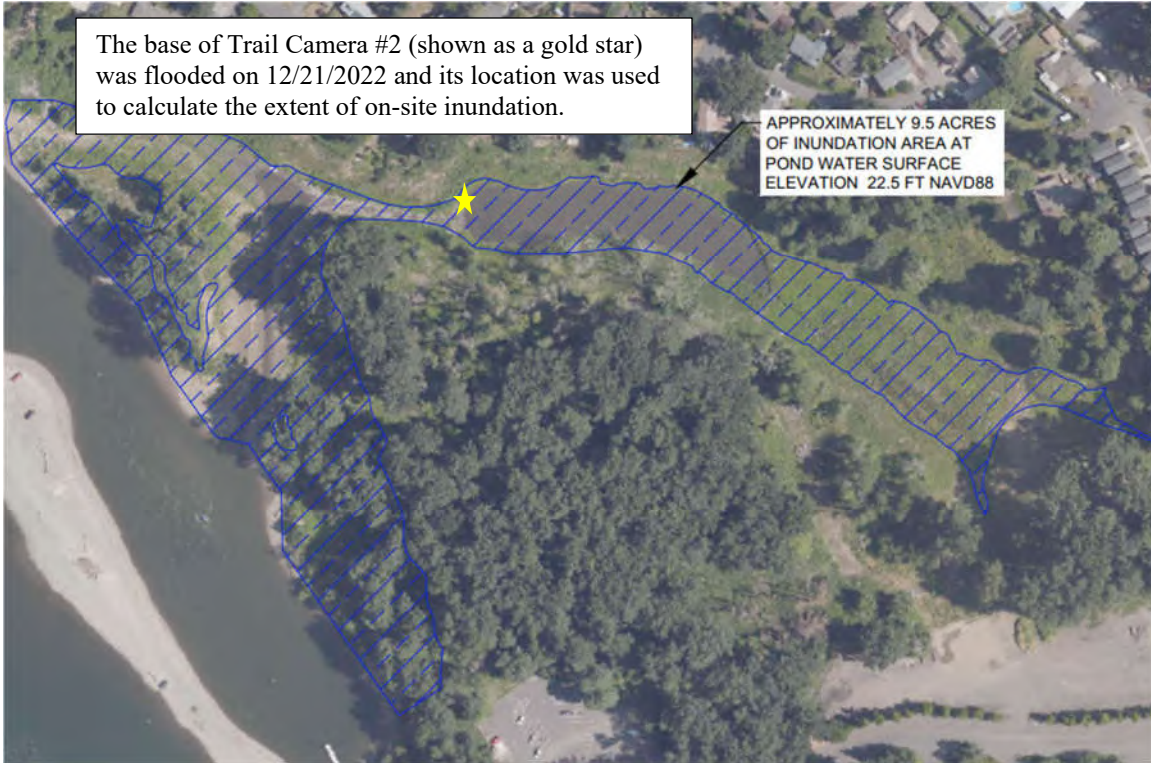
A storm event on December 21, 2021 caused the Willamette River to overtop the sill by approximately 0.5 to 1 foot and inundated 9.5 acres of the site (Figure 2-8). The extent of the inundation was measured based on the flooding of a known point on the ground (Trail Camera #2 located north of the pond outlet) and extrapolated as shown in Figure 2-8. Refer to Figure 2-9 for an image of the inundation on December 21, 2021.

Figure 2-8: A high-water event observed on December 21, 2021 inundated approximately 9.5 acres of the site when the Oregon City gauge station was at 19.97 feet (NAVD88).

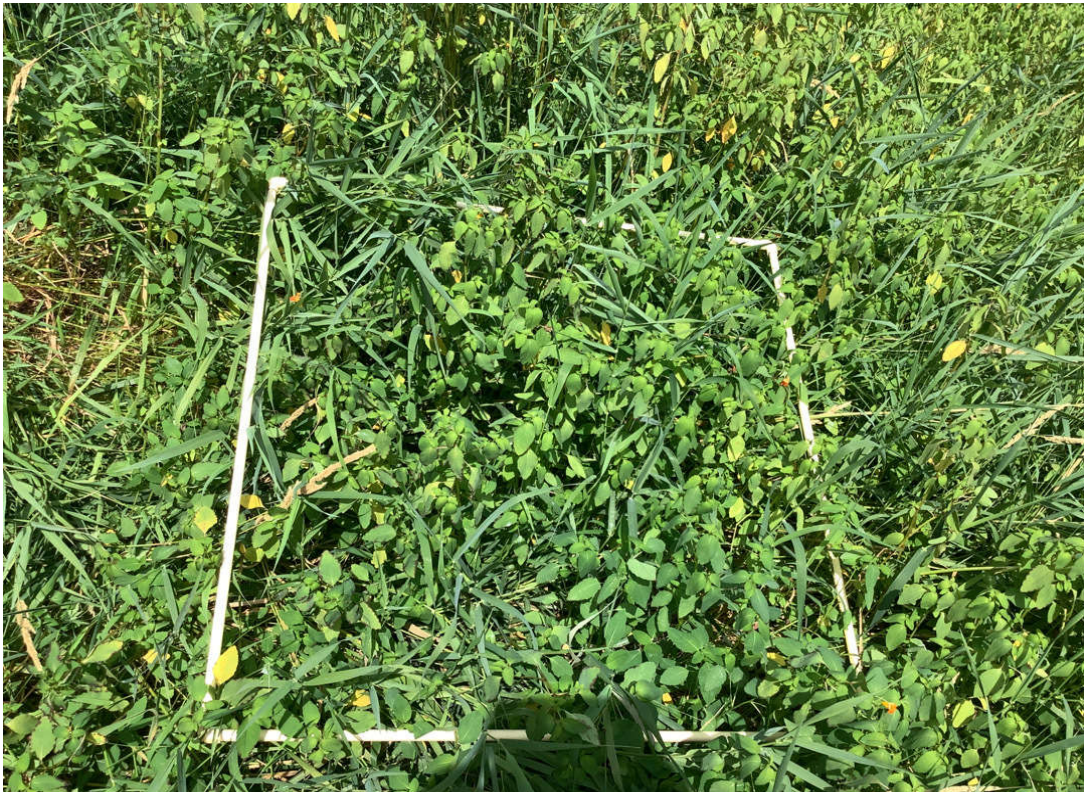
Result: Only one native species meets the abundance and frequency threshold – *Juncus effusus*. This performance standard is not met. The emergent marsh is dominated by a mix of non-native and invasive species. Refer to **Figures 3-2 and 3-3** for representative plots.

Figure 3-2. Plot EM11 – Note High Cover of Spotted Jewelweed along with Reed Canarygrass, August 2021

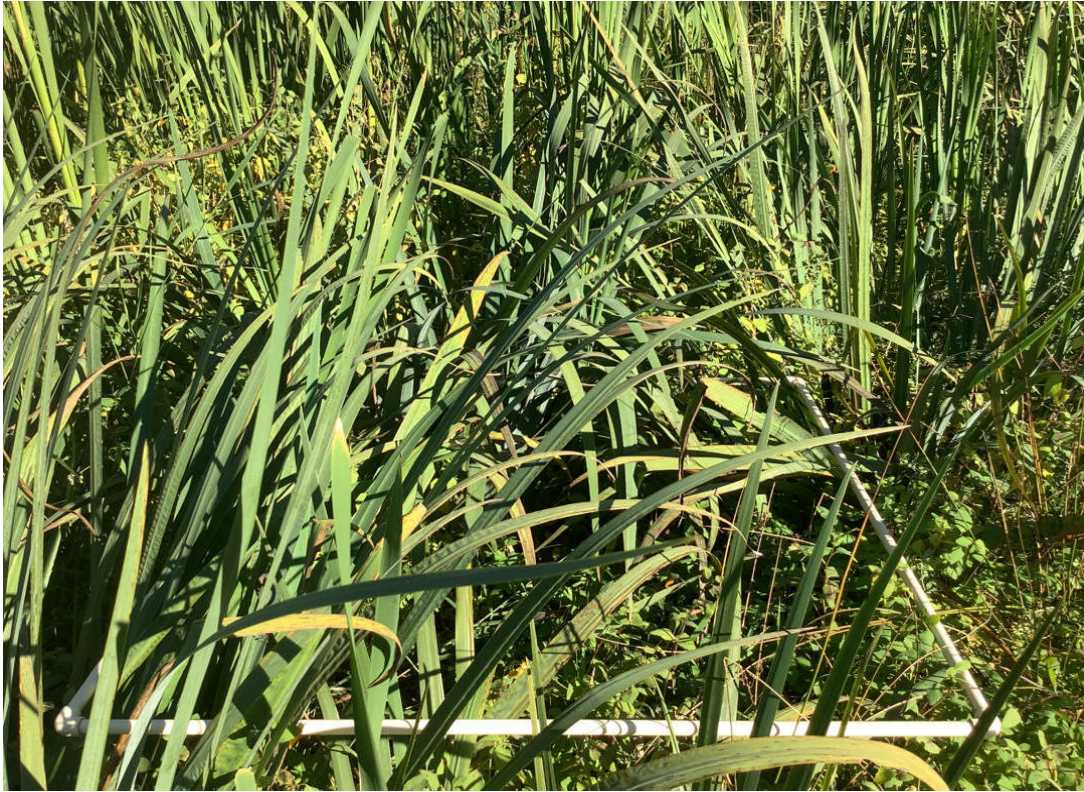
Figure 3-3. Plot EM10 - Yellow Flag Iris (foreground), Jewelweed, Cattail, and a Small Amount of Soft Rush, September 2021

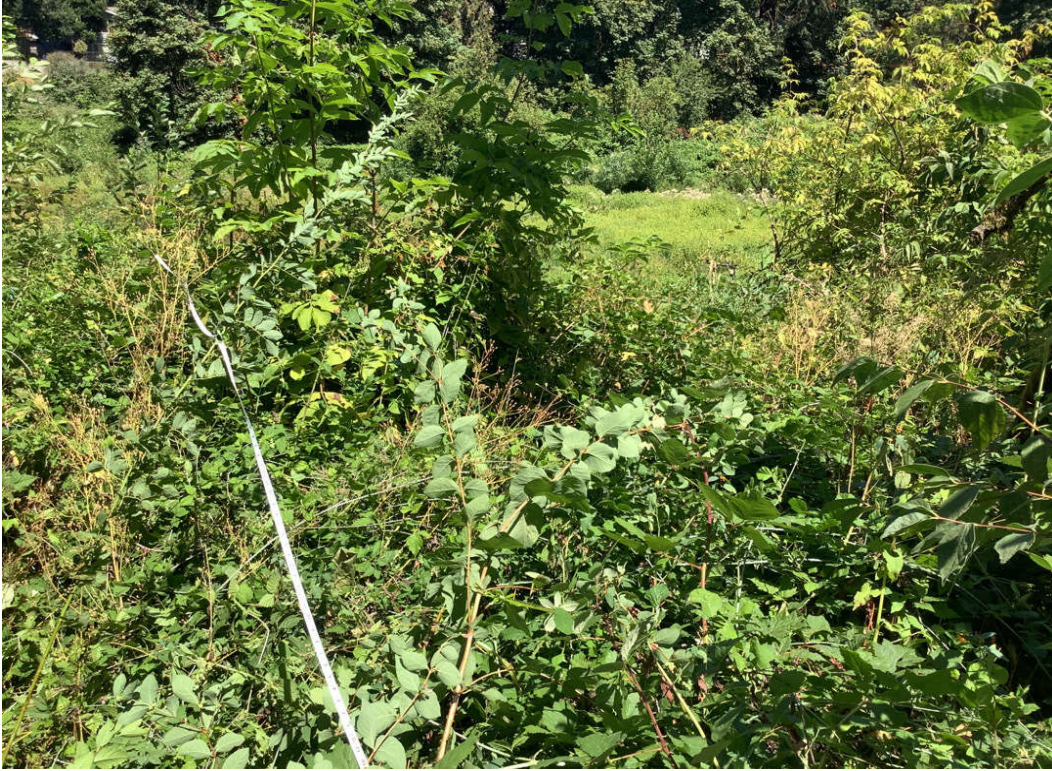
Result: Woody stem density averaged 5,432 **living native stems** per acre and substantially exceeded the minimum requirement. This performance standard is met. Refer to **Figures 3-4 and 3-5** for typical plots. **Living native** woody stems averaged 27 (raw count) across 18 plots with a standard deviation of 19.64.

Figure 3-4. Plot RFR10 – Looking Northwest; Remnant Pond in the Background.
Note Dense Elderberry, Mock-Orange, Rose, Spirea, etc., August 2021.

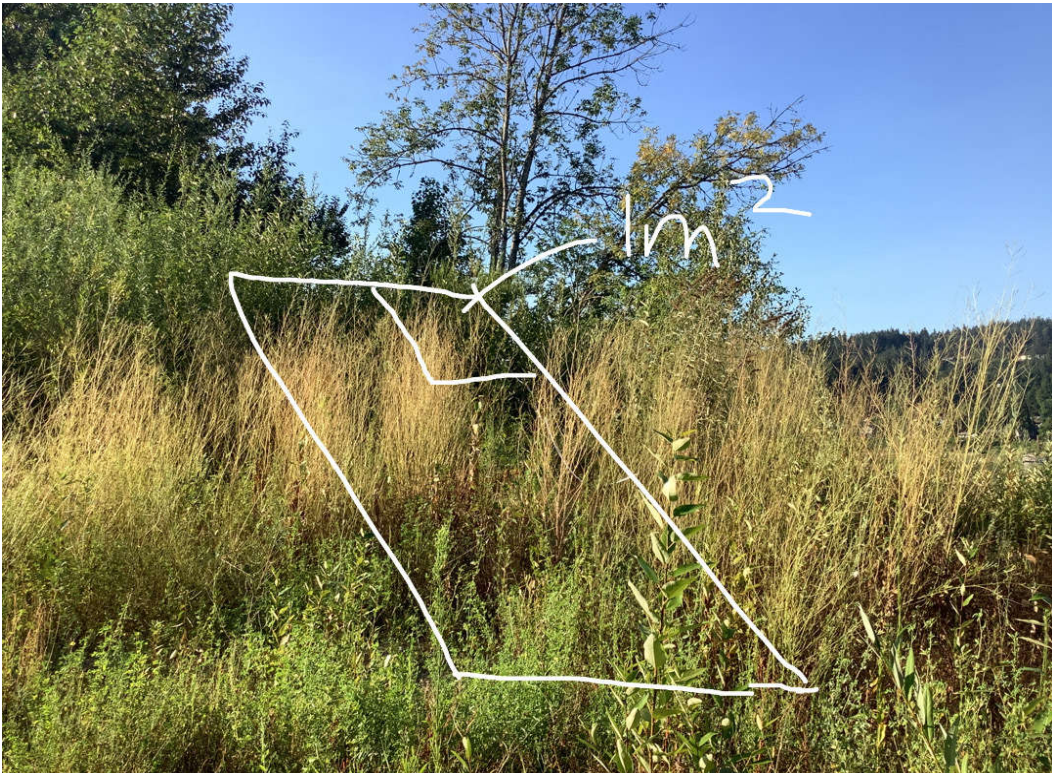
Figure 3-5. Plot RFR18 – Woody Plot and Herb Plot are Approximated by the White Lines.
Dense Willows and Cottonwood at Top of Slope, August 2021.

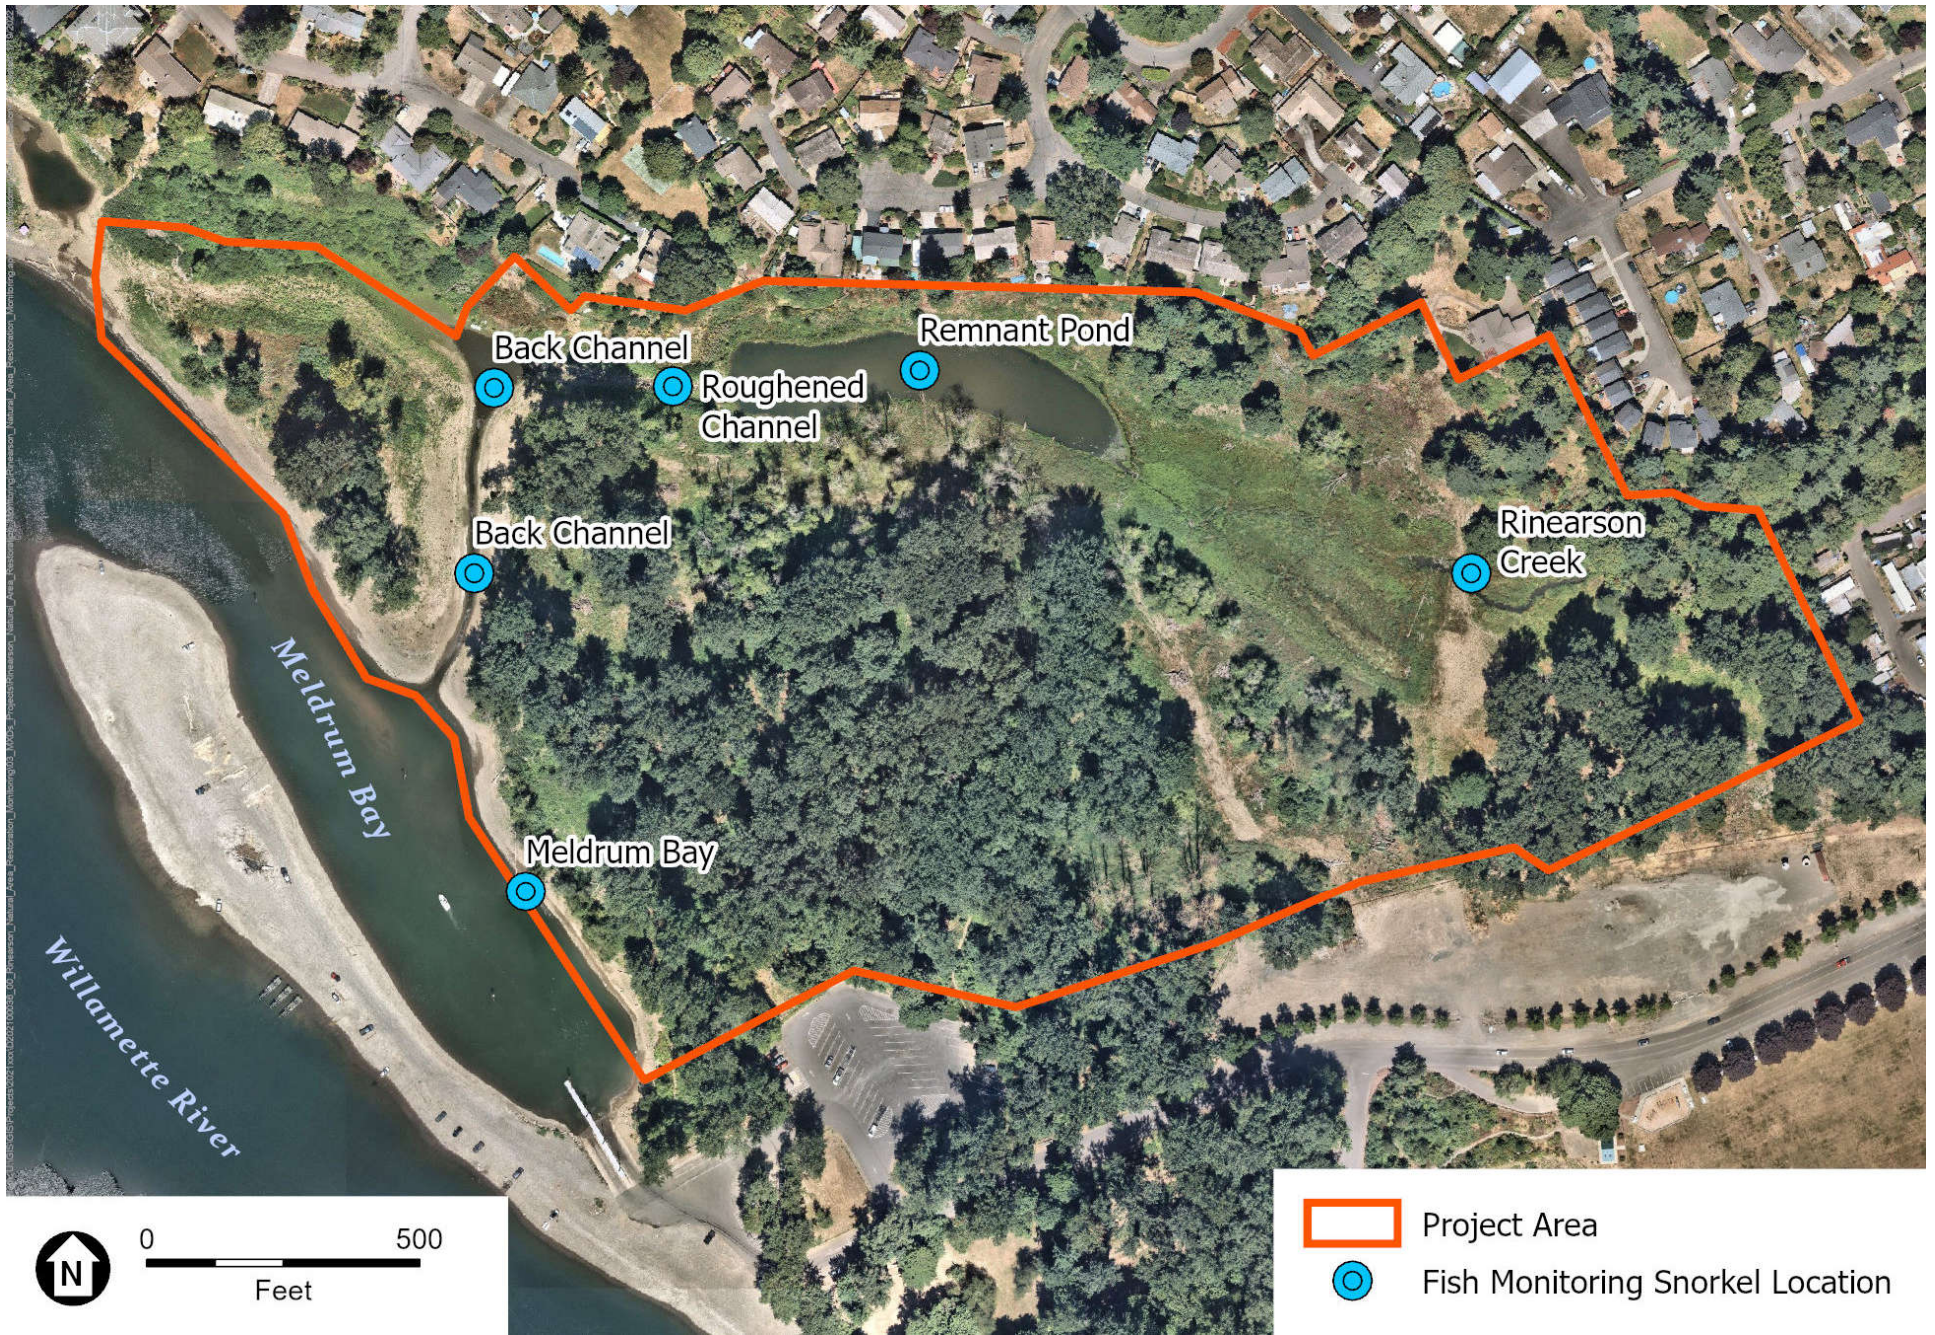
Snorkel surveys were conducted in February, March, and April 2021 to determine if native fish species are using the restored site. Seining was not permitted because juvenile salmonids were caught in seine nets during 2020 surveys, and non-contact methods were recommended for Year 3. Snorkeling was concluded to be the best non-contact method for sampling native fish. Refer to **Figure 4-1** for a depiction of snorkel survey locations.

Figure 4-1. Fish Monitoring – Snorkel Locations

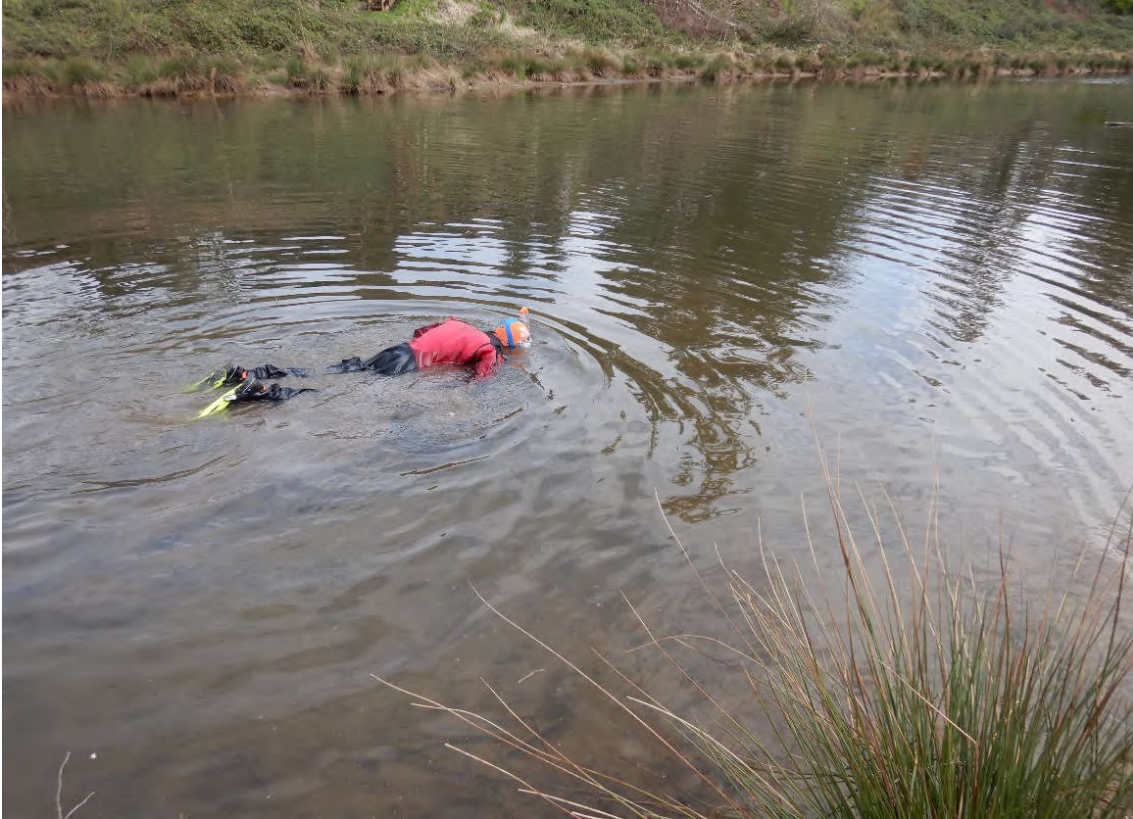
Figure 4-2. Snorkeling the Remnant Pond, March 30, 2021

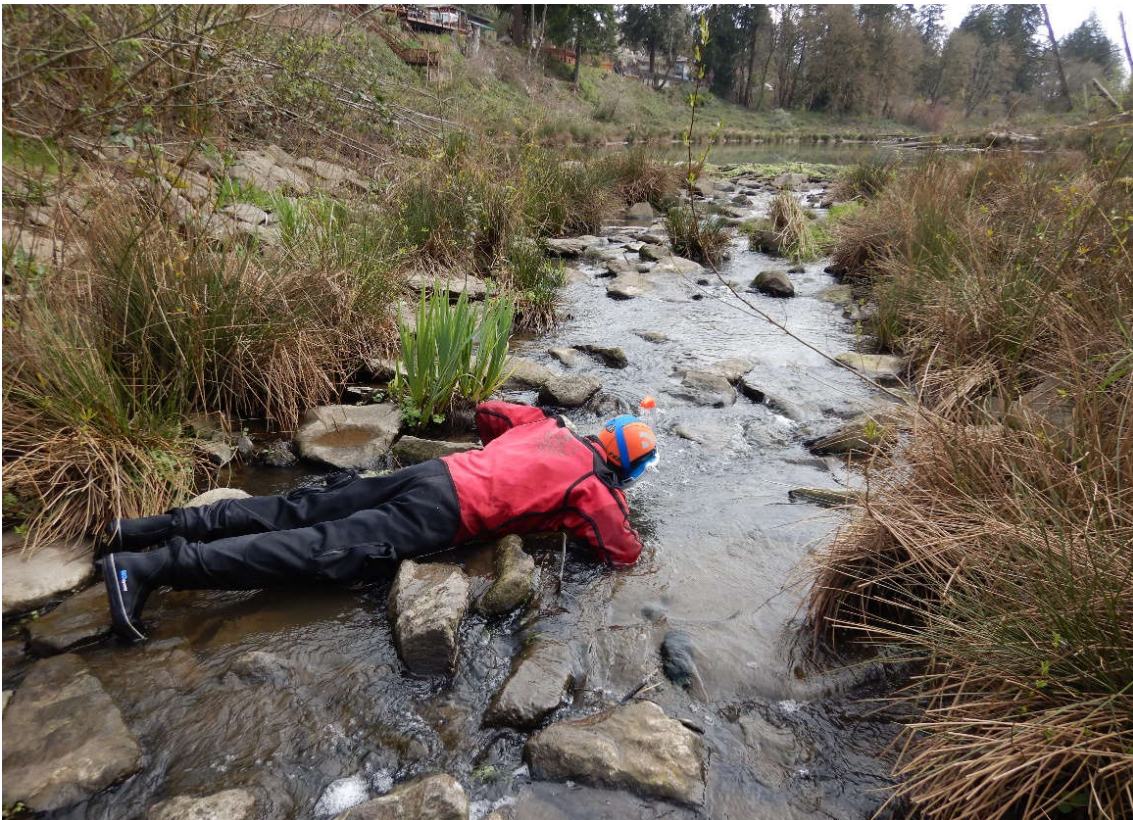
Figure 4-3. Snorkeling the Roughened Channel, Looking Upstream, March 30, 2021

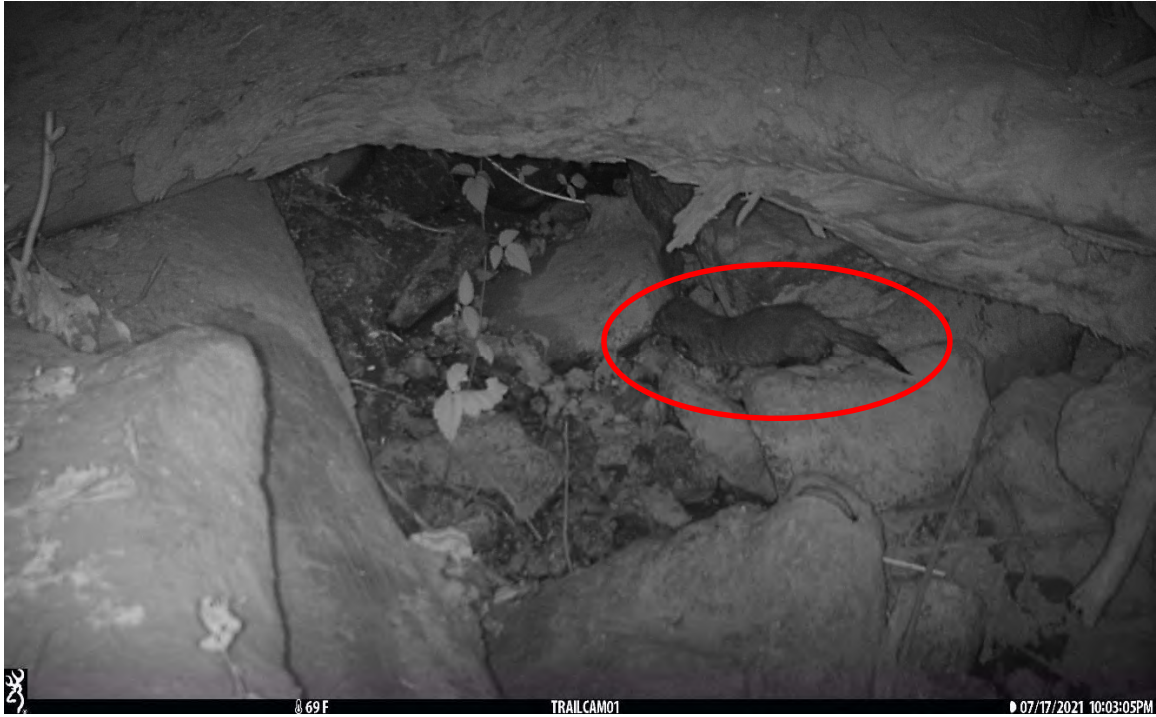
Mink were photo-documented on-site two times in 2021 for an average of 0.11 mink per station. No mink tracks were detected and no fur samples were obtained in the hair-snag traps. The first detection was on July 17 and the second was on August 7 (**Figures 4-7 and 4-8**). Both detections were at Trail Camera 1 in a gap of one of the installed large wood pieces. In comparison, mink were photo-documented on-site four times during baseline surveys for an average of 0.10 mink per station. Five camera stations baited with mink scent were used in the baseline study, whereas three cameras were used in 2021.

When accounting for level of survey effort between baseline and Year 3, mink use of the site stayed approximately the same. The fact that mink were detected at Trail Camera 1 where a large log structure is embedded with and without the use of mink scent indicates that the large wood structures installed in the roughened channel provide suitable cover along the stream banks and enhance the area as a movement corridor for numerous species, including mink.

Figure 4-7. Mink Detected at Trail Camera 1 in the Gap of an Installed Log Structure on July 17, 2021.

Mink scent was not in use at the trap station at this time.

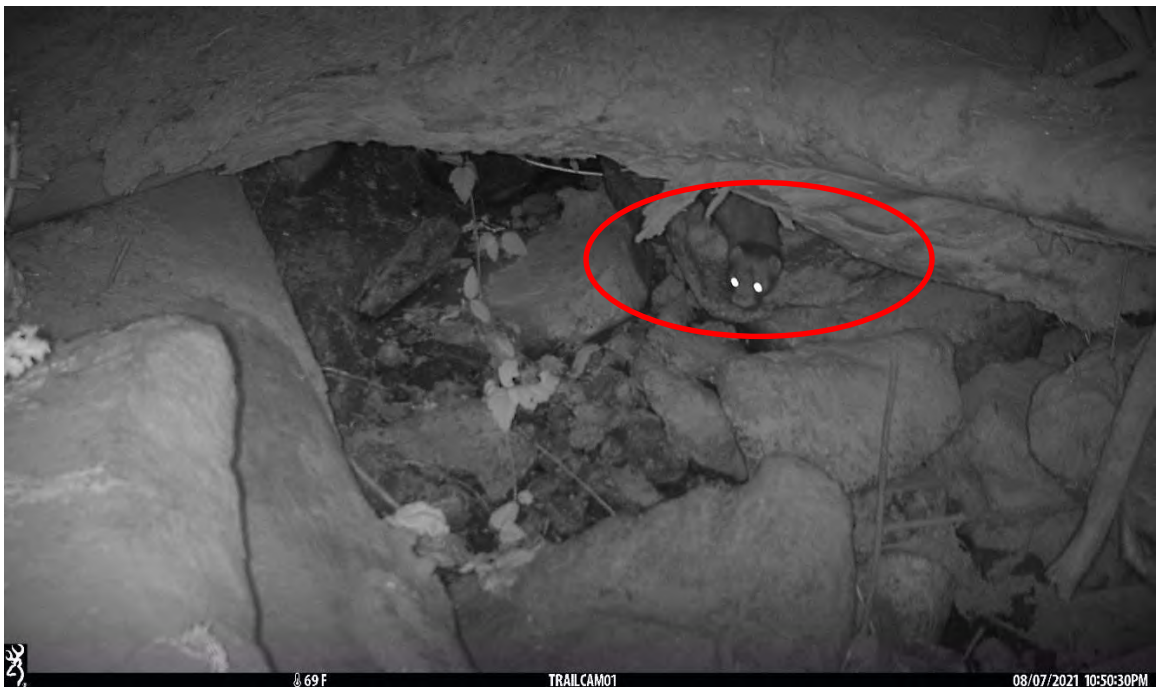
Figure 4-8. Mink Detected at Trail Camera 1 on August 7, 2021.

Mink scent was applied.

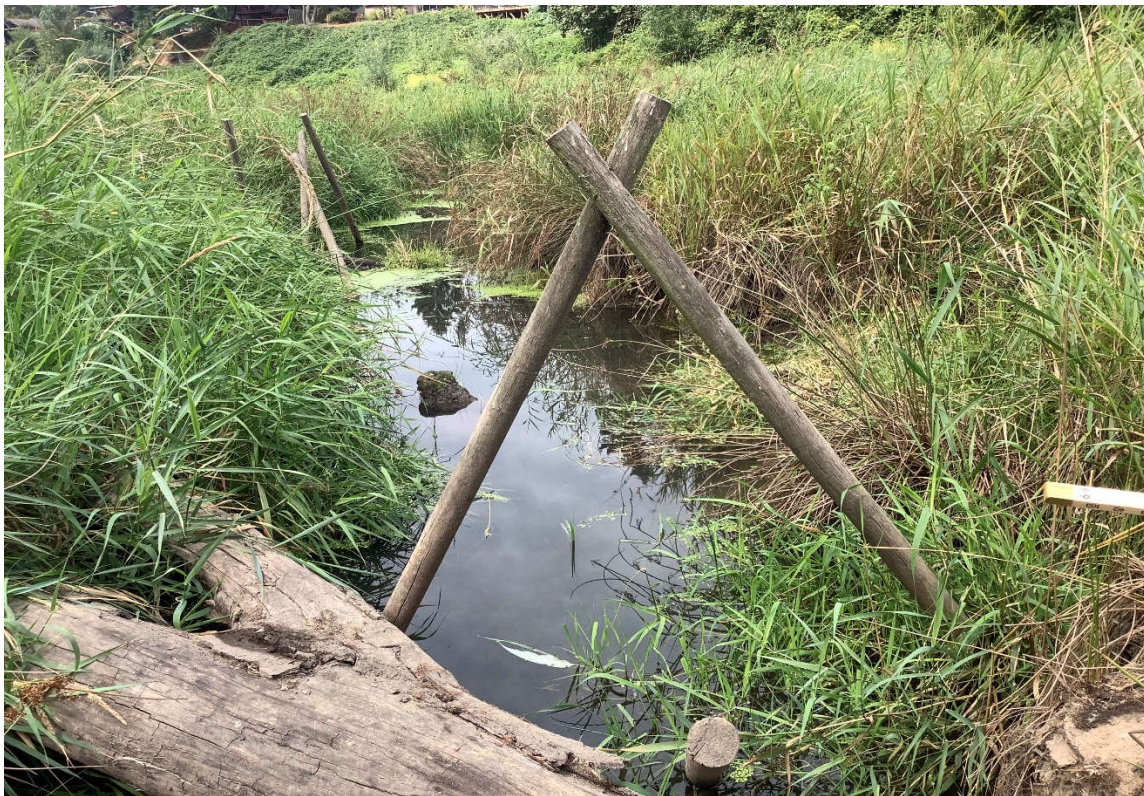
Figure 7-1. Floodplain channel section where head-cuts were previously reported but not found in Year 3 monitoring.

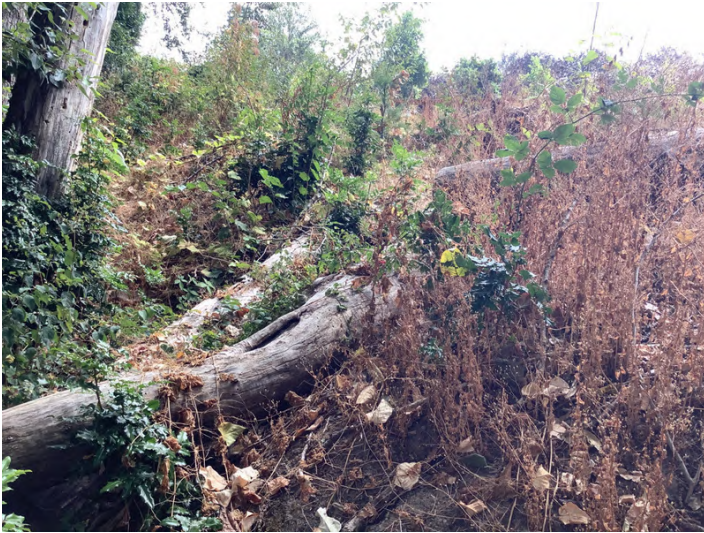
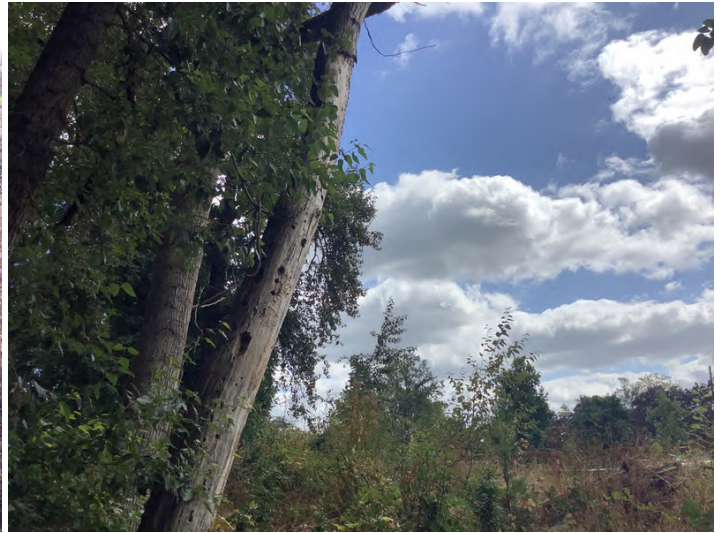
Date	August 30, 2021
Time	11:40
Feature ID	Debris pile, natural
Observer	Sarah Hartung
Type of feature	Debris Pile
Condition of feature	Good
Recommendation	None
General Notes	5 large logs and a snag

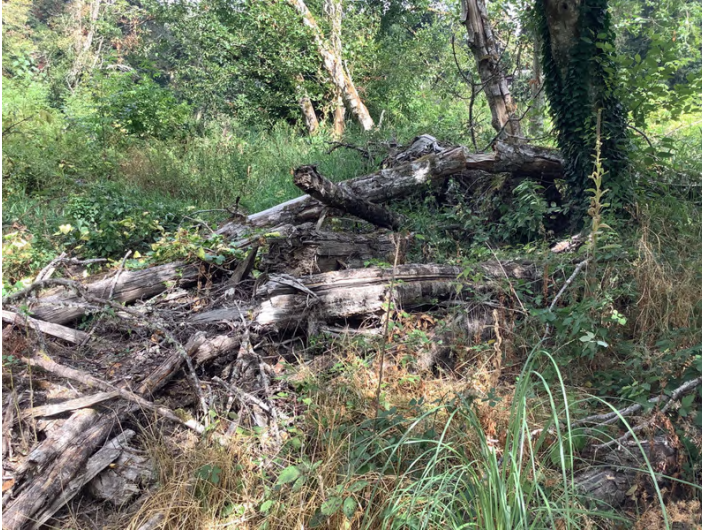
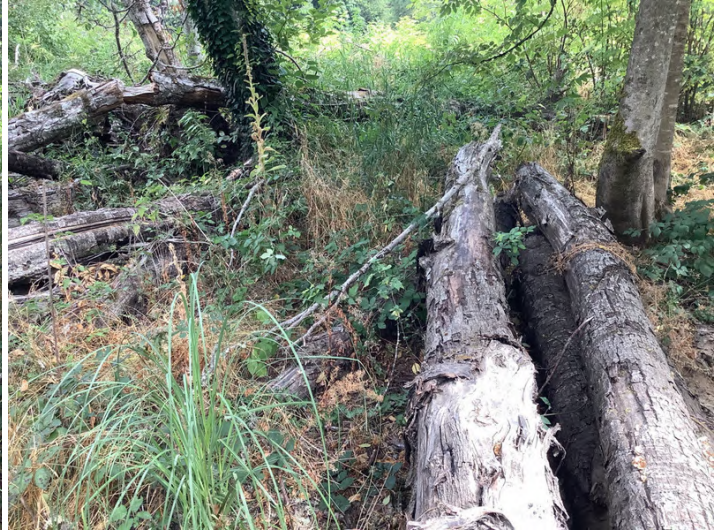
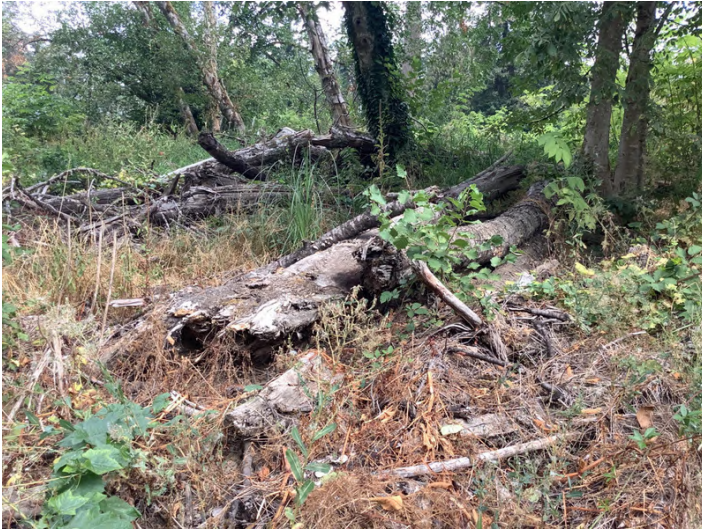
Date	August 30, 2021
Time	11:40
Feature ID	Debris pile, undoc?
Observer	Sarah Hartung
Type of feature	Debris Pile
Condition of feature	NA
Recommendation	None
General Notes	15+ logs, several small logs

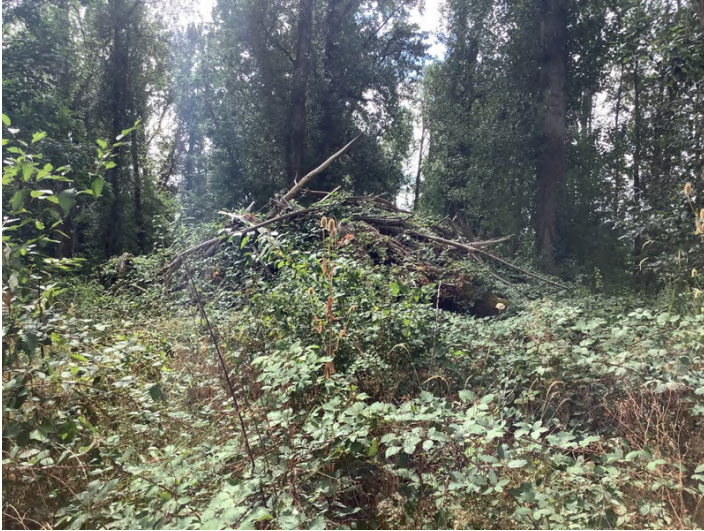
Date	August 31, 2021
Time	09:40
Feature ID	8
Observer	Sarah Hartung
Type of feature	Debris Pile
Condition of feature	Good
Recommendation	None
General Notes	25 pieces, Himalayan blackberry.

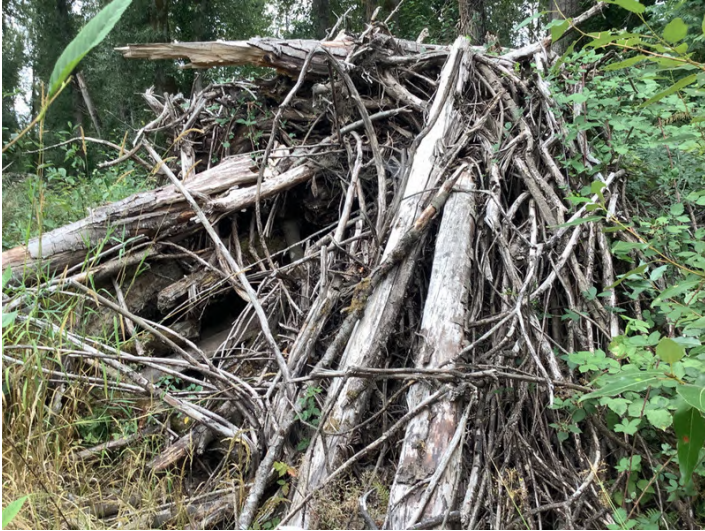
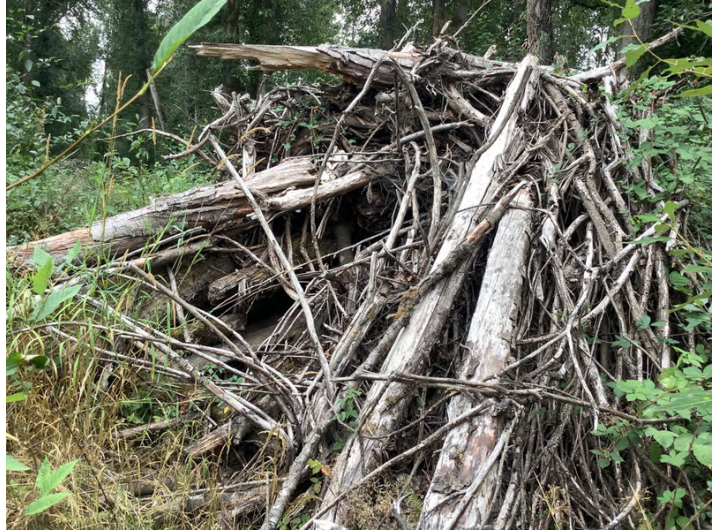
Date	August 31, 2021
Time	09:40
Feature ID	8
Observer	Hannah Smiley
Type of feature	Debris Pile
Condition of feature	Good
Recommendation	None
General Notes	35 pieces
