RINEARSON NATURAL AREA RESTORATION MONITORING REPORT **YEAR 3 (2021)**

Prepared for
Columbia Restoration Group, LLC

Submitted January 2022;
Revised September 2022

Rinearson Natural Area Restoration Monitoring – Cover Sheet

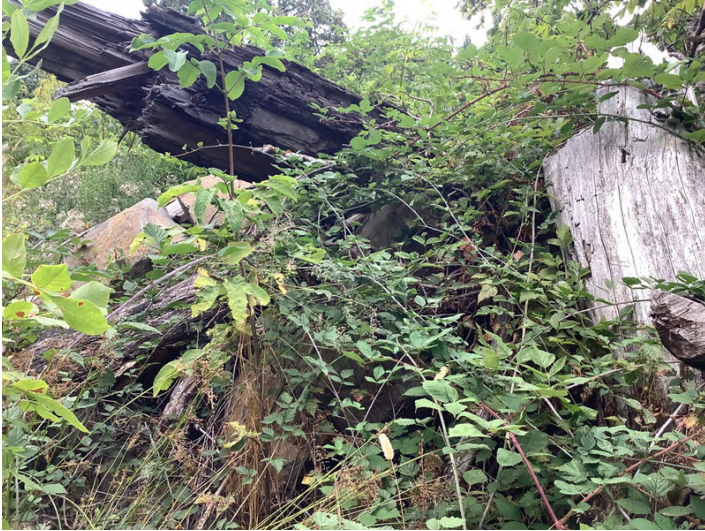
Date	August 31, 2021
Time	09:40
Feature ID	17
Observer	Hannah Smiley
Type of feature	Debris Pile
Condition of feature	Good
Recommendation	None
General Notes	3 wood, 25 rocks.

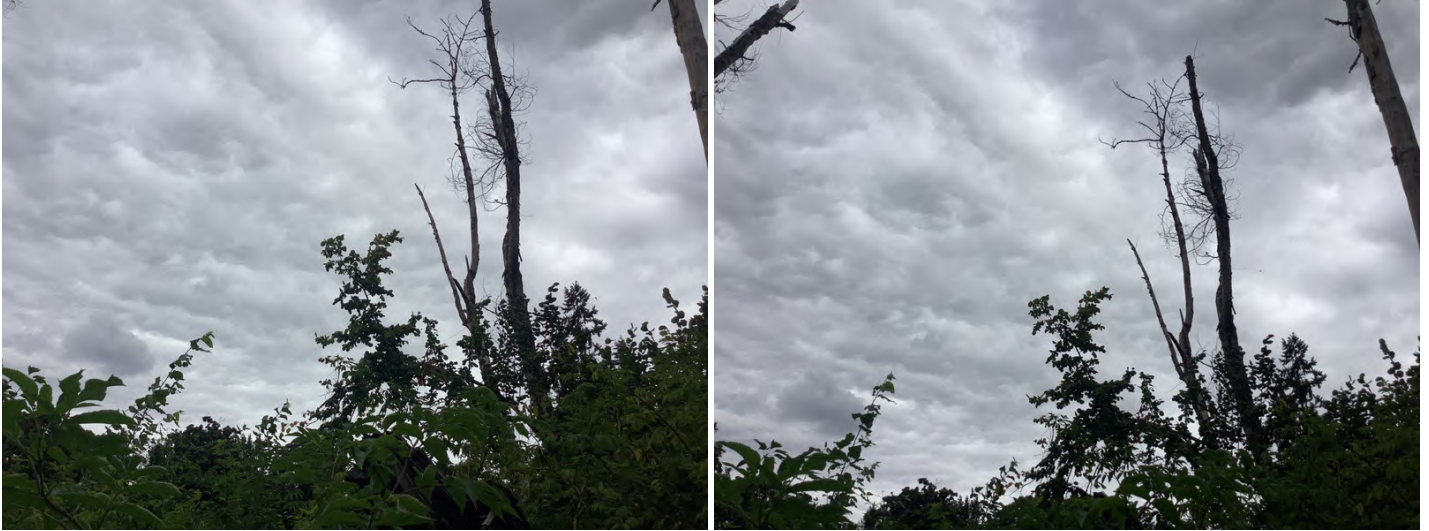
Date	August 31, 2021
Time	09:40
Feature ID	17
Observer	Hannah Smiley
Type of feature	Debris Pile
Condition of feature	Good
Recommendation	None
General Notes	Two trunks, bird perch

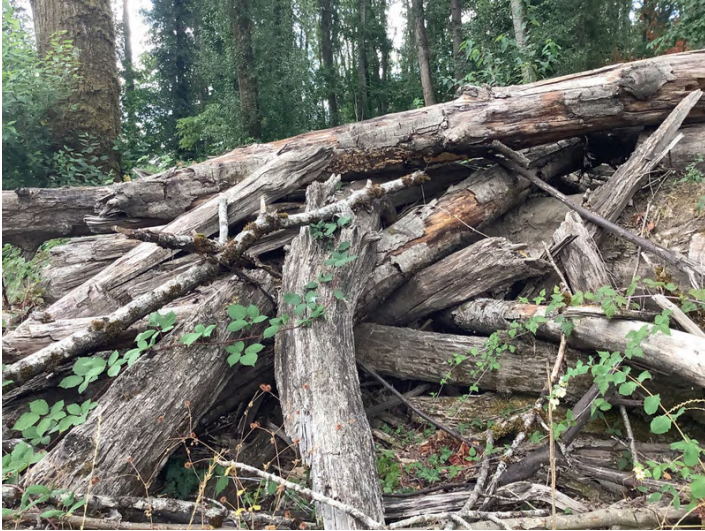
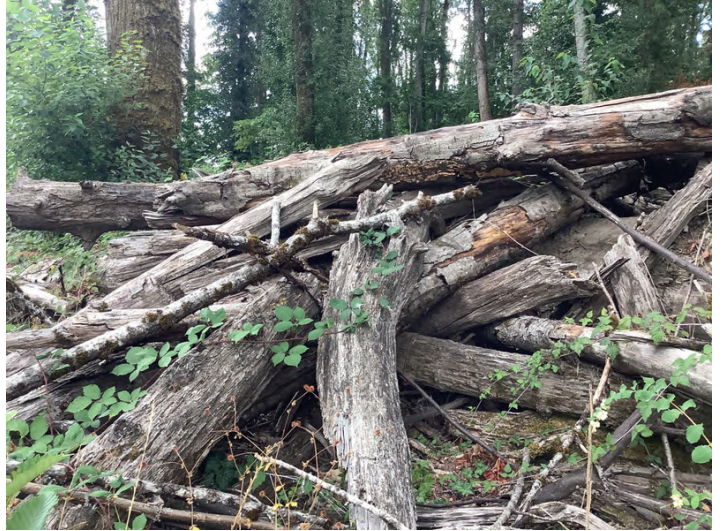
Date	August 31, 2021
Time	09:40
Feature ID	21
Observer	Hannah Smiley
Type of feature	Debris Pile
Condition of feature	Good
Recommendation	None
General Notes	20 pieces

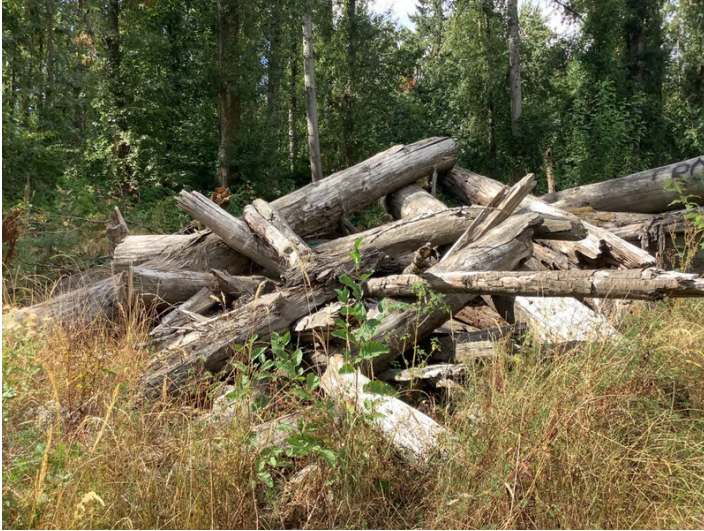
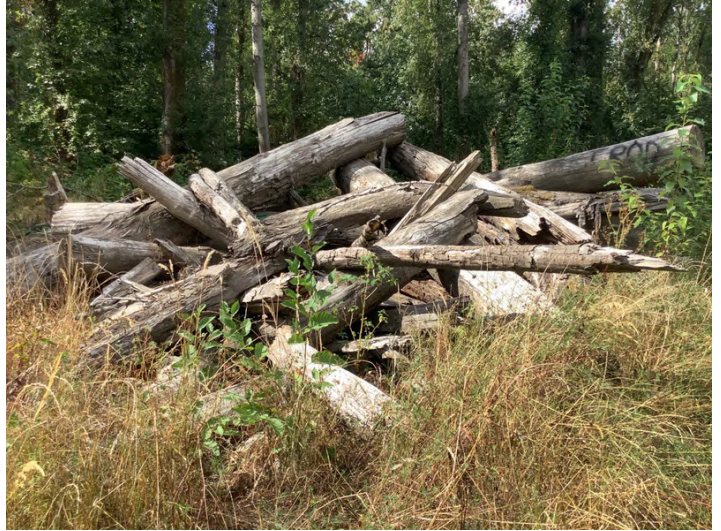
Date	August 31, 2021
Time	09:40
Feature ID	23
Observer	Hannah Smiley
Type of feature	Debris Pile
Condition of feature	Good
Recommendation	None
General Notes	25 pieces

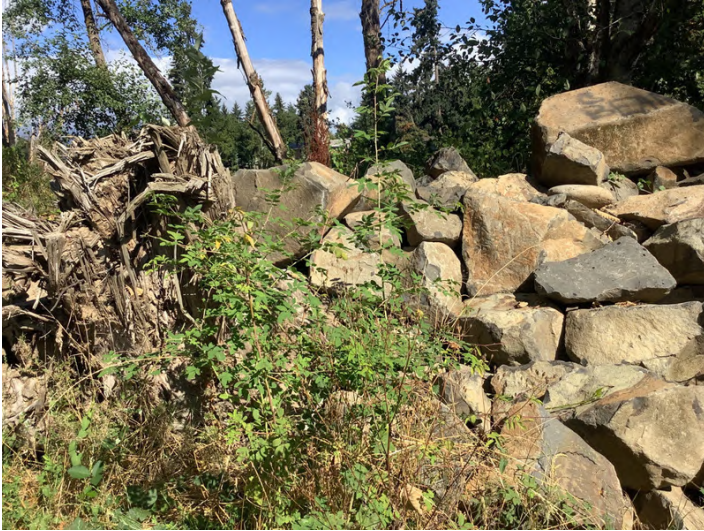
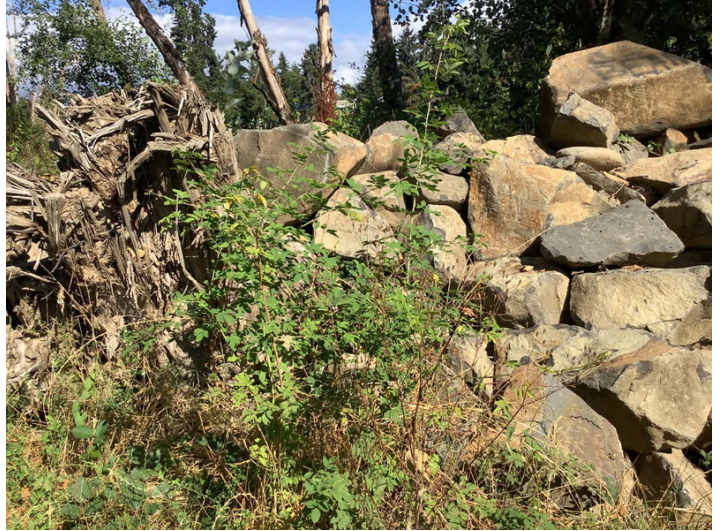
Date	August 31, 2021
Time	09:40
Feature ID	25
Observer	Hannah Smiley
Type of feature	Debris Pile
Condition of feature	Good
Recommendation	None
General Notes	Rootwad, 35 rocks

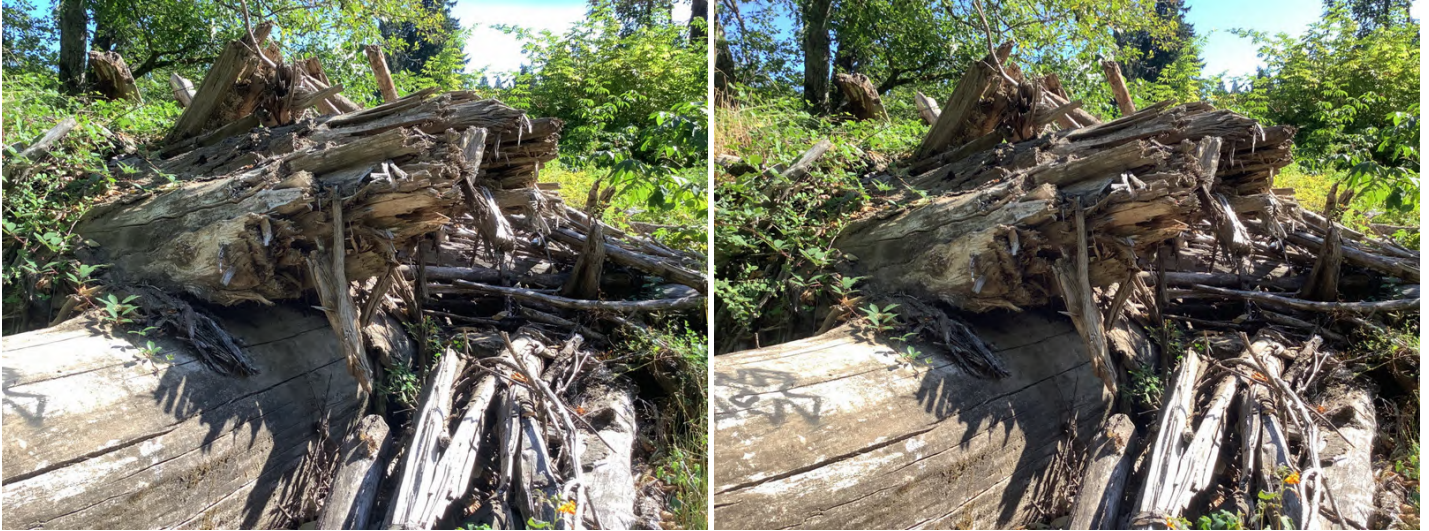
Date	August 31, 2021
Time	09:40
Feature ID	26
Observer	Hannah Smiley
Type of feature	Debris Pile
Condition of feature	Good
Recommendation	None
General Notes	30 pieces

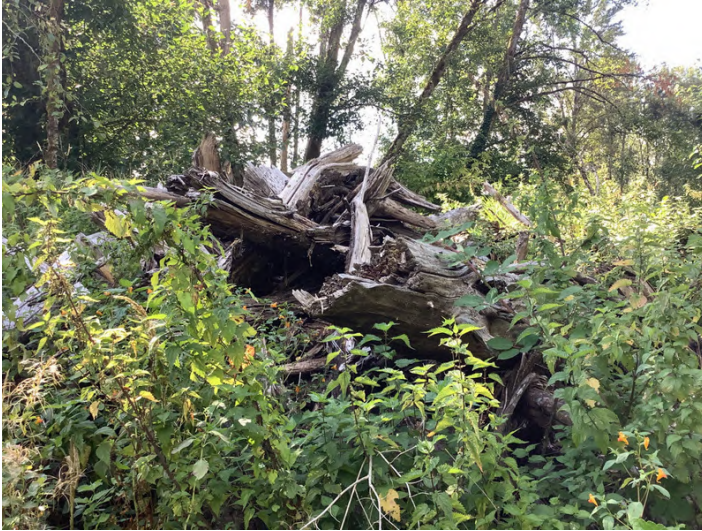
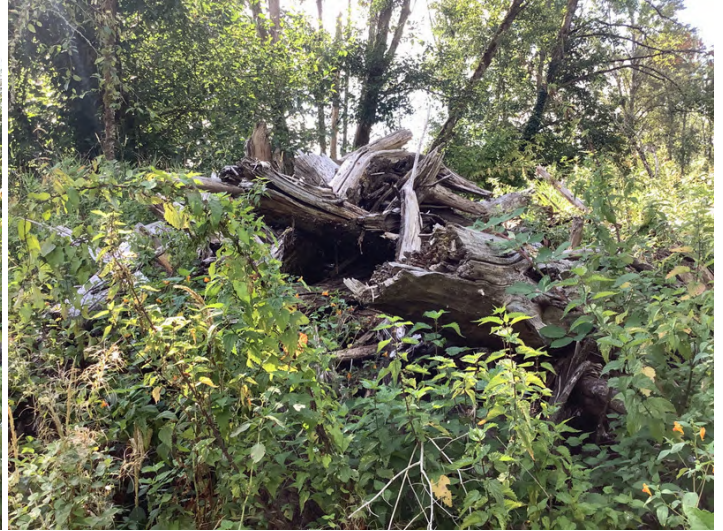
Date	August 31, 2021
Time	09:40
Feature ID	Debris pile 27
Observer	Hannah Smiley
Type of feature	Debris Pile
Condition of feature	Good
Recommendation	None
General Notes	30 pieces, lots of jewel weed

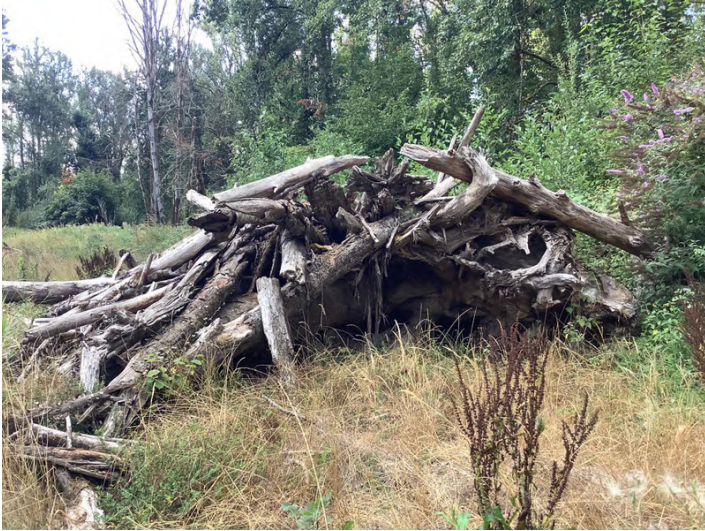
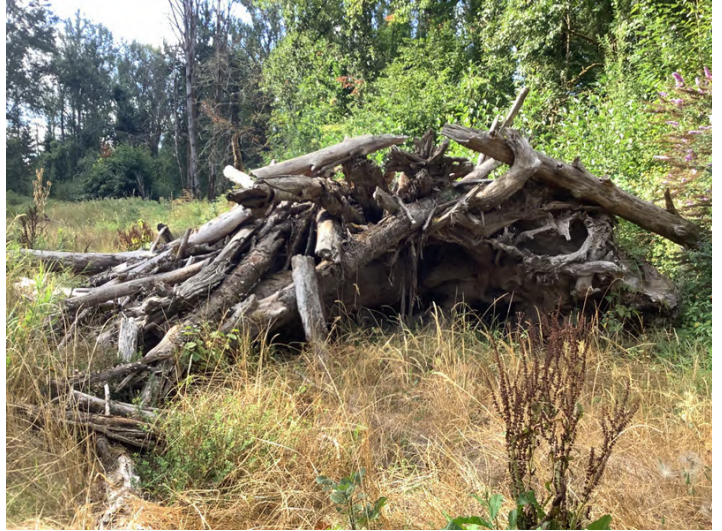
Date	August 31, 2021
Time	09:40
Feature ID	Debris pile 28
Observer	Hannah Smiley
Type of feature	Debris Pile
Condition of feature	Good
Recommendation	None
General Notes	30 pieces

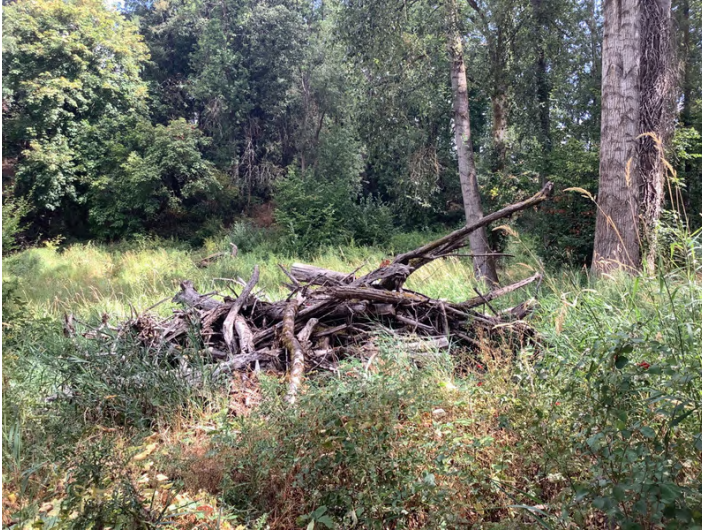
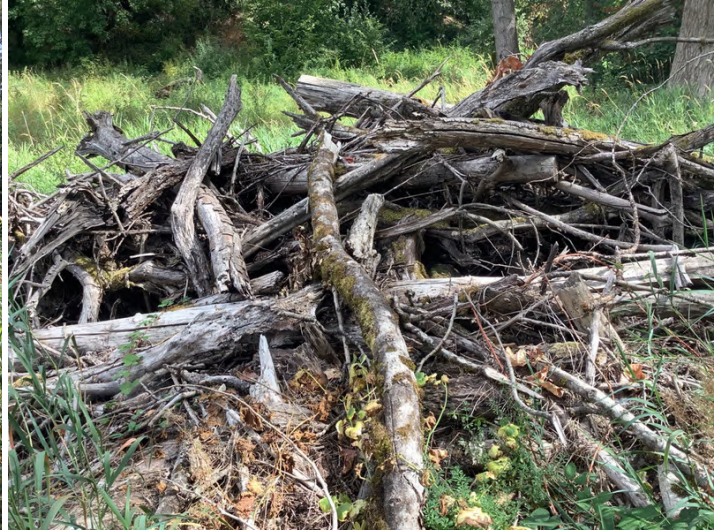
Date	August 30, 2021
Time	11:40
Feature ID	Debris pile 31
Observer	Sarah Hartung
Type of feature	Debris Pile
Condition of feature	Good
Recommendation	None
General Notes	25+ logs, several small logs

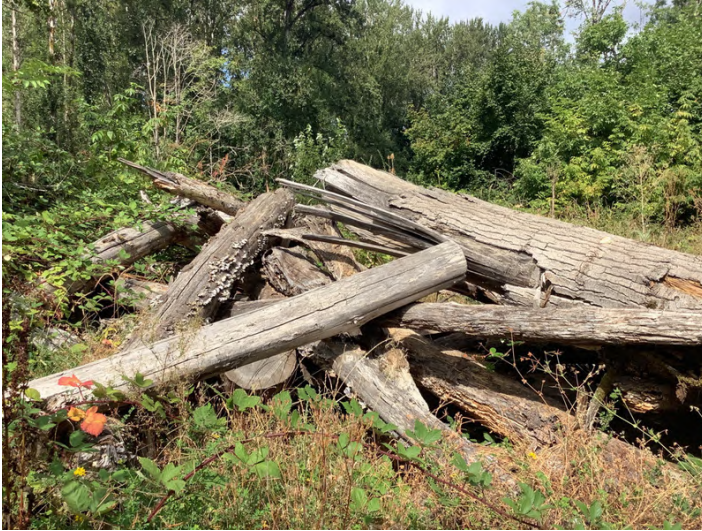
Date	August 30, 2021
Time	11:40
Feature ID	Debris pile 32
Observer	Sarah Hartung
Type of feature	Debris Pile
Condition of feature	Good
Recommendation	None
General Notes	25-30 logs

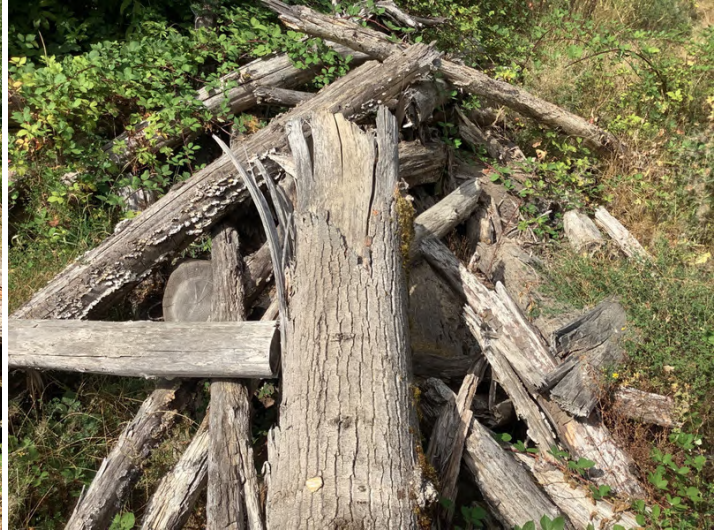
Date	August 30, 2021
Time	11:40
Feature ID	Debris pile 33
Observer	Sarah Hartung
Type of feature	Debris Pile
Condition of feature	Unknown
Recommendation	N/A
General Notes	Unable to count logs, covered under blackberry thicket

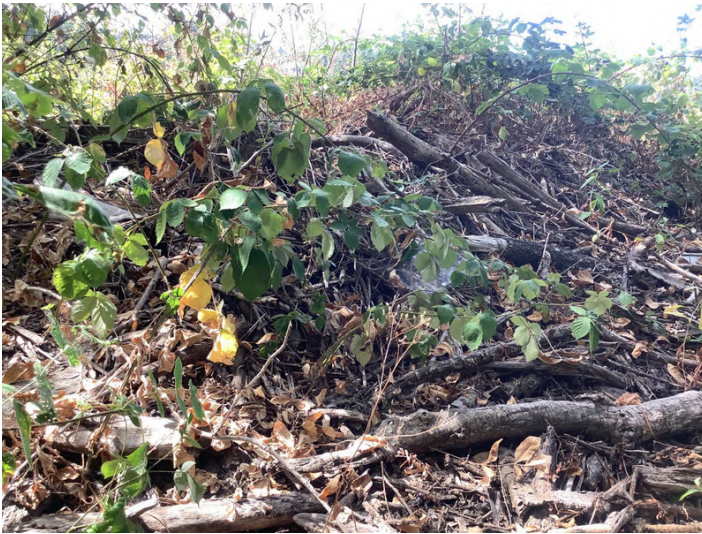
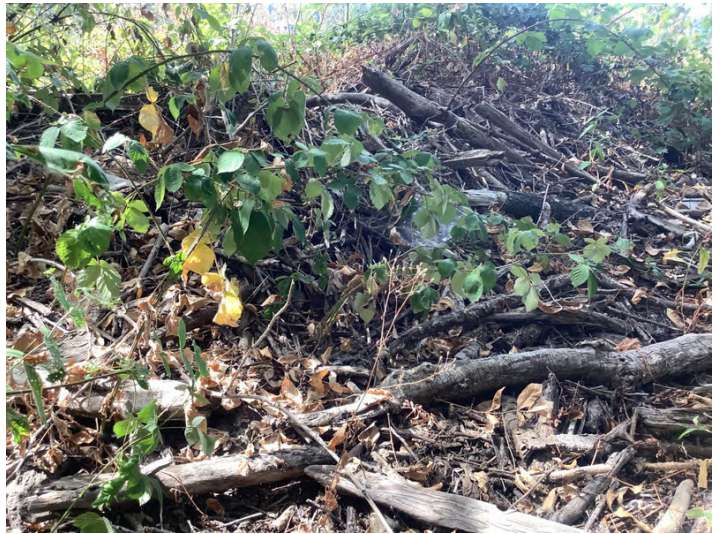
Date	August 31, 2021
Time	09:40
Feature ID	43
Observer	Hannah Smiley
Type of feature	Debris Pile
Condition of feature	Marginal
Recommendation	None
General Notes	1 visible large piece, many small pieces, looks like brush pile, does not look engineered, 50ft away on trail looks like dismantled debris piles, nearby log/branch structure

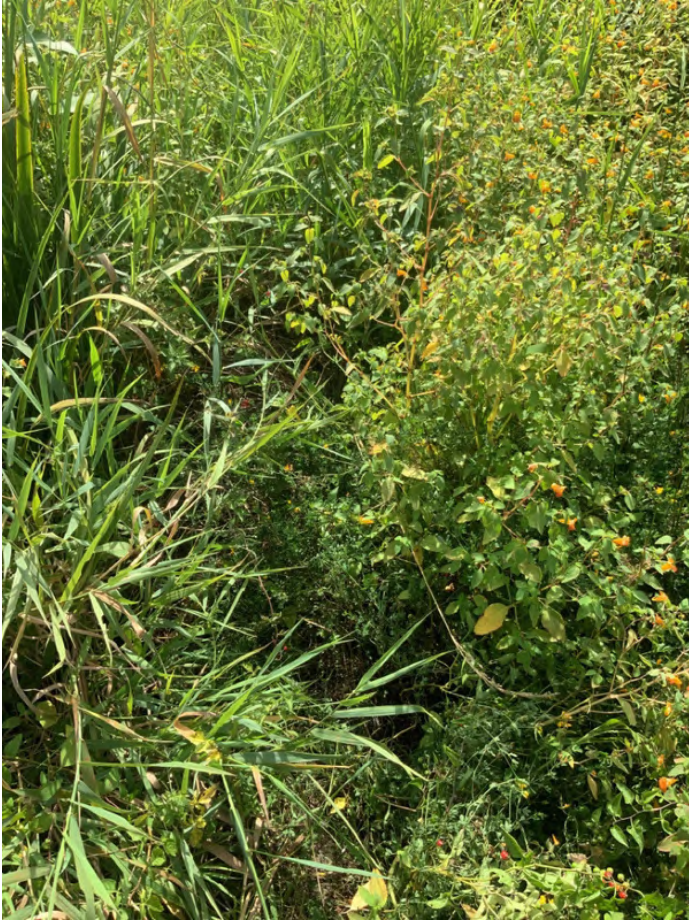
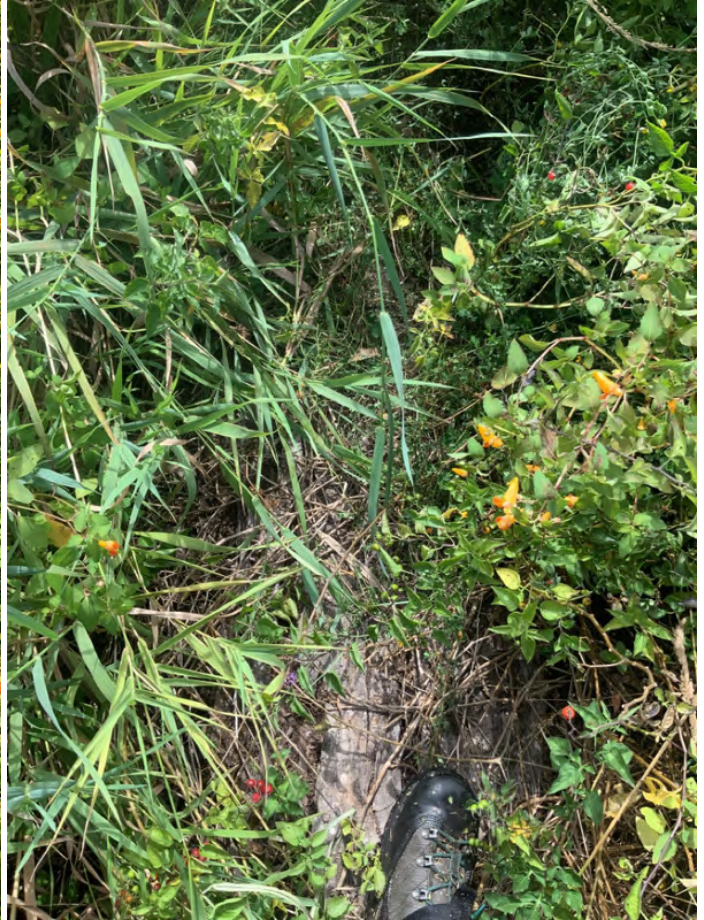
Date	August 31, 2021
Time	14:07
Feature ID	floodplain wood
Observer	Alaina Floor
Type of feature	Floodplain Log Structure
Condition of feature	Good
Recommendation	None
General Notes	two pieces

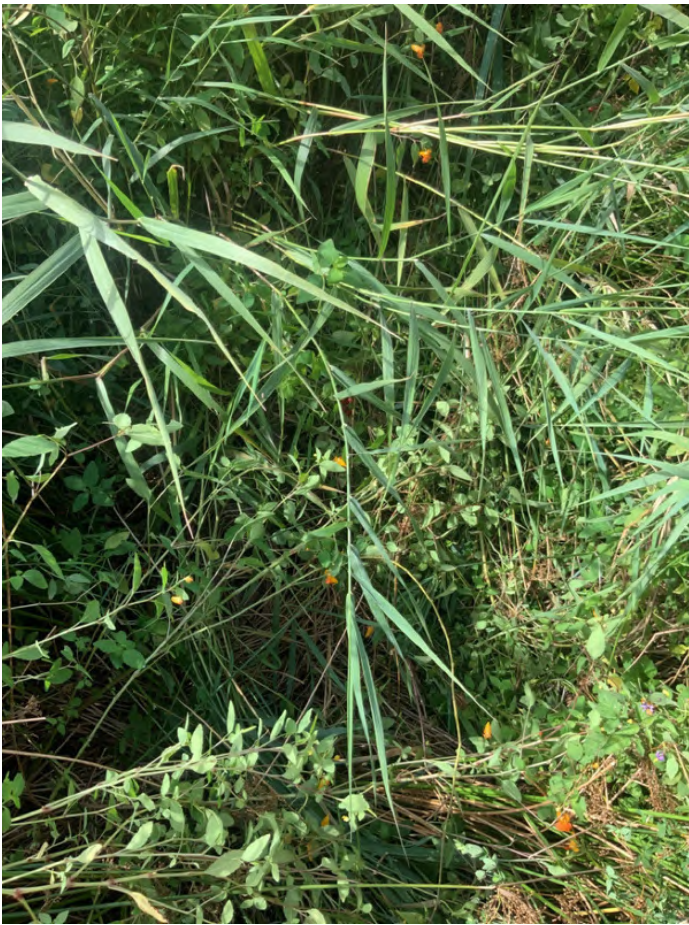
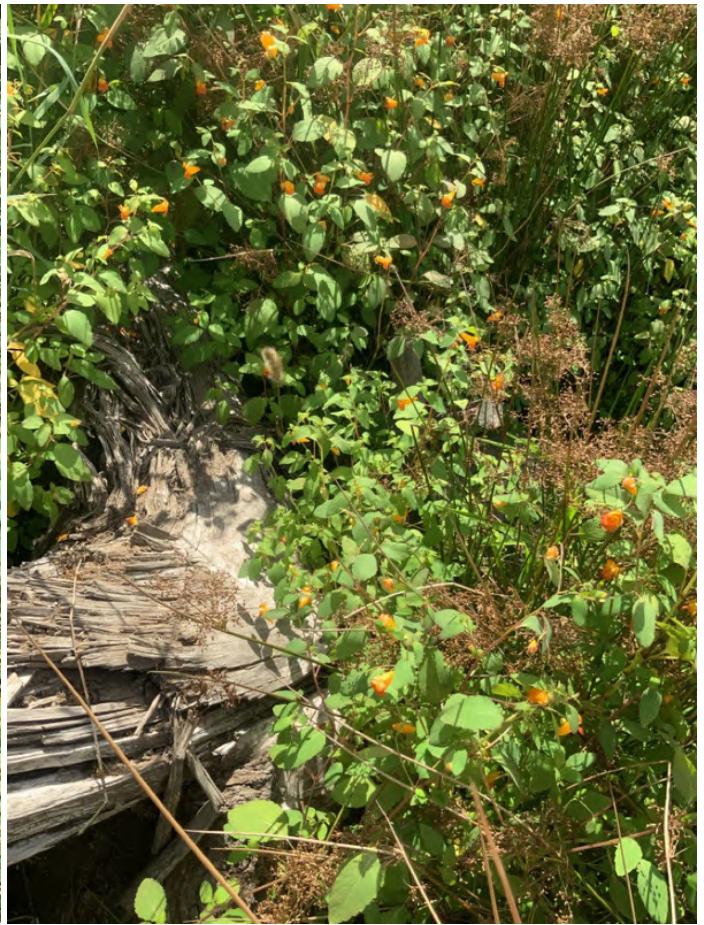
Date	August 31, 2021
Time	14:12
Feature ID	floodplain wood
Observer	Alaina Floor
Type of feature	Floodplain Log Structure
Condition of feature	Good
Recommendation	None
General Notes	three pieces

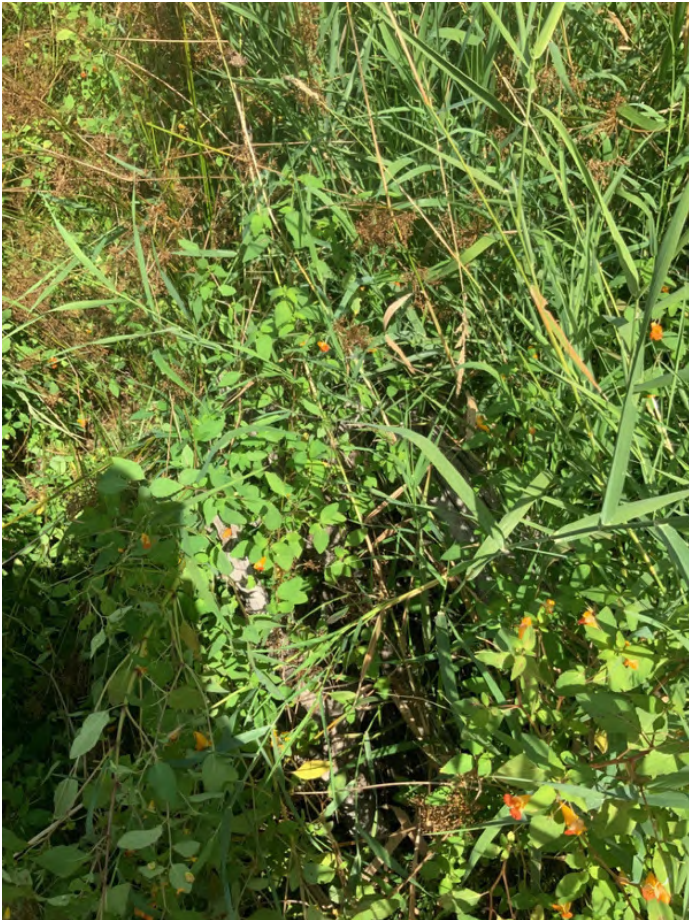
Date	August 31, 2021
Time	14:56
Feature ID	floodplain wood
Observer	Alaina Floor
Type of feature	Floodplain Log Structure
Condition of feature	Absent
Recommendation	Replace
General Notes	log piece found downstream

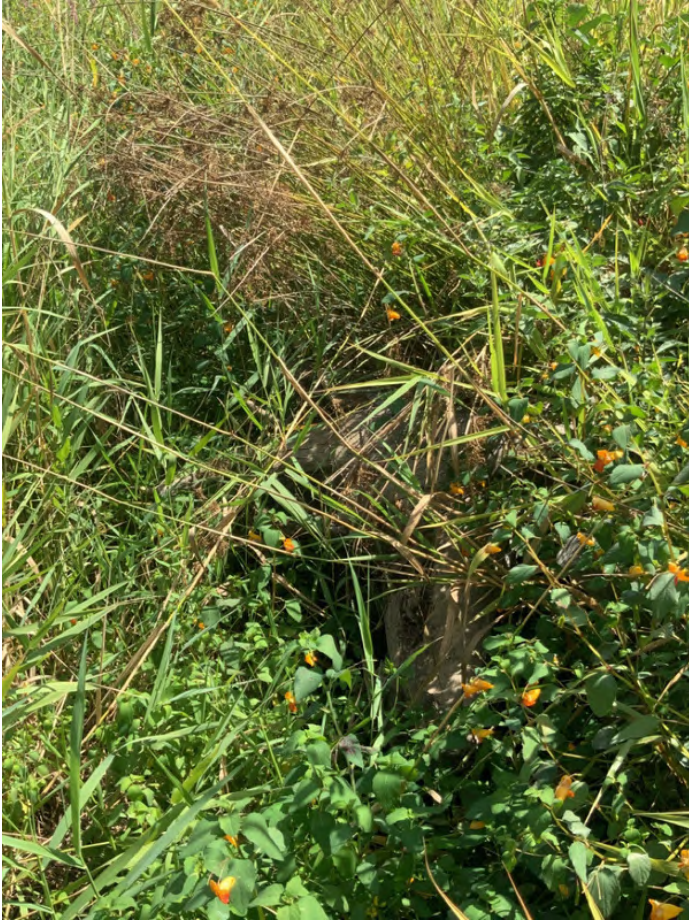
Date	August 31, 2021
Time	13:48
Feature ID	floodplain wood
Observer	Alaina Floor
Type of feature	Floodplain Log Structure
Condition of feature	Good
Recommendation	None
General Notes	two pieces

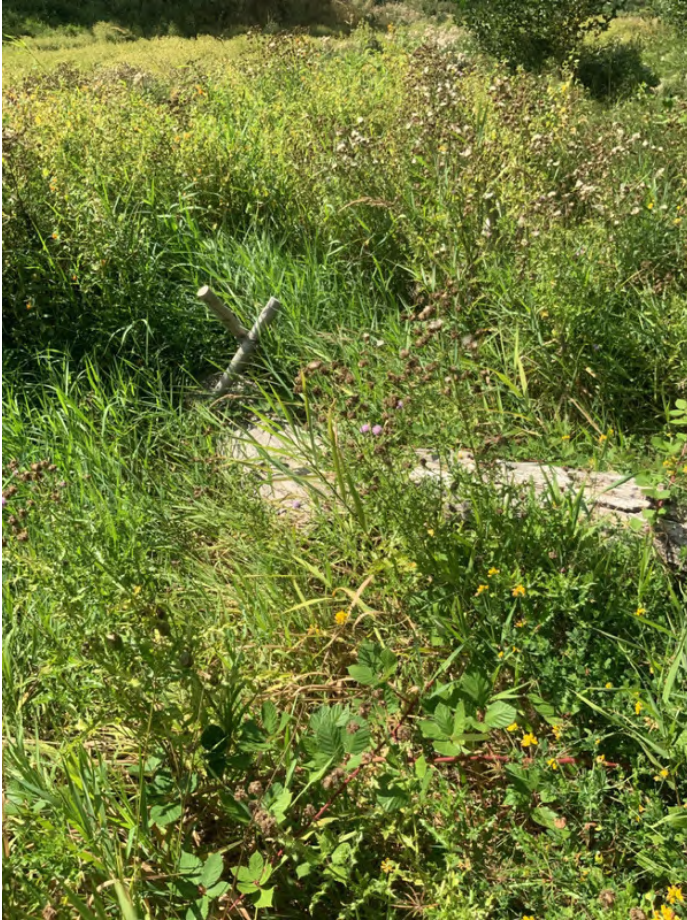
Date	August 31, 2021
Time	13:41
Feature ID	floodplain wood
Observer	Alaina Floor
Type of feature	Floodplain Log Structure
Condition of feature	Good
Recommendation	None
General Notes	two peices

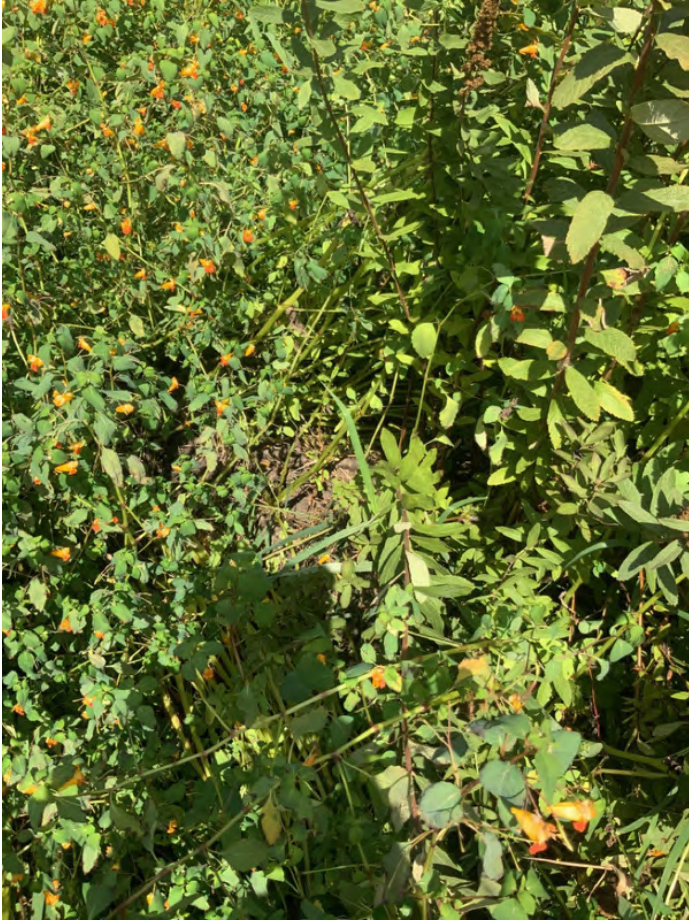
Date	August 31, 2021
Time	14:55
Feature ID	floodplain wood
Observer	Alaina Floor
Type of feature	Floodplain Log Structure
Condition of feature	Poor
Recommendation	Replace
General Notes	wood member from missing upstream structure

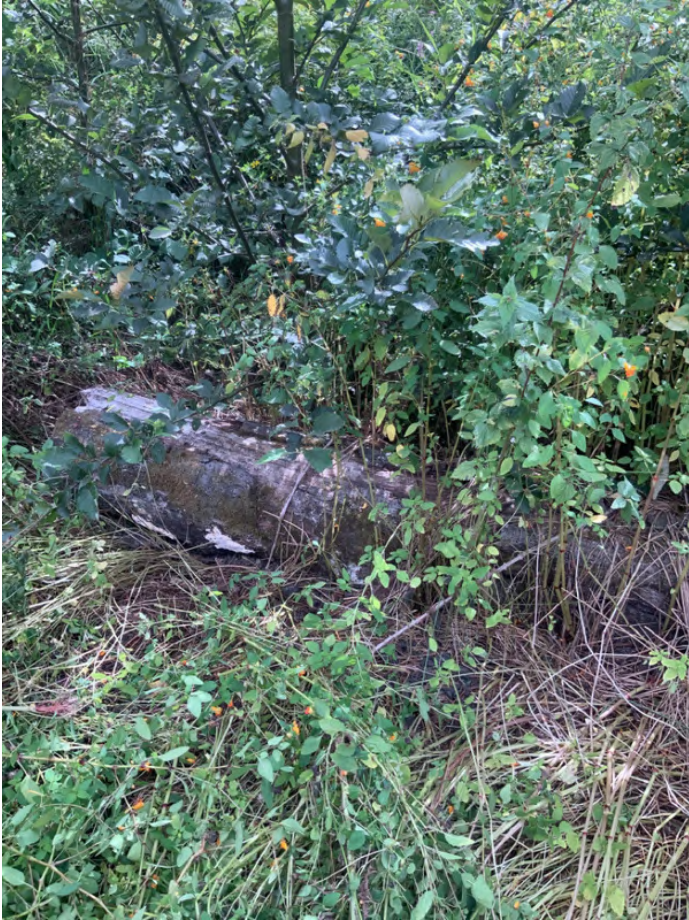
Date	August 31, 2021
Time	13:28
Feature ID	floodpain structure
Observer	Alaina Floor
Type of feature	Floodplain Log Structure
Condition of feature	Absent
Recommendation	Replace
General Notes	pinning stakes present no large wood members

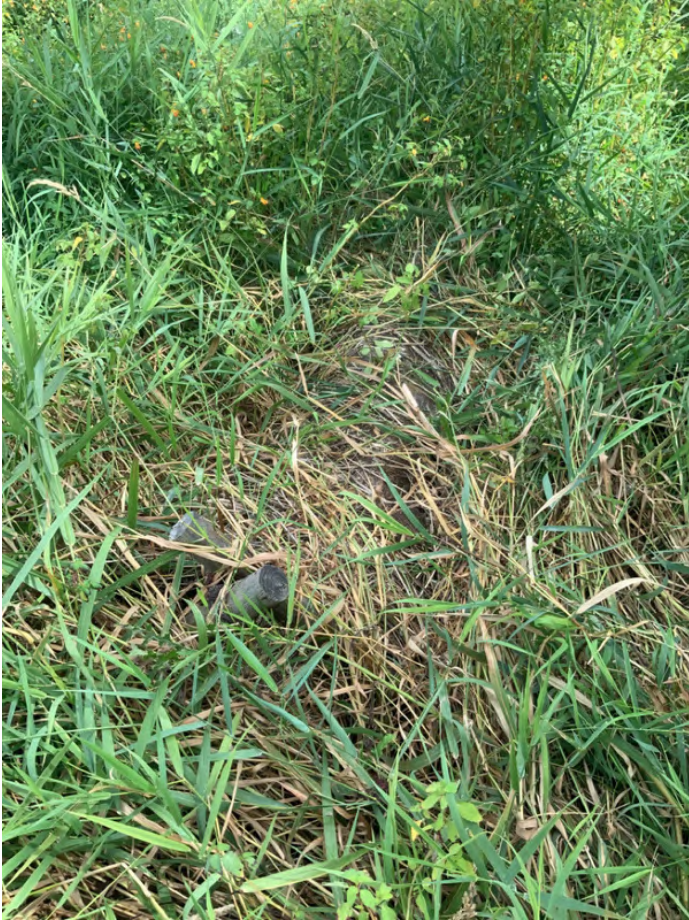
Date	August 31, 2021
Time	15:00
Feature ID	floodplain log
Observer	Alaina Floor
Type of feature	Floodplain Log Structure
Condition of feature	Good
Recommendation	None
General Notes	one member

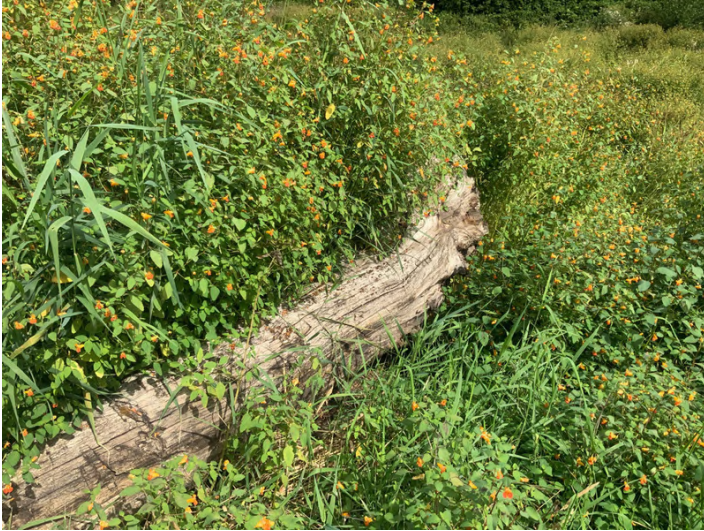
Date	August 31, 2021
Time	12:06
Feature ID	floodplain wood
Observer	Alaina Floor
Type of feature	Floodplain Log Structure
Condition of feature	Good
Recommendation	None
General Notes	two peices

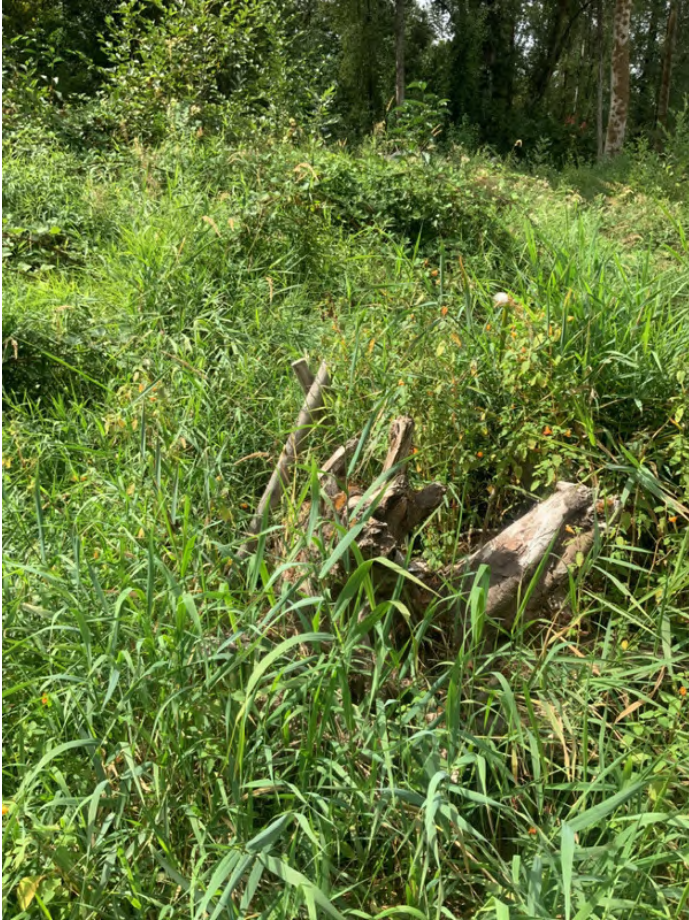
Date	August 31, 2021
Time	12:07
Feature ID	floodplain wood
Observer	Alaina Floor
Type of feature	Floodplain Log Structure
Condition of feature	Good
Recommendation	None
General Notes	twopeices

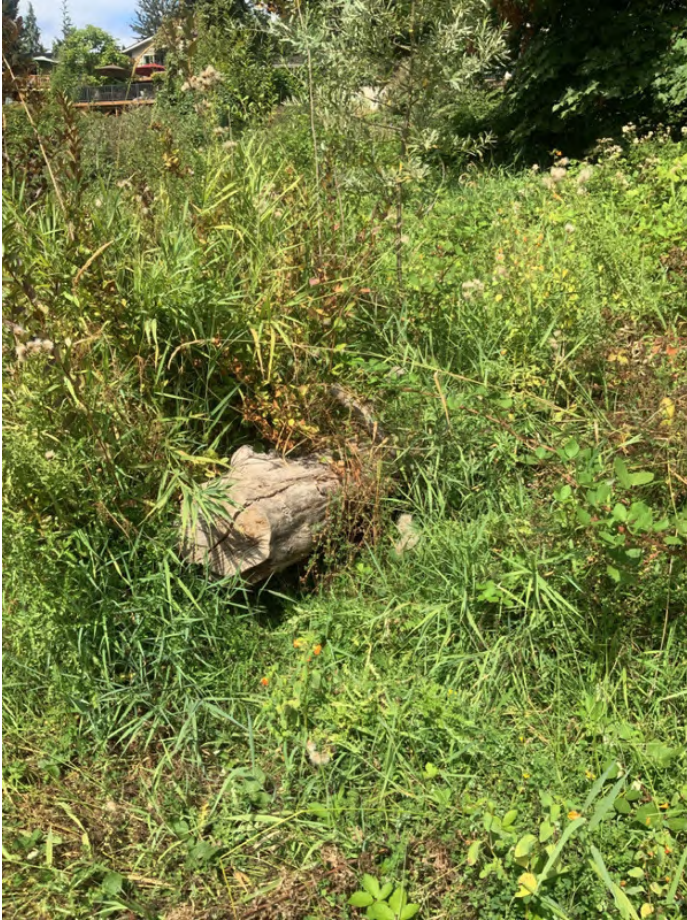
Date	August 31, 2021
Time	13:13
Feature ID	floodplain log
Observer	Alaina Floor
Type of feature	Floodplain Log Structure
Condition of feature	Good
Recommendation	None
General Notes	twopeices

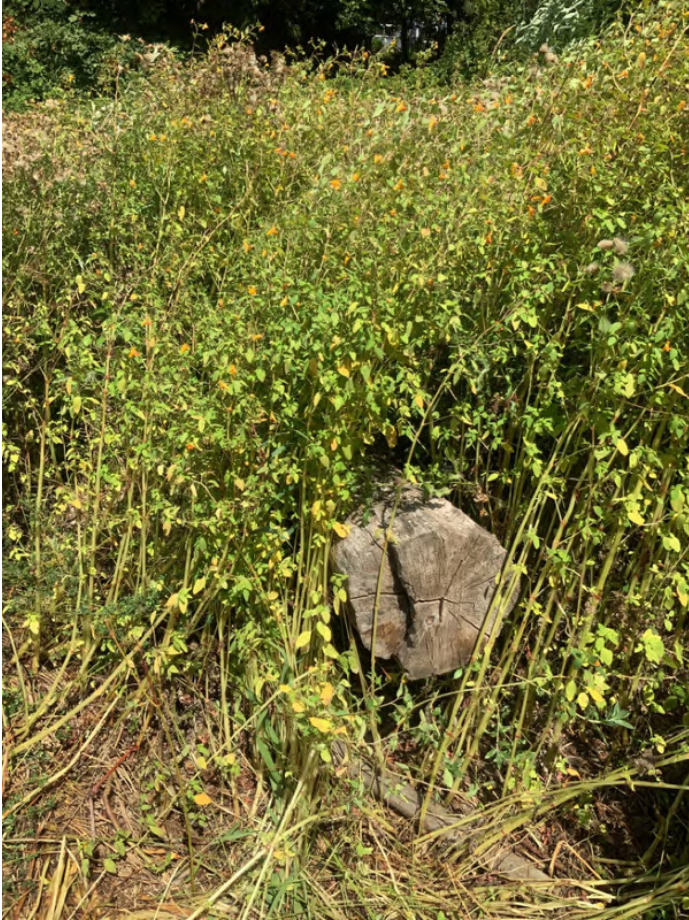
Date	August 31, 2021
Time	13:21
Feature ID	floodplain log
Observer	Alaina Floor
Type of feature	Floodplain Log Structure
Condition of feature	Good
Recommendation	None
General Notes	twopeices

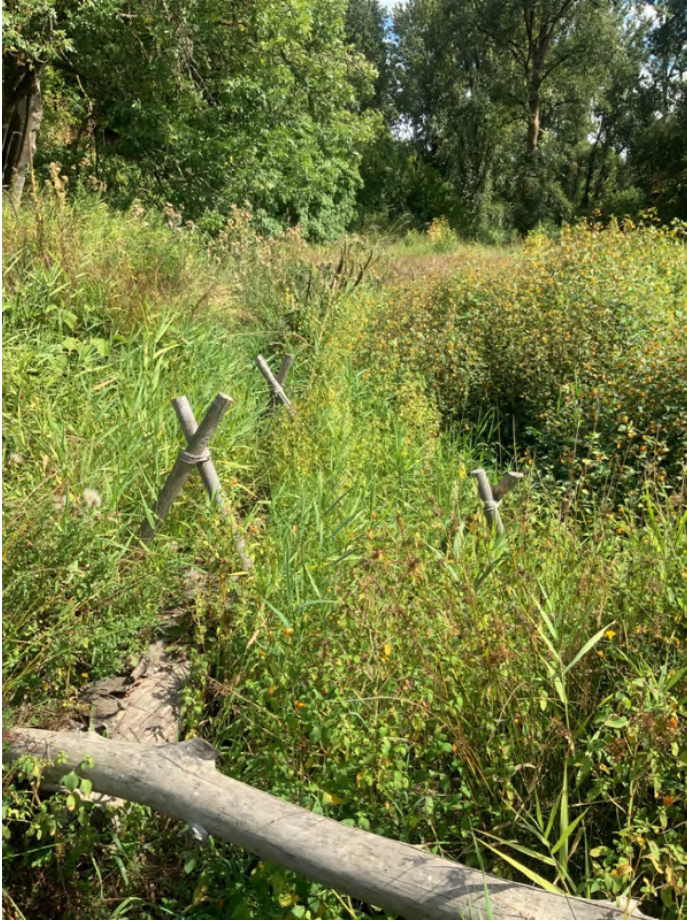
Date	August 31, 2021
Time	13:56
Feature ID	channel structure
Observer	Alaina Floor
Type of feature	Meander Channel Log Structure
Condition of feature	Good
Recommendation	None
General Notes	three pieces

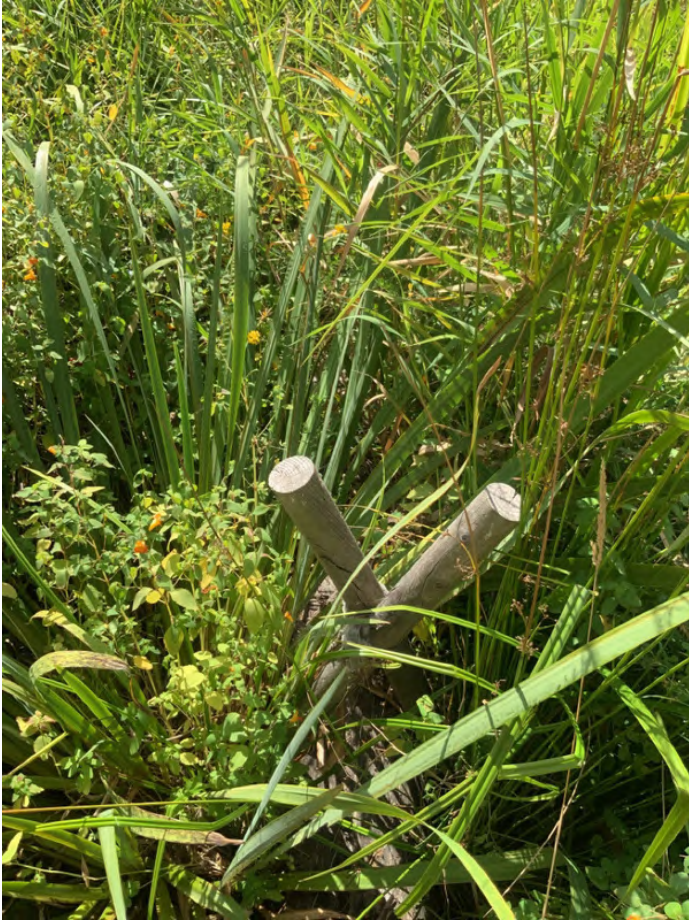
Date	August 31, 2021
Time	13:54
Feature ID	channel structure
Observer	Alaina Floor
Type of feature	Meander Channel Log Structure
Condition of feature	Good
Recommendation	None
General Notes	two pieces

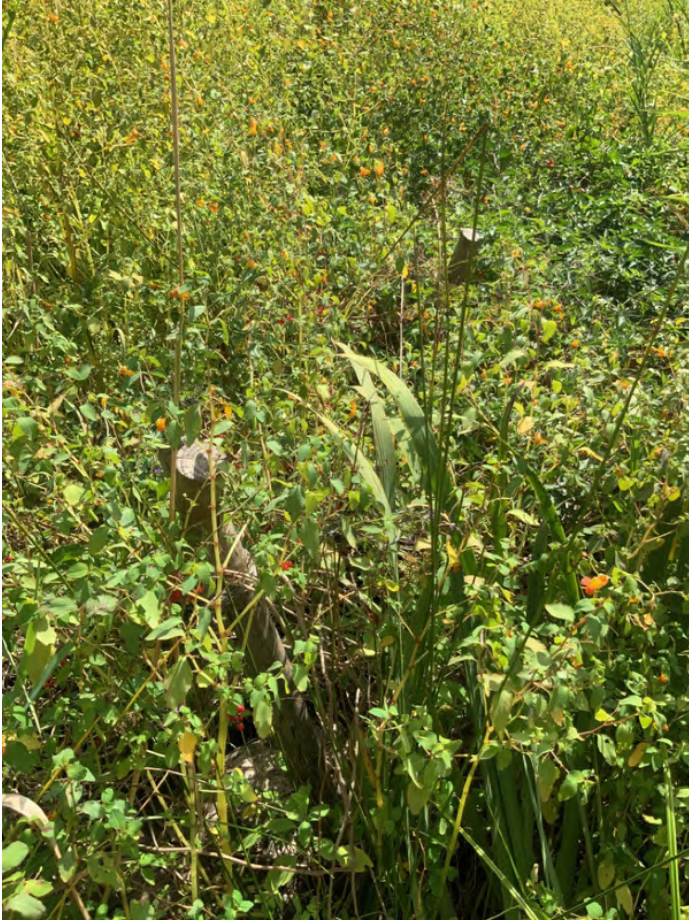
Date	August 31, 2021
Time	13:54
Feature ID	channel structure
Observer	Alaina Floor
Type of feature	Meander Channel Log Structure
Condition of feature	Good
Recommendation	None
General Notes	two peices

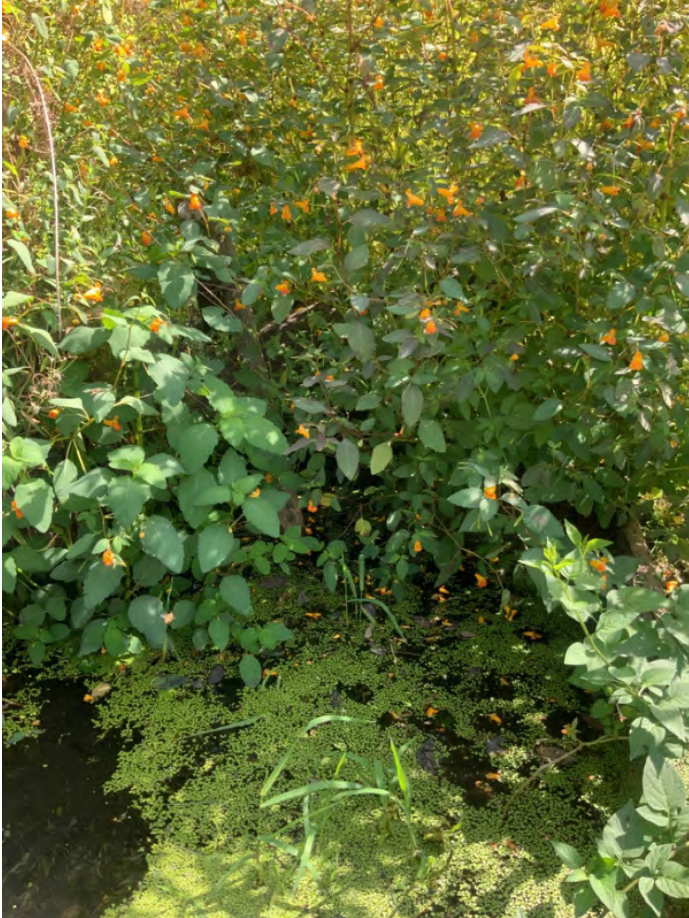
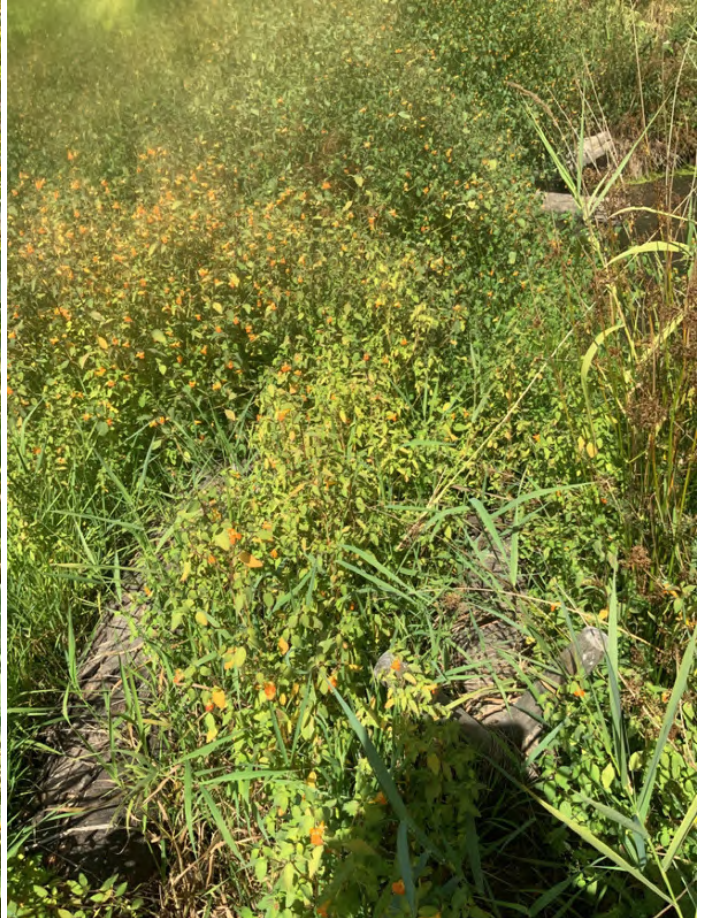
Date	August 31, 2021
Time	13:49
Feature ID	channel jam
Observer	Alaina Floor
Type of feature	Meander Channel Log Structure
Condition of feature	Good
Recommendation	None
General Notes	two pieces

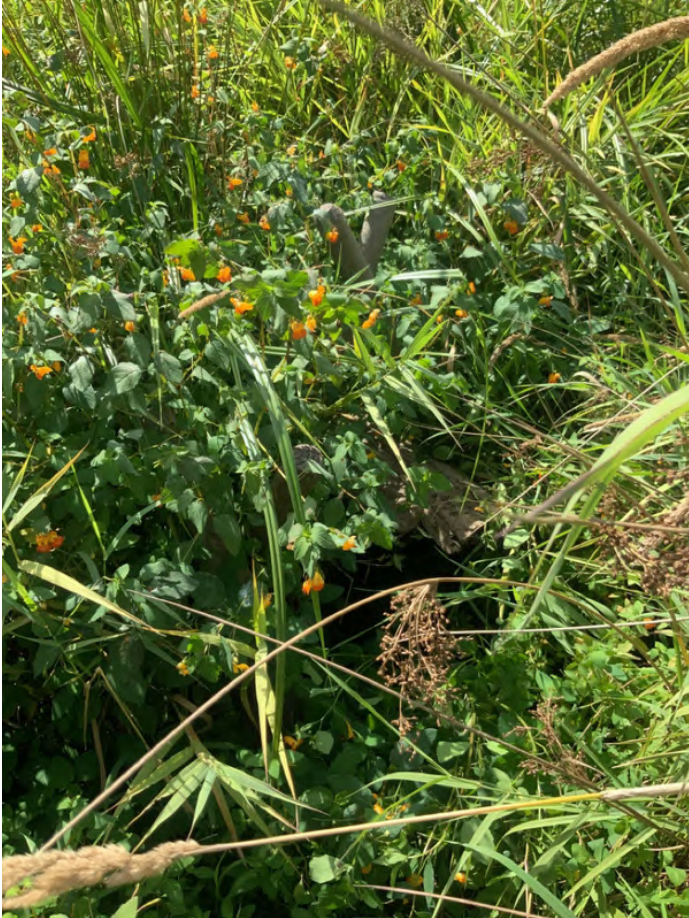
Date	August 31, 2021
Time	13:35
Feature ID	meander channel structure
Observer	Alaina Floor
Type of feature	Meander Channel Log Structure
Condition of feature	Good
Recommendation	None
General Notes	two peices

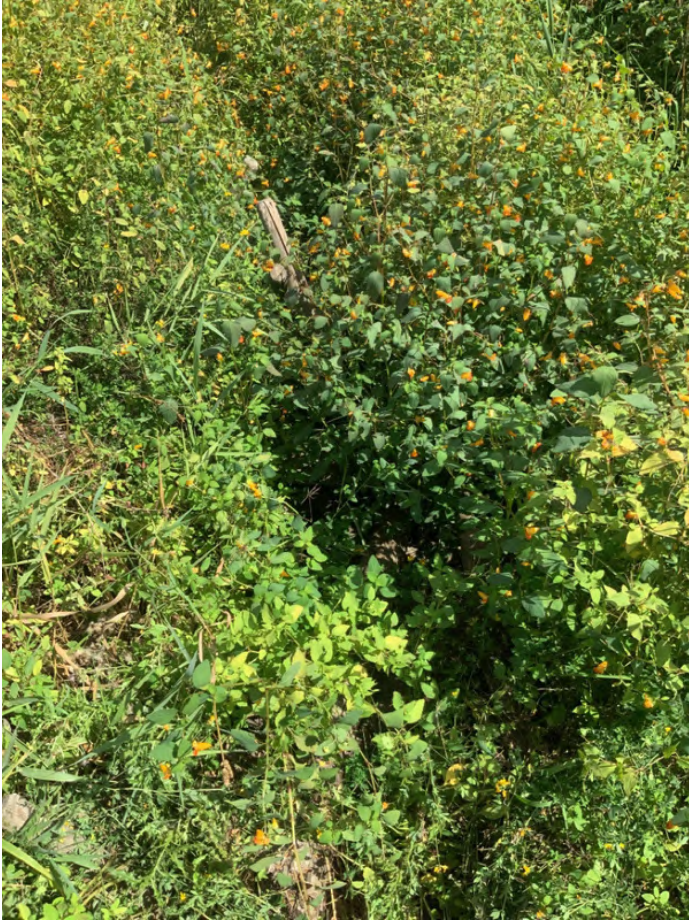
Date	August 31, 2021
Time	12:08
Feature ID	channel structure
Observer	Alaina Floor
Type of feature	Meander Channel Log Structure
Condition of feature	Good
Recommendation	None
General Notes	one piece. could be flood plain structure member from missing upstream structure

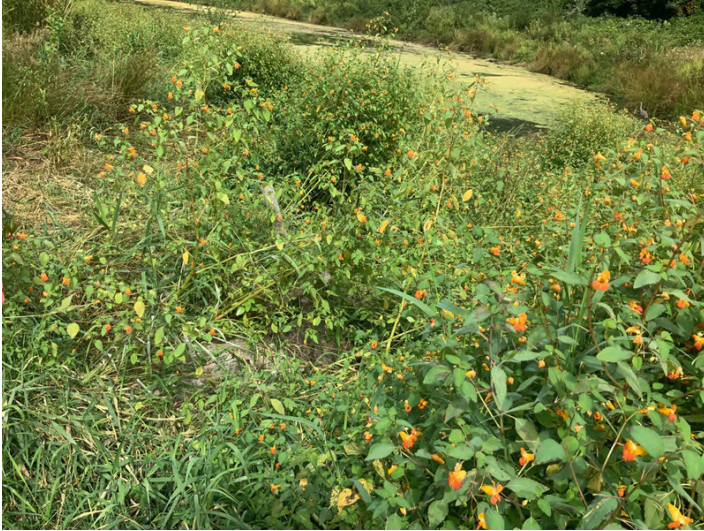
Date	August 31, 2021
Time	11:56
Feature ID	meander structure
Observer	Alaina Floor
Type of feature	Meander Channel Log Structure
Condition of feature	Good
Recommendation	None
General Notes	two peices
