RINEARSON NATURAL AREA RESTORATION MONITORING REPORT **YEAR 3 (2021)**

Prepared for
Columbia Restoration Group, LLC

Submitted January 2022;
Revised September 2022

Rinearson Natural Area Restoration Monitoring – Cover Sheet

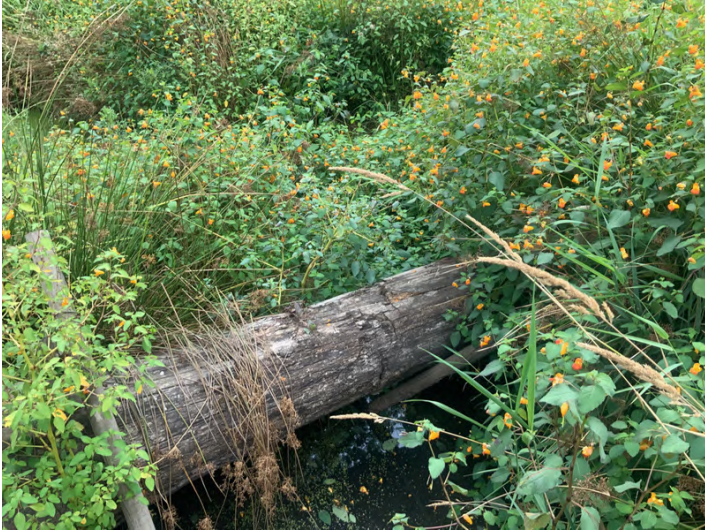
Date	August 31, 2021
Time	12:00
Feature ID	meander channel structure
Observer	Alaina Floor
Type of feature	Meander Channel Log Structure
Condition of feature	Good
Recommendation	None
General Notes	three peices

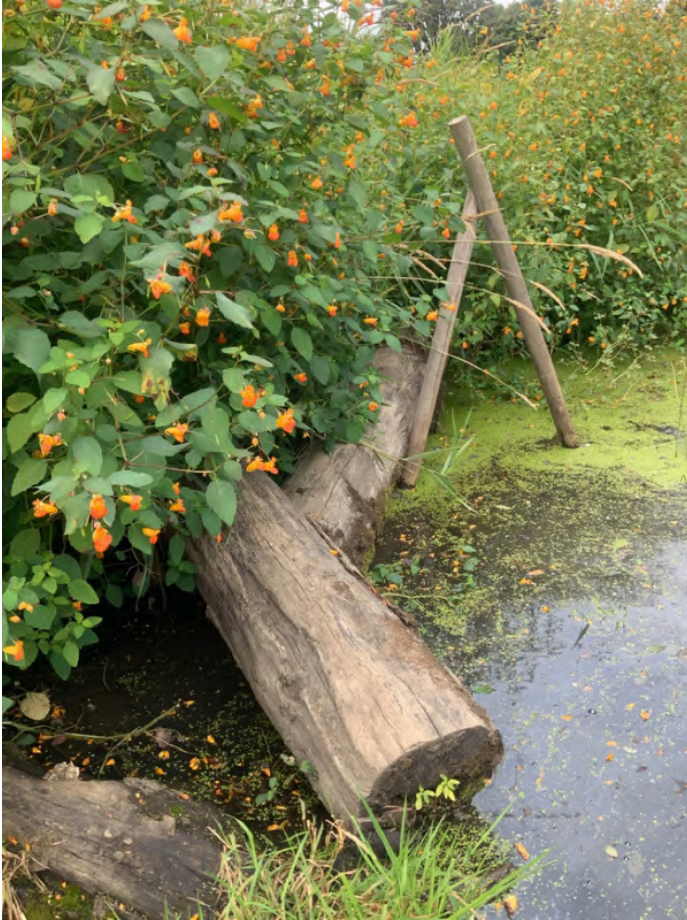
Date	August 31, 2021
Time	13:11
Feature ID	channel structure
Observer	Alaina Floor
Type of feature	Meander Channel Log Structure
Condition of feature	Good
Recommendation	None
General Notes	two peices

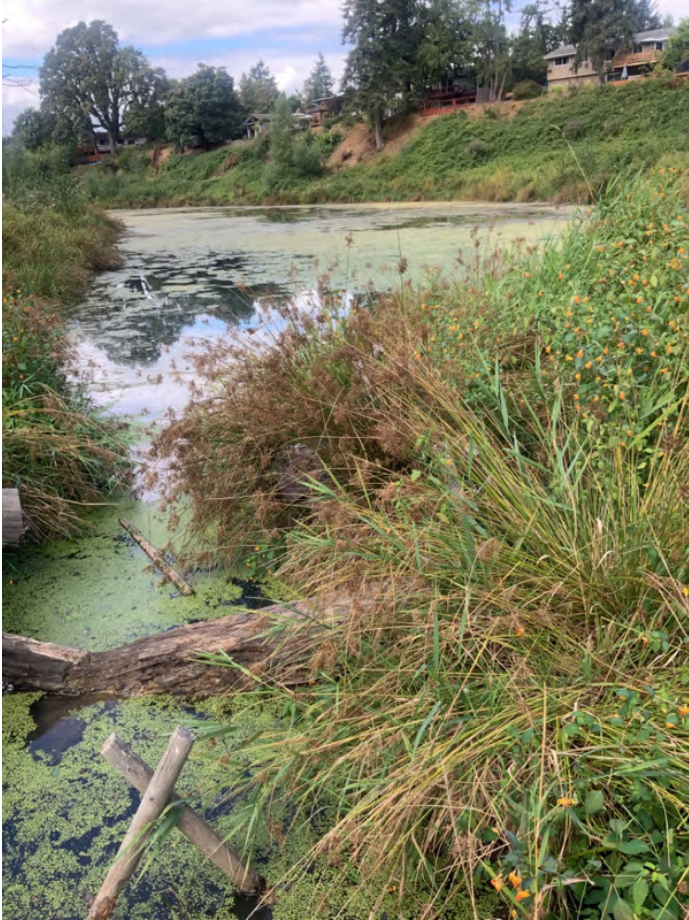
Date	August 31, 2021
Time	13:10
Feature ID	channel structure
Observer	Alaina Floor
Type of feature	Meander Channel Log Structure
Condition of feature	Good
Recommendation	None
General Notes	one peice

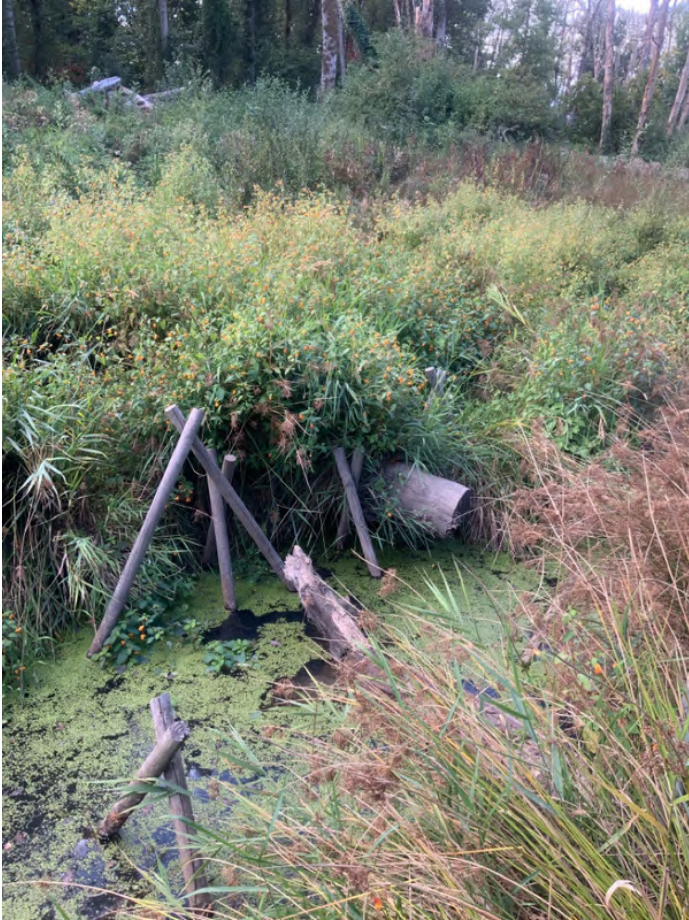
Date	August 31, 2021
Time	14:28
Feature ID	channel jam
Observer	Alaina Floor
Type of feature	Meander Channel Log Structure
Condition of feature	Good
Recommendation	None
General Notes	two peices

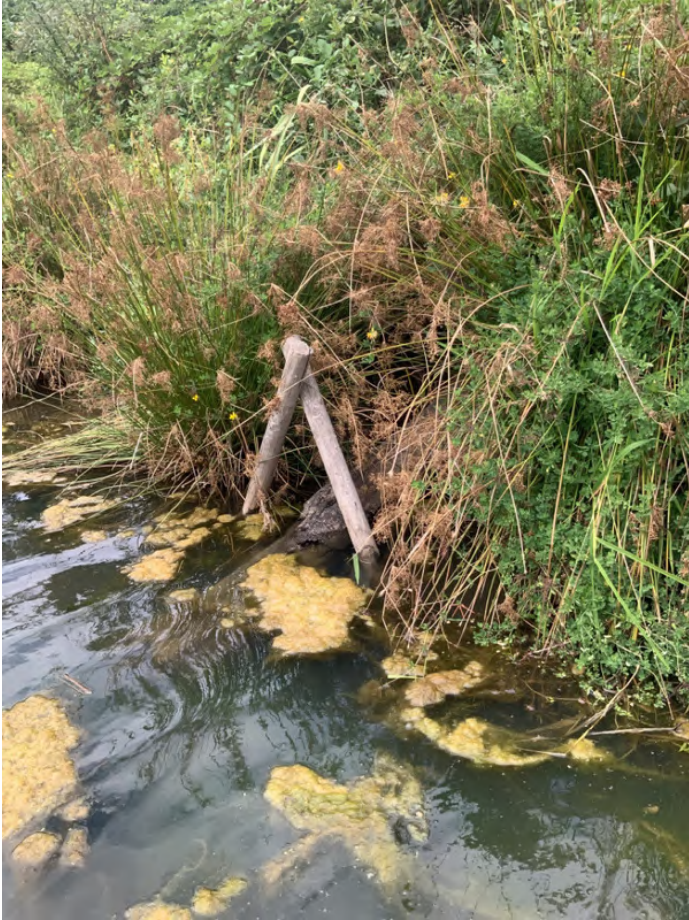
Date	August 30, 2021
Time	16:05
Feature ID	roughened channel log jam 1
Observer	Alaina Floor
Type of feature	Roughened Channel Log Structure
Condition of feature	Good
Recommendation	None
General Notes	two rootwads

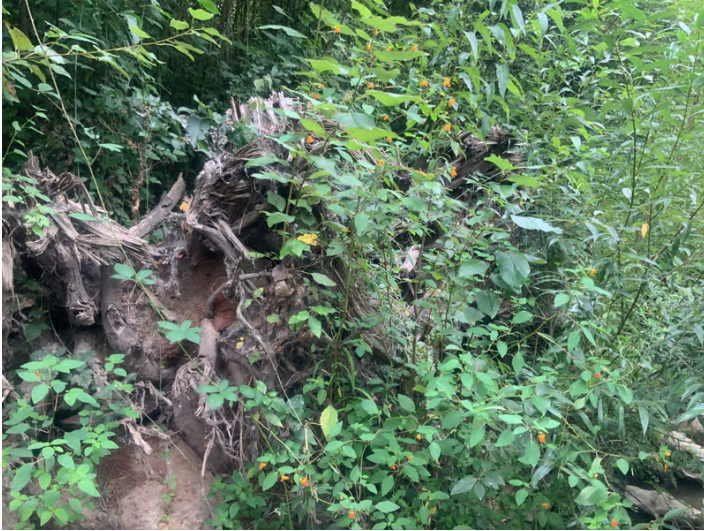
Date	August 30, 2021
Time	16:07
Feature ID	roughened channel log jam 2
Observer	Alaina Floor
Type of feature	Roughened Channel Log Structure
Condition of feature	Good
Recommendation	None
General Notes	two rootwads and toe log

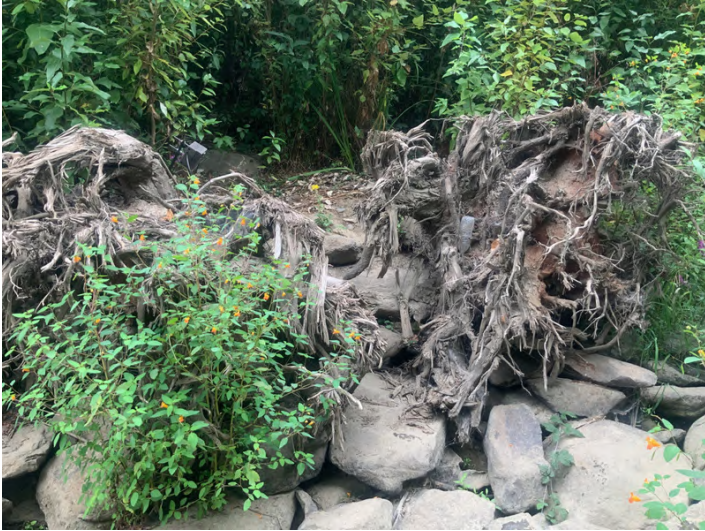
Date	August 30, 2021
Time	16:10
Feature ID	roughened channel log jam three
Observer	Alaina Floor
Type of feature	Roughened Channel Log Structure
Condition of feature	Good
Recommendation	None
General Notes	two rootwads and a sill log

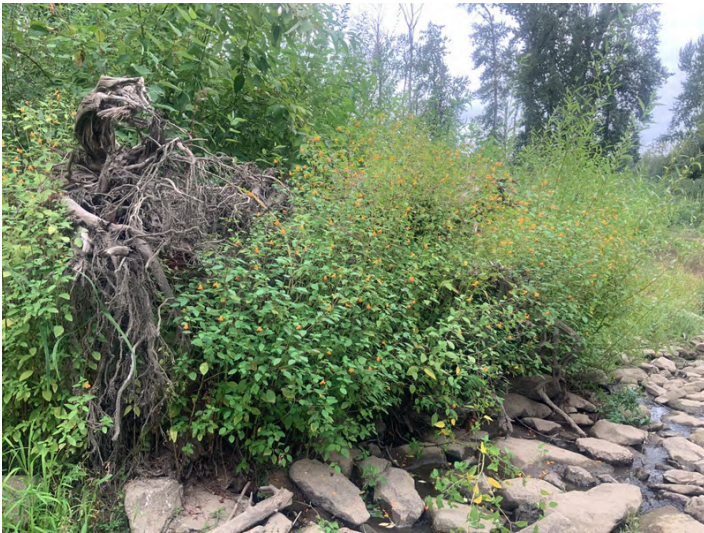
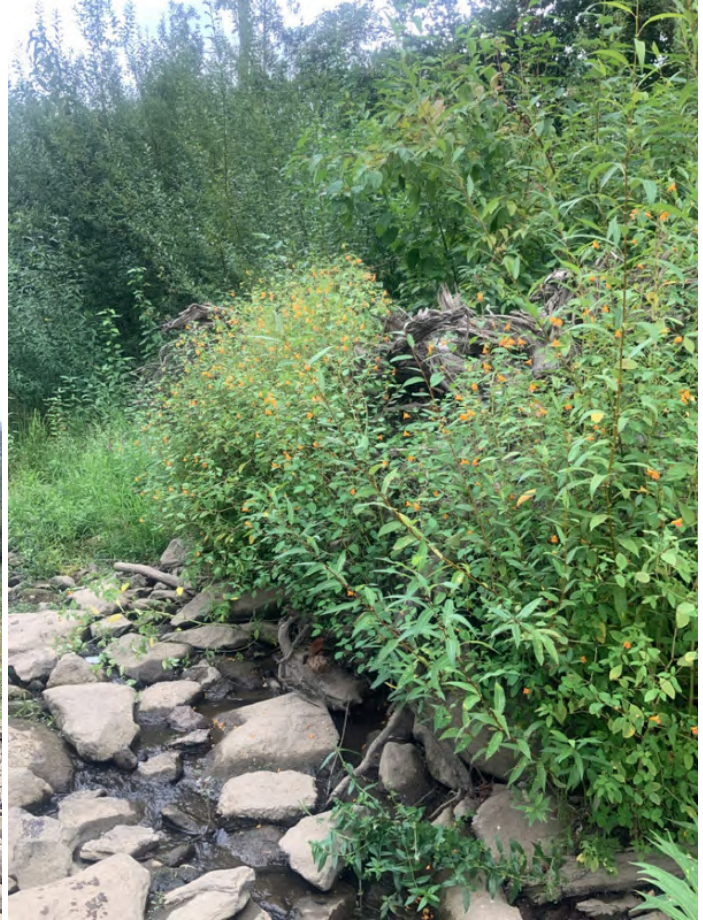
Date	August 30, 2021
Time	16:12
Feature ID	roughened channel log jam4
Observer	Alaina Floor
Type of feature	Roughened Channel Log Structure
Condition of feature	Good
Recommendation	None
General Notes	two rootwads and sill logs

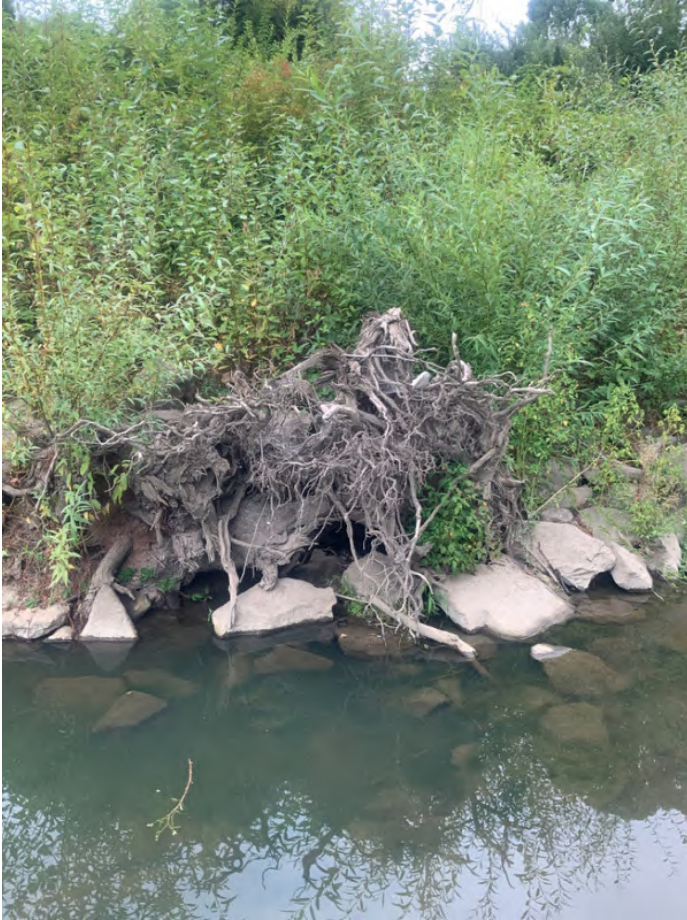
Date	August 31, 2021
Time	09:40
Feature ID	16
Observer	Hannah Smiley
Type of feature	Rock Pile (large)
Condition of feature	Good
Recommendation	None
General Notes	25 pieces.

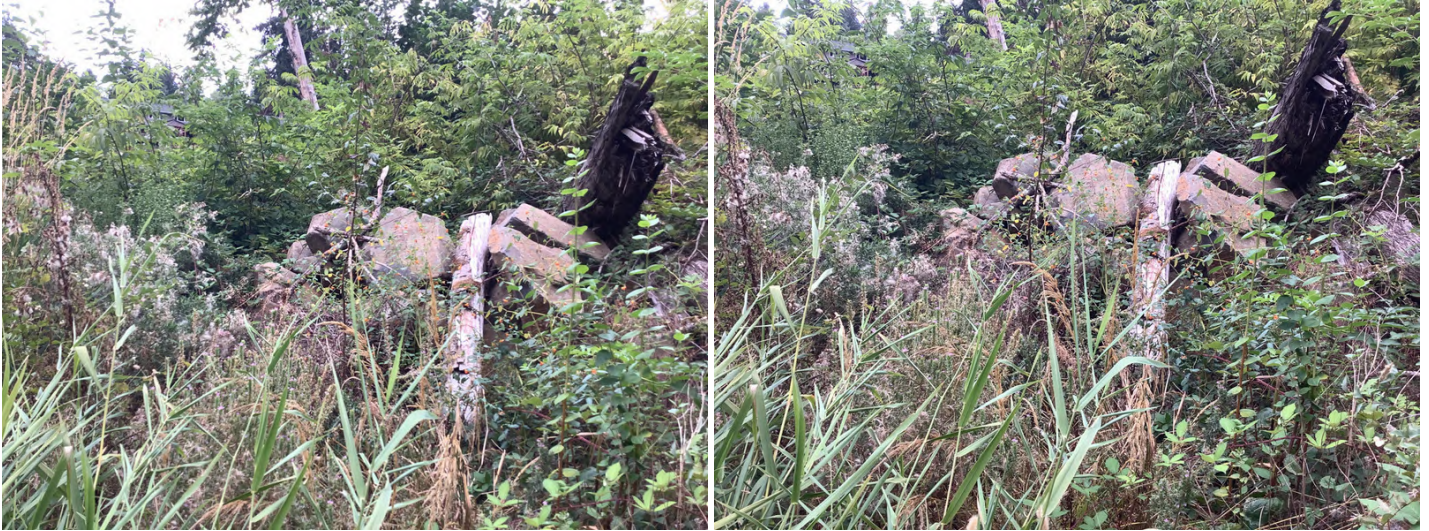
Date	August 31, 2021
Time	09:40
Feature ID	24
Observer	Hannah Smiley
Type of feature	Rock Pile (large)
Condition of feature	Good
Recommendation	None
General Notes	35 pieces

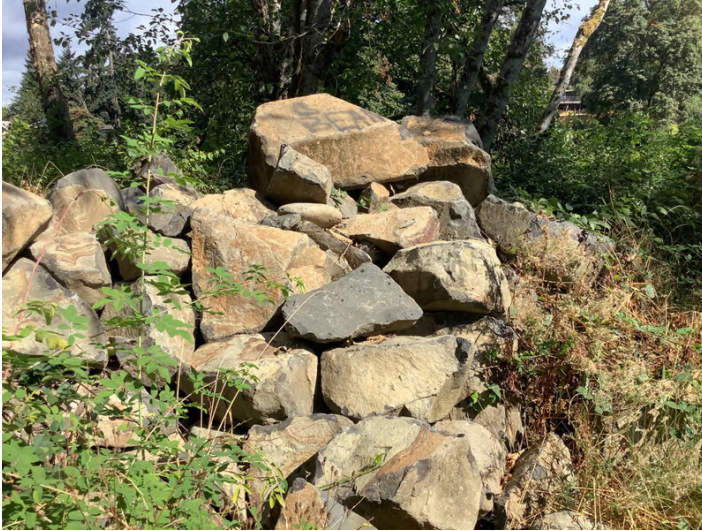
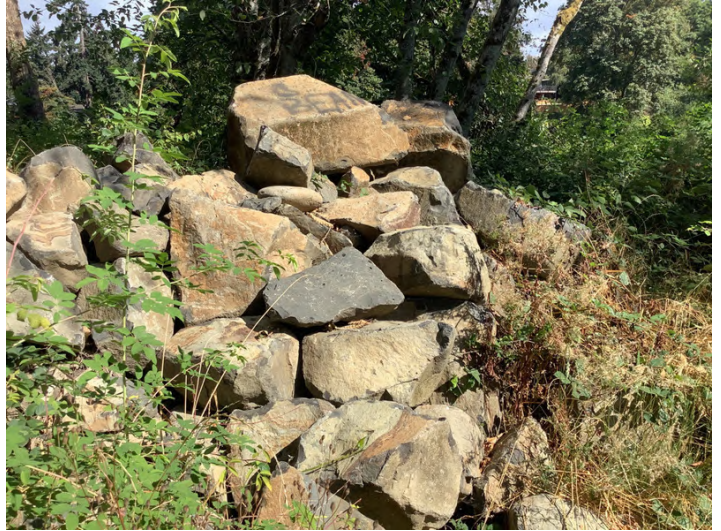
Date	August 30, 2021
Time	12:14
Feature ID	Rock pile, large, 34
Observer	Sarah Hartung
Type of feature	Rock Pile (large)
Condition of feature	Good
Recommendation	None
General Notes	3 large logs at base

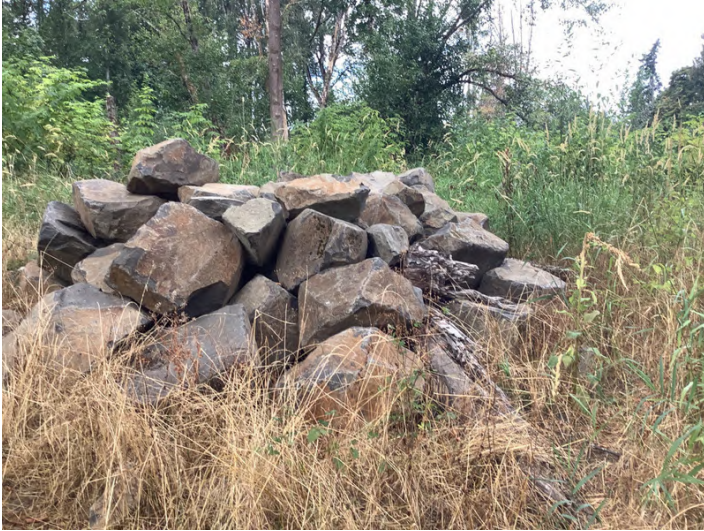
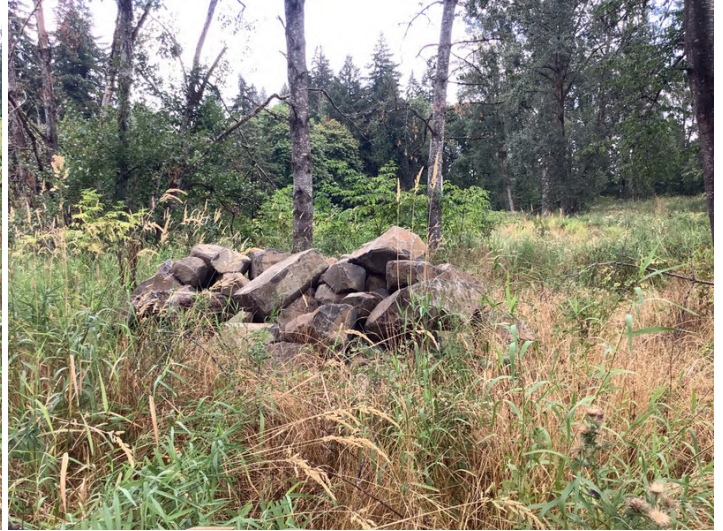
Date	August 31, 2021
Time	09:40
Feature ID	42
Observer	Hannah Smiley
Type of feature	Rock Pile (large)
Condition of feature	Maybe absent
Recommendation	None
General Notes	Lots of woody debris and human disturbance, I stomped down a bunch of plants, under bushes , needs machete

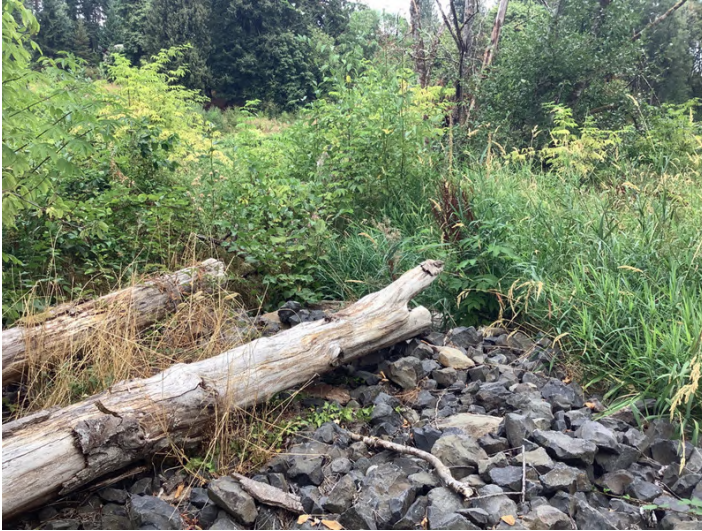
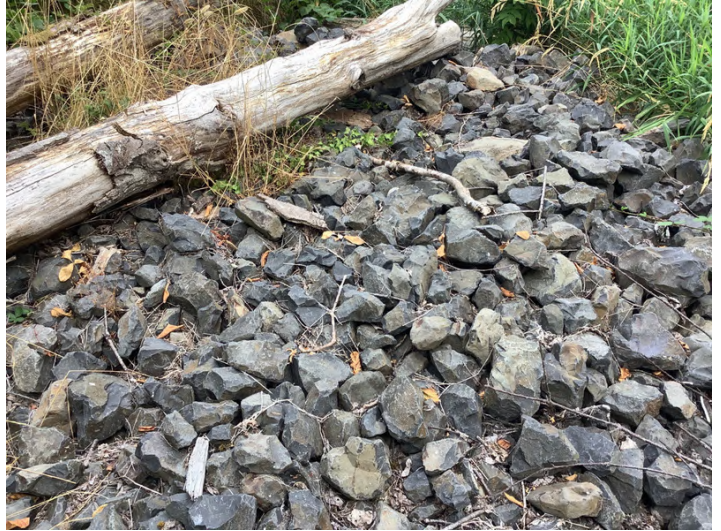
Date	August 31, 2021
Time	09:40
Feature ID	5
Observer	Hannah Smiley
Type of feature	Rock Pile (small)
Condition of feature	Good
Recommendation	None
General Notes	14

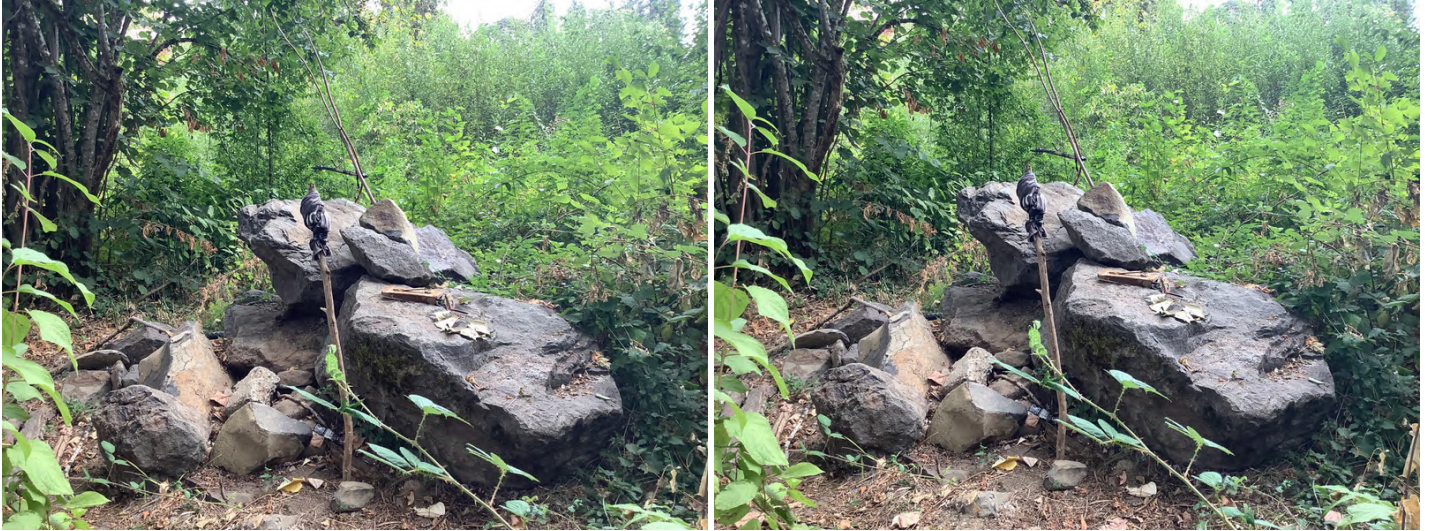
Date	August 31, 2021
Time	09:40
Feature ID	6
Observer	Hannah Smiley
Type of feature	Rock Pile (small)
Condition of feature	Maybe absent
Recommendation	Maintenance
General Notes	Hard to see, needs machete, did not find, maybe under blackberry, maybe same as debris pile

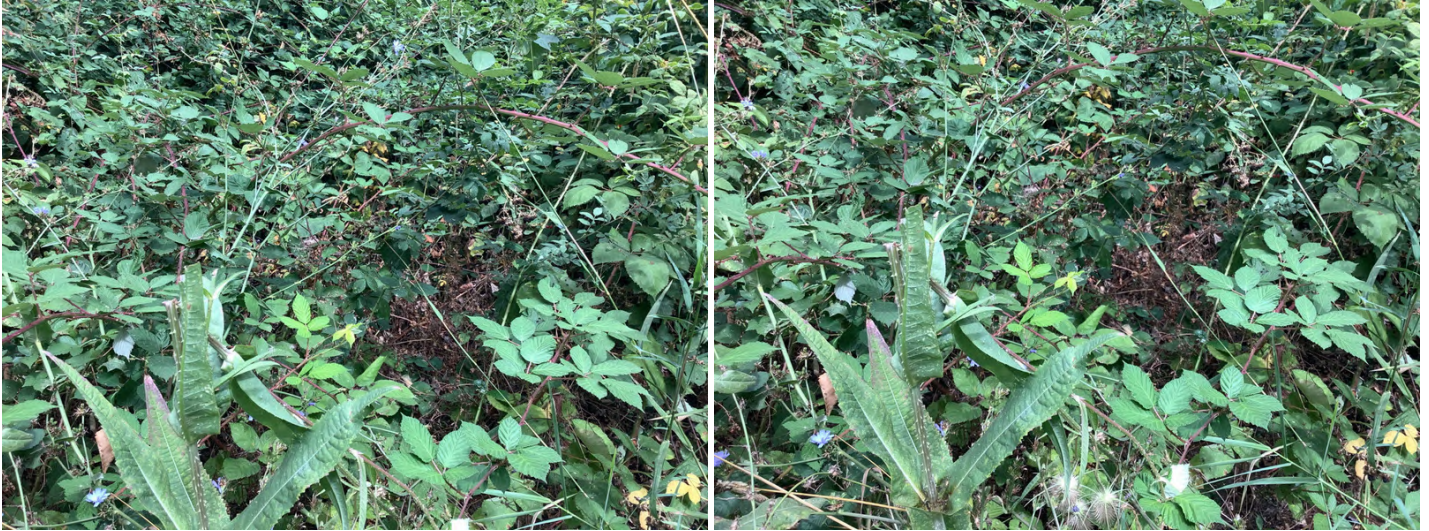
Date	August 31, 2021
Time	09:40
Feature ID	9
Observer	Sarah Hartung
Type of feature	Rock Pile (small)
Condition of feature	Good
Recommendation	None
General Notes	5 rocks, Himalayan blackberry

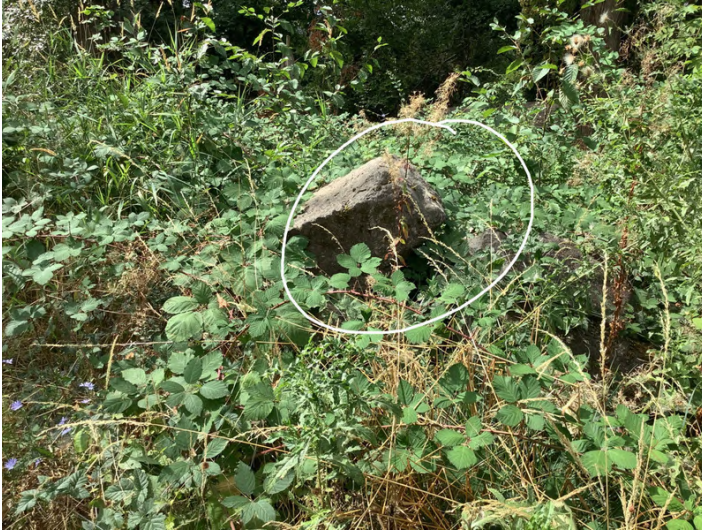
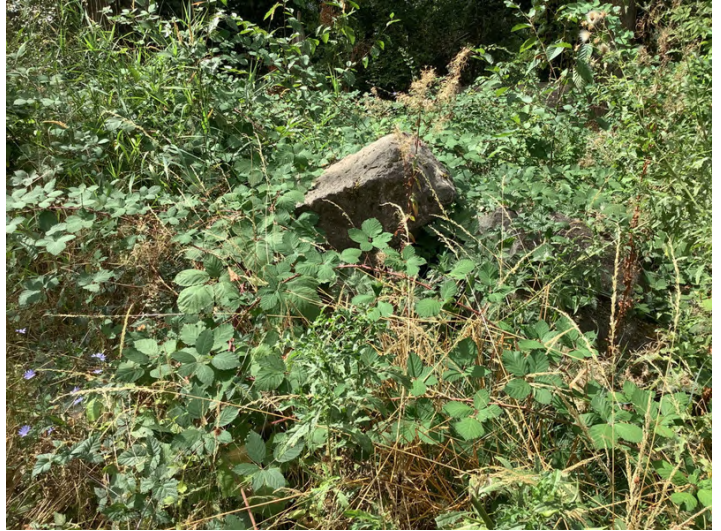
Date	August 31, 2021
Time	09:40
Feature ID	10
Observer	Hannah Smiley
Type of feature	Rock Pile (small)
Condition of feature	Good
Recommendation	None
General Notes	10 rocks, covered in blackberry

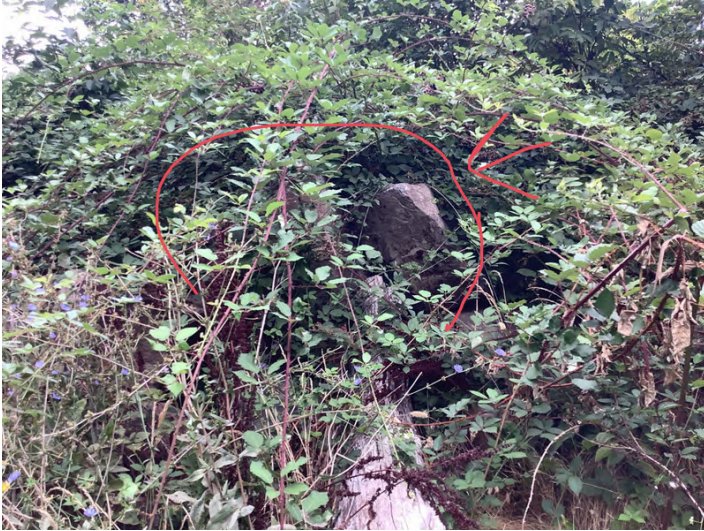
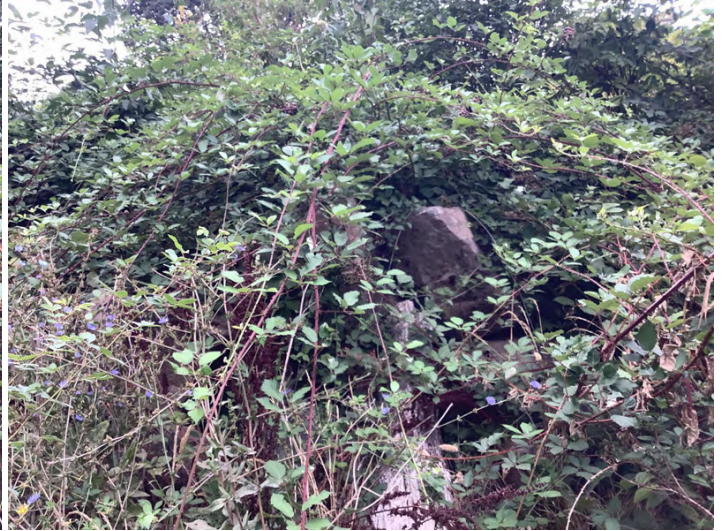
Date	August 31, 2021
Time	09:40
Feature ID	14
Observer	Hannah Smiley
Type of feature	Rock Pile (small)
Condition of feature	Good
Recommendation	None
General Notes	8 pieces of rock, over grown with blackberry

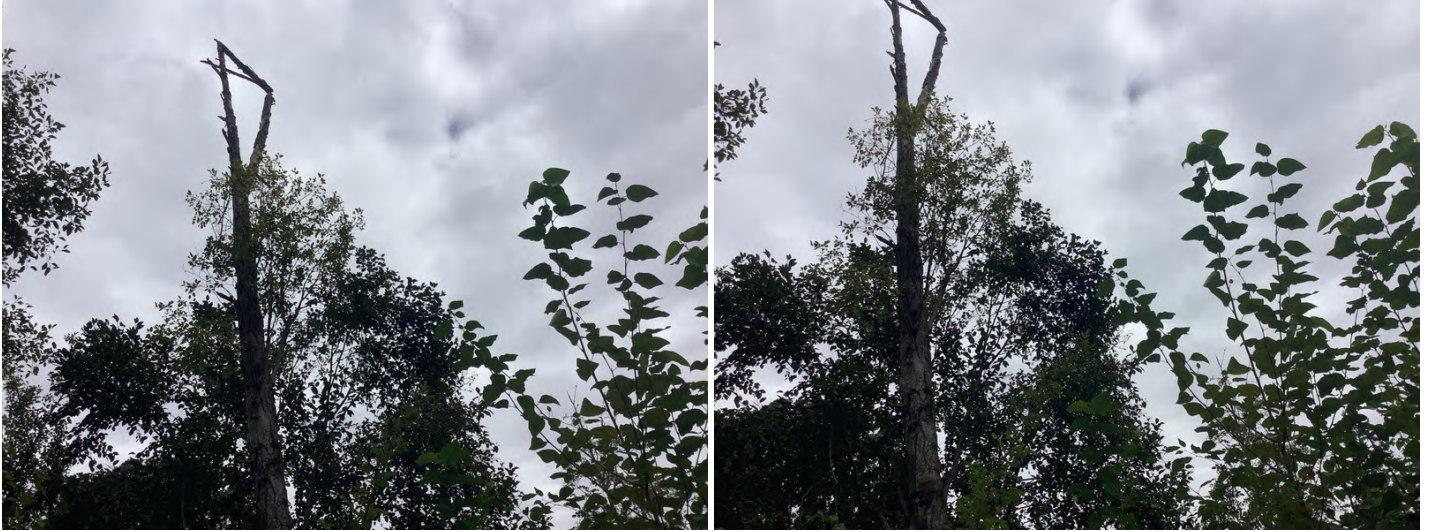
Date	August 31, 2021
Time	09:40
Feature ID	13
Observer	Hannah Smiley
Type of feature	Snag
Condition of feature	Good
Recommendation	None
General Notes	bird perch, medium

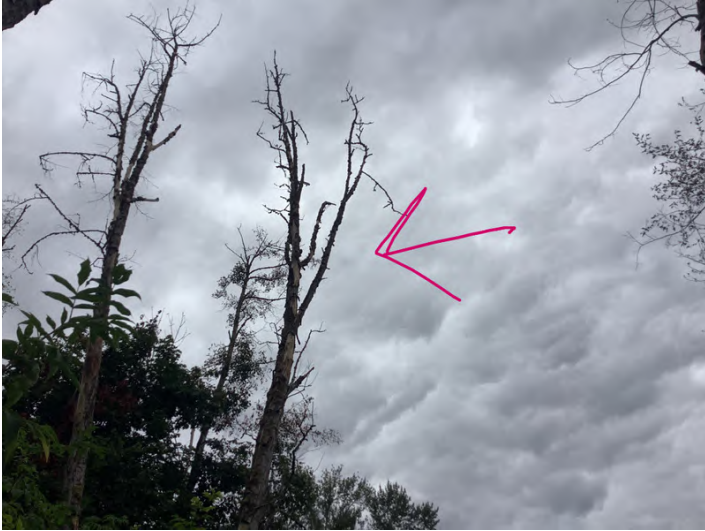
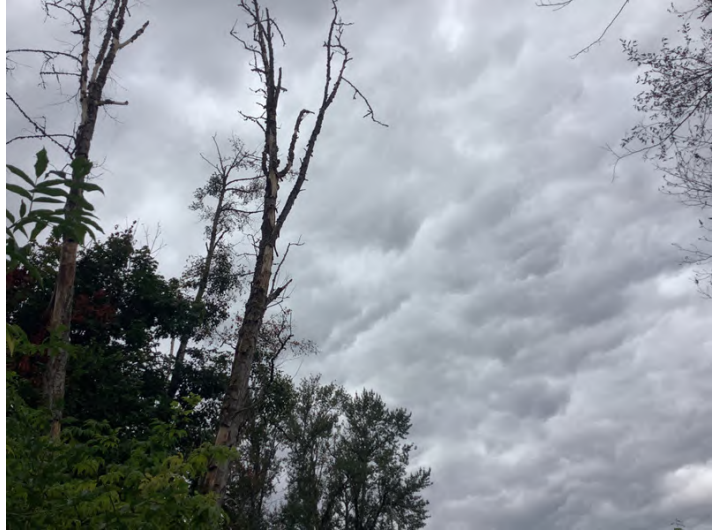
Date	August 31, 2021
Time	09:40
Feature ID	22
Observer	Hannah Smiley
Type of feature	Snag
Condition of feature	Good
Recommendation	None
General Notes	Multiple stems, two trunks, bird perch

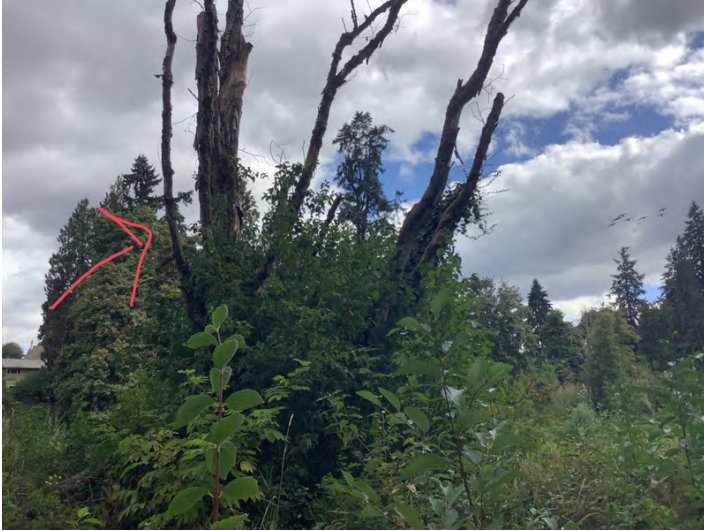
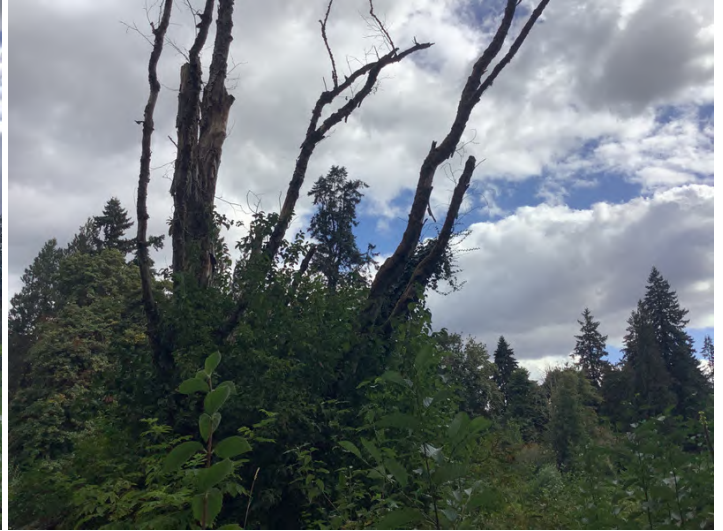
Date	August 30, 2021
Time	11:40
Feature ID	Snag 28
Observer	Sarah Hartung
Type of feature	Snag
Condition of feature	Good
Recommendation	None
General Notes	7 large snags in area

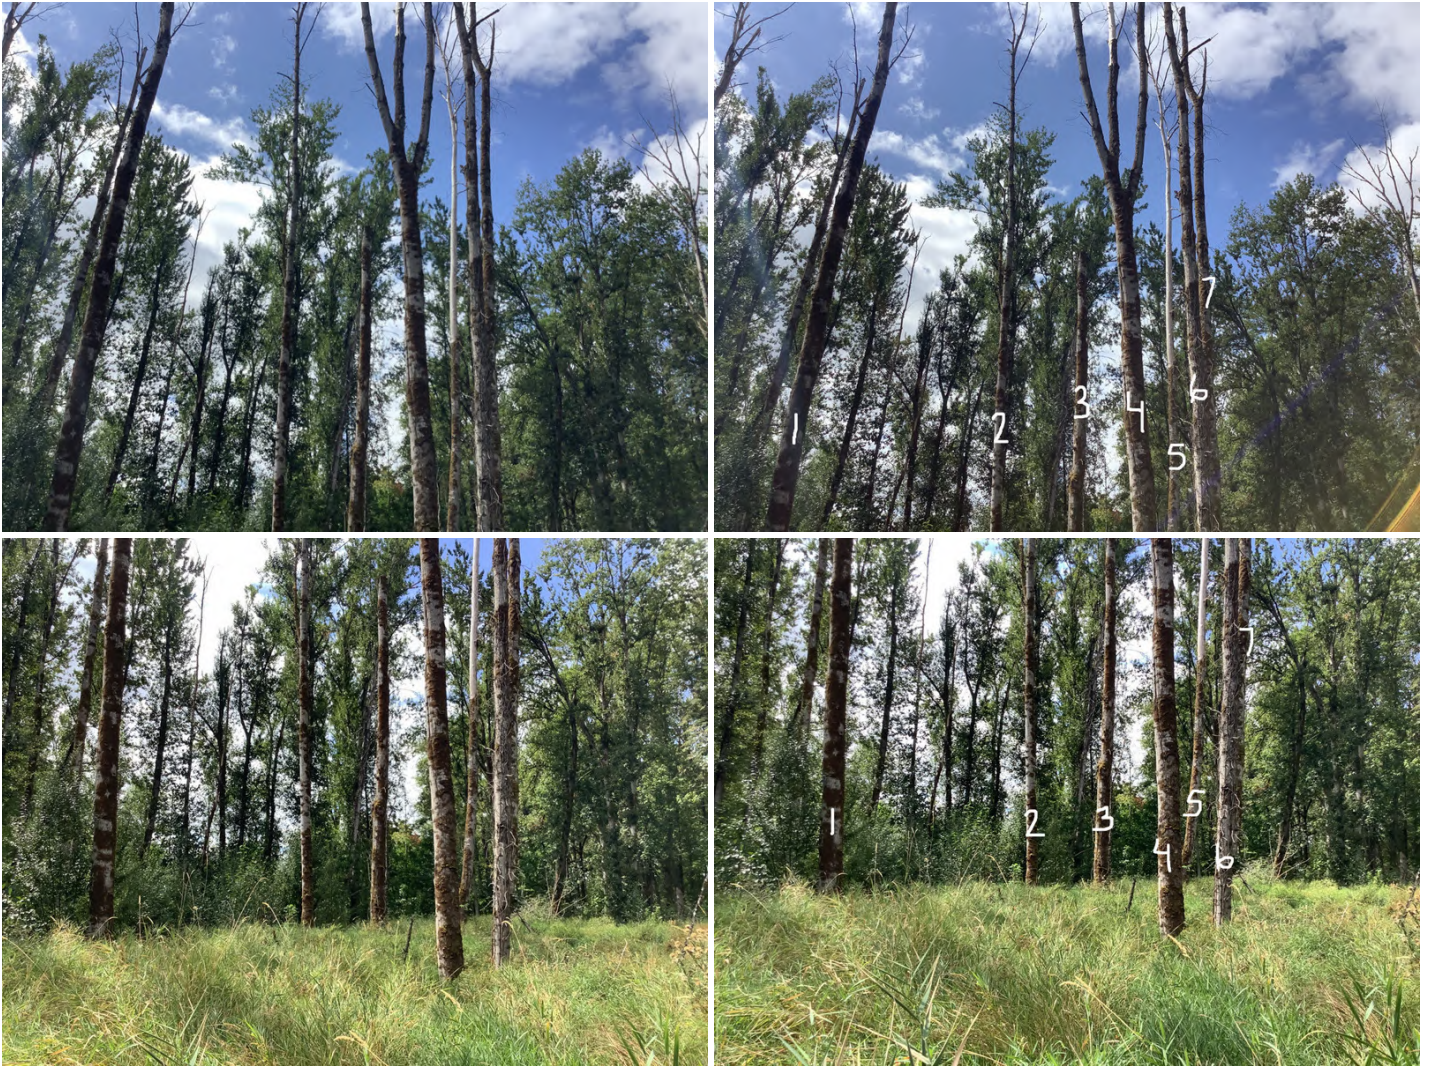
Date	August 30, 2021
Time	11:40
Feature ID	Snag 37
Observer	Sarah Hartung
Type of feature	Snag
Condition of feature	Good
Recommendation	None
General Notes	7 large snags in area

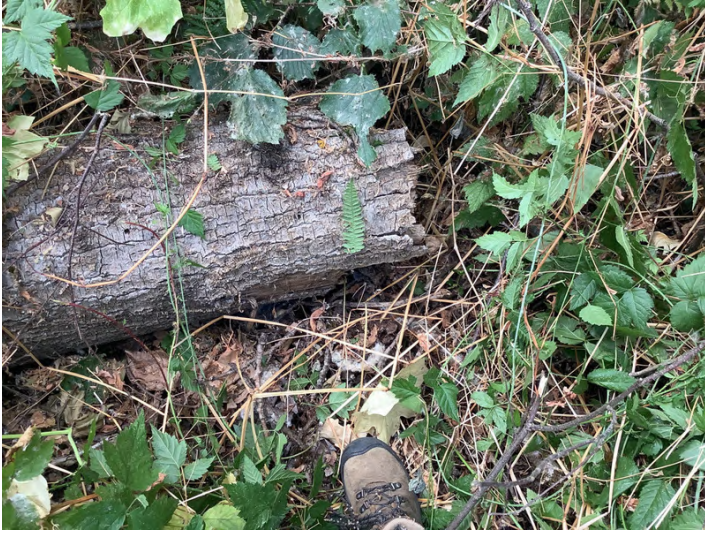
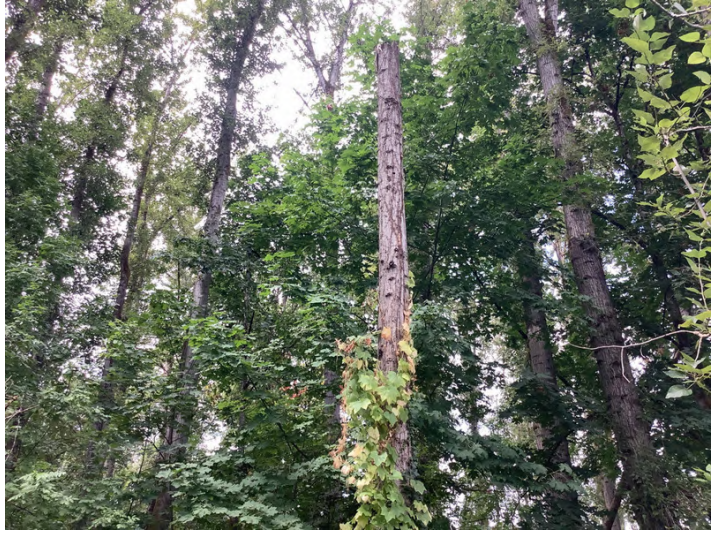
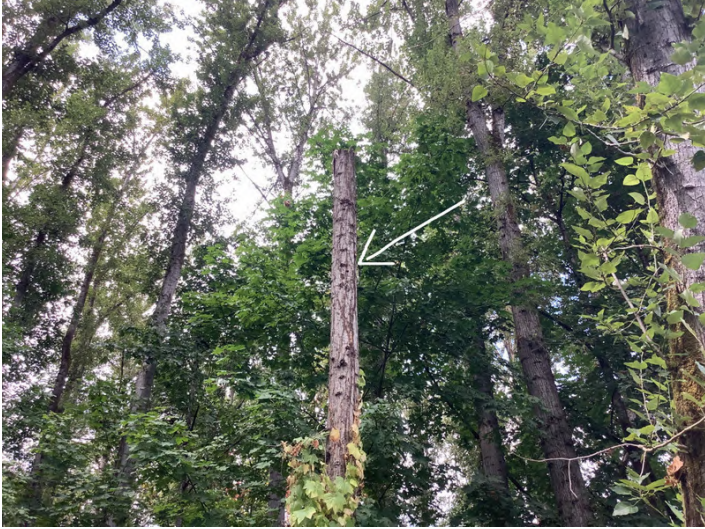
Date	August 30, 2021
Time	11:40
Feature ID	Snag 39
Observer	Sarah Hartung
Type of feature	Snag
Condition of feature	Good
Recommendation	None
General Notes	Medium snag, 10" dbh, plus medium log on ground

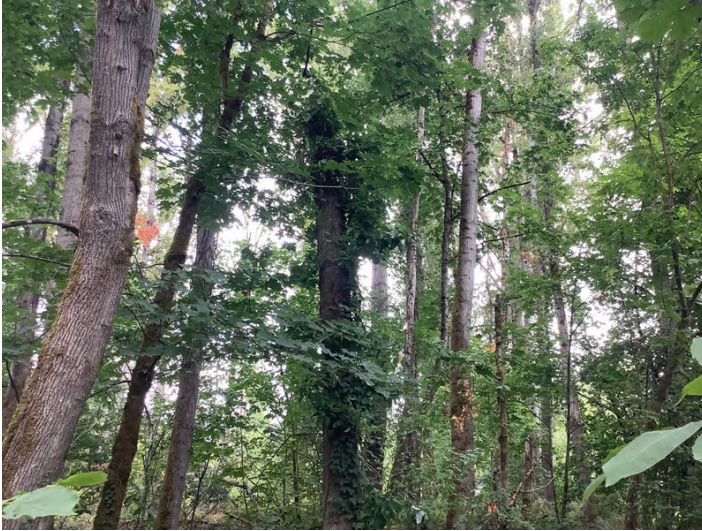
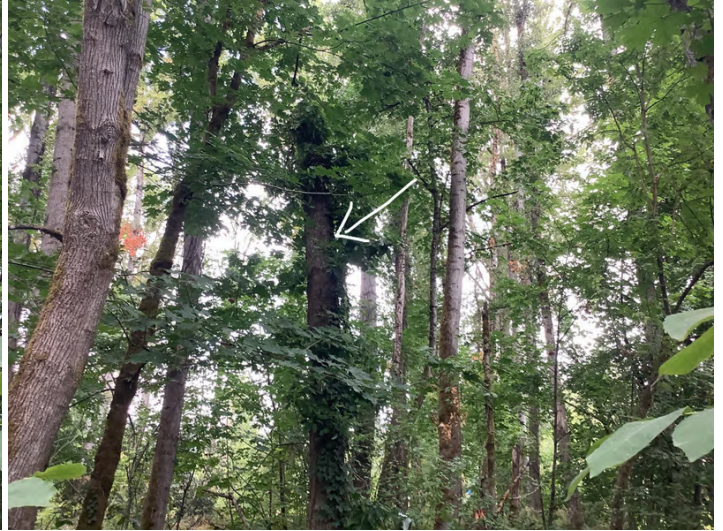
Date	August 30, 2021
Time	11:40
Feature ID	Snag 40
Observer	Sarah Hartung
Type of feature	Snag
Condition of feature	Good
Recommendation	None
General Notes	Medium snag, 10" dbh

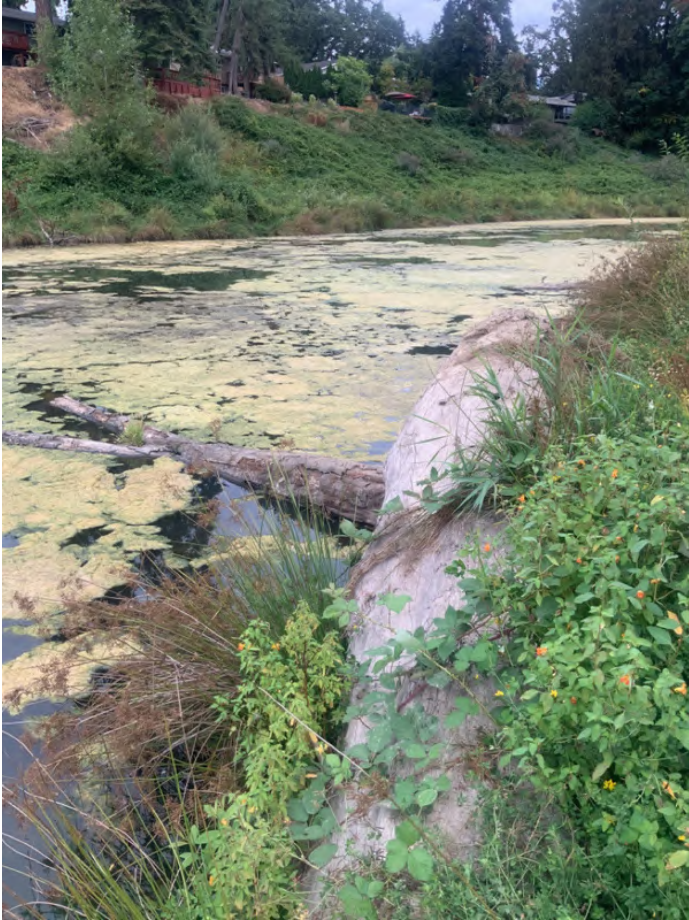
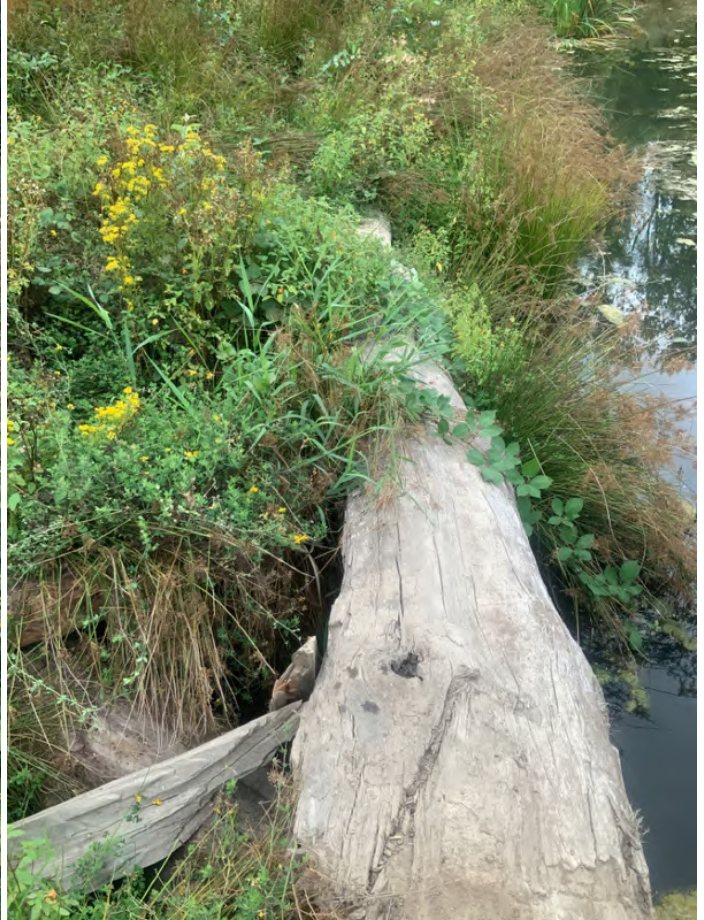
Date	August 30, 2021
Time	15:49
Feature ID	pond log 1
Observer	Alaina Floor
Type of feature	Tree Tipped into Pond
Condition of feature	Good
Recommendation	None
General Notes	three pieces

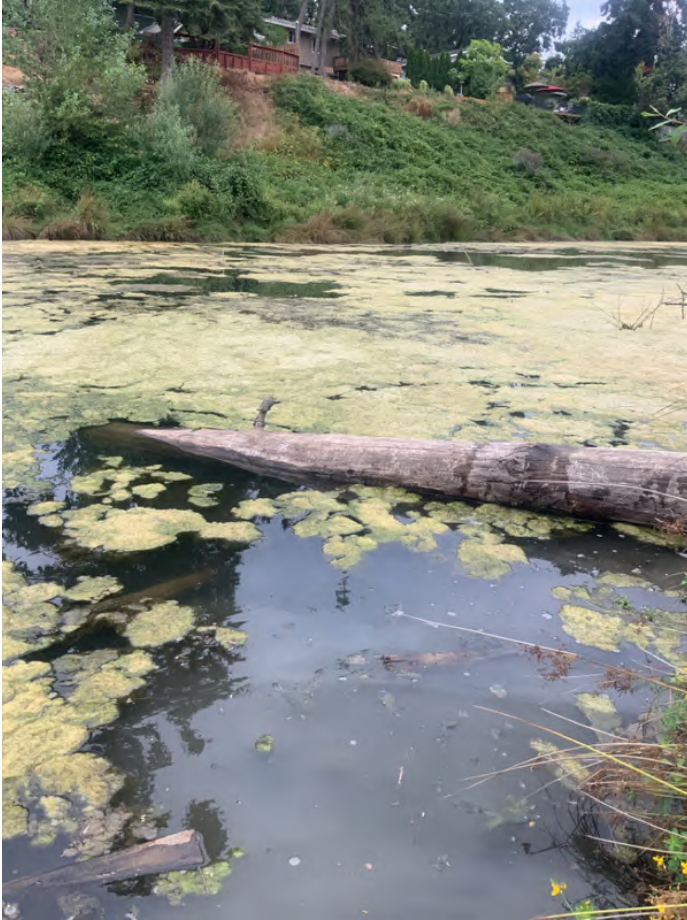
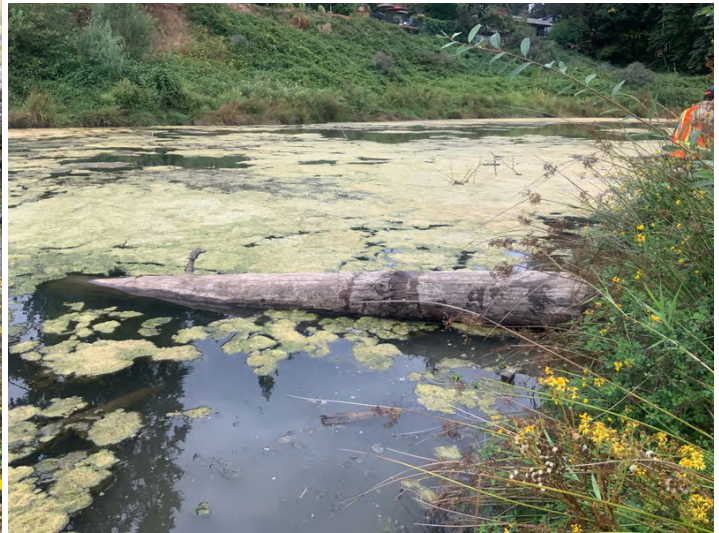
Date	August 30, 2021
Time	15:54
Feature ID	pond log 2
Observer	Alaina Floor
Type of feature	Tree Tipped into Pond
Condition of feature	Good
Recommendation	None
General Notes	one log piece

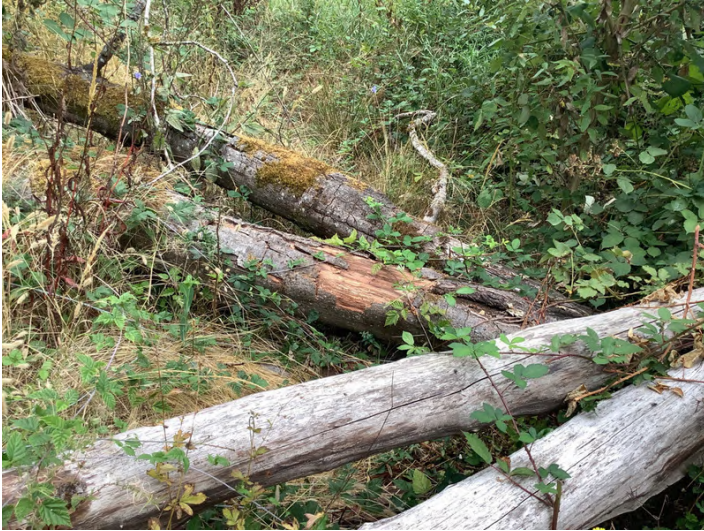
Date	August 31, 2021
Time	09:40
Feature ID	11
Observer	Hannah Smiley
Type of feature	Upland Log Structure
Condition of feature	Good
Recommendation	None
General Notes	2 logs

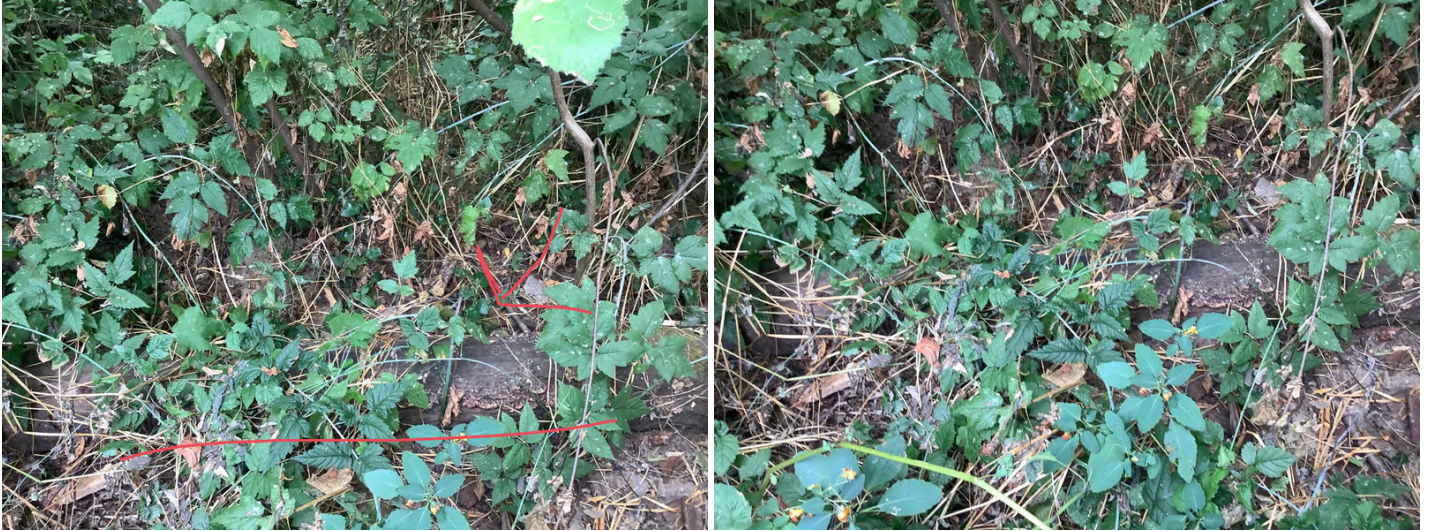
Date	August 31, 2021
Time	09:40
Feature ID	12
Observer	Sarah Hartung
Type of feature	Upland Log Structure
Condition of feature	Good
Recommendation	None
General Notes	A few logs, covered in blackberry

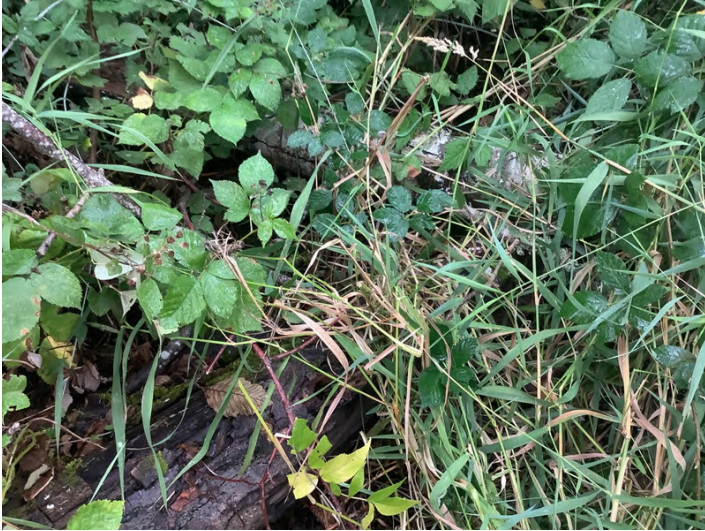
Date	September 30, 2021
Time	13:29
Feature ID	29
Observer	Sarah Hartung
Type of feature	Upland Log Structure
Condition of feature	Good
Recommendation	None
General Notes	Overgrown
