RINEARSON NATURAL AREA RESTORATION MONITORING REPORT **YEAR 3 (2021)**

Prepared for
Columbia Restoration Group, LLC

Submitted January 2022;
Revised September 2022

Rinearson Natural Area Restoration Monitoring – Cover Sheet

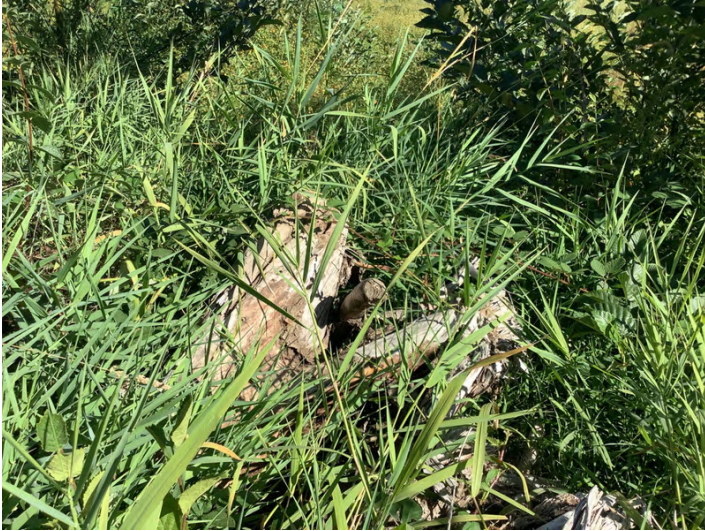
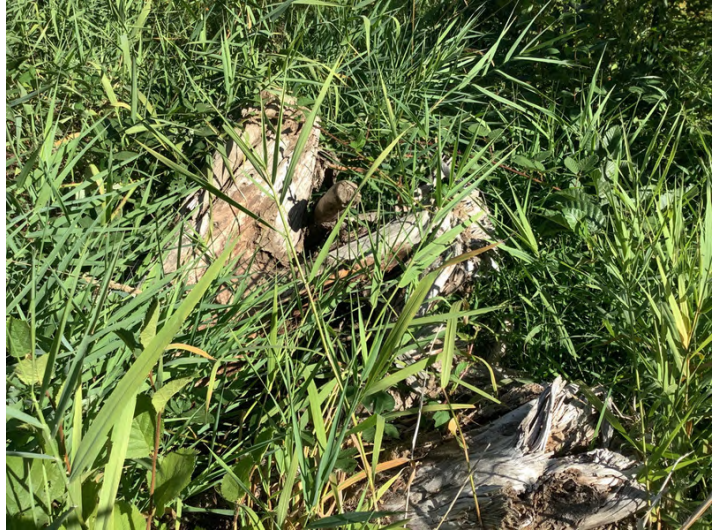
Date	August 31, 2021
Time	09:40
Feature ID	Upland log structure 30
Observer	Hannah Smiley
Type of feature	Upland Log Structure
Condition of feature	Good
Recommendation	None
General Notes	Rootwad, lots of vegetation,

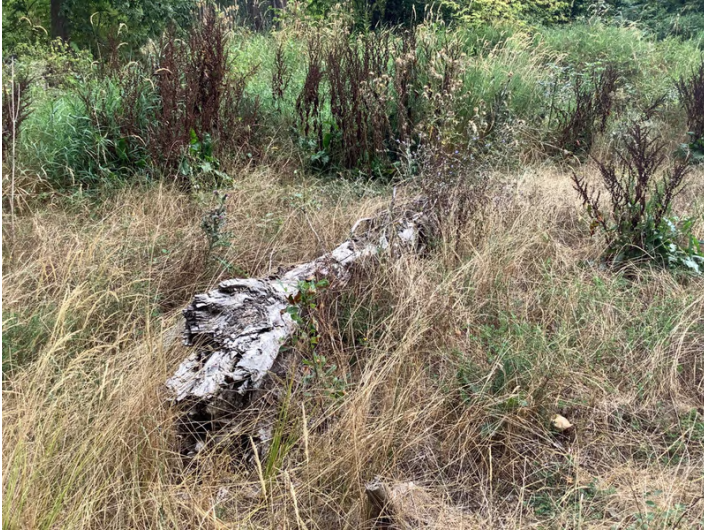
Date	August 30, 2021
Time	11:40
Feature ID	Upland log structure, 35
Observer	Sarah Hartung
Type of feature	Upland Log Structure
Condition of feature	Good
Recommendation	None
General Notes	1 large log

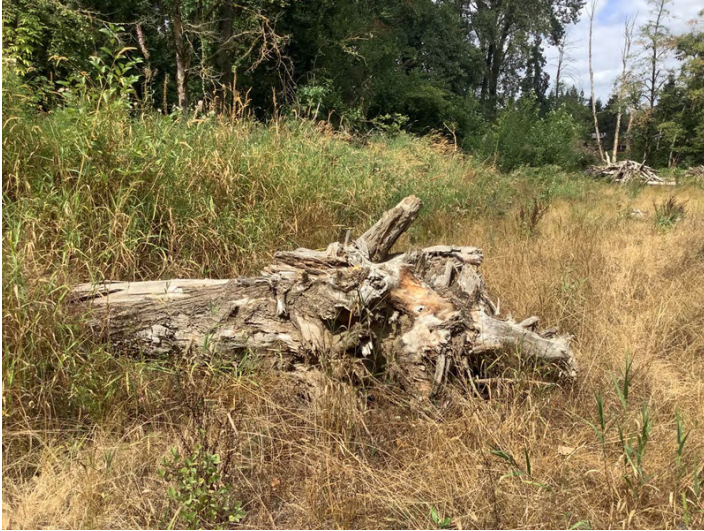
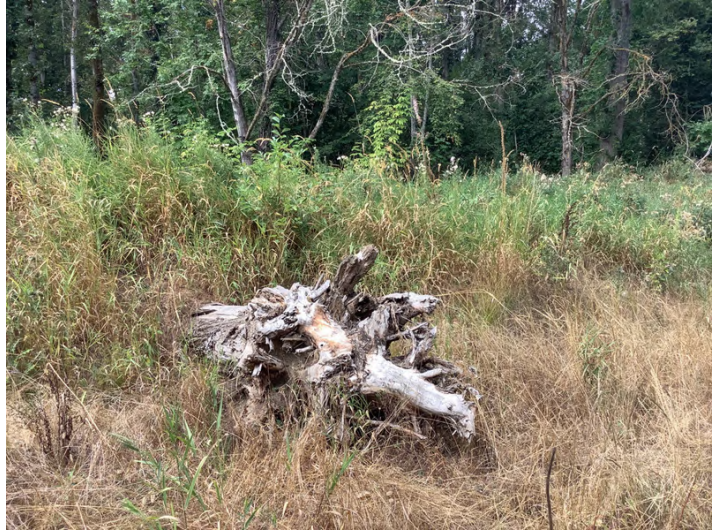
Date	August 30, 2021
Time	11:40
Feature ID	Upland log structure, 36
Observer	Sarah Hartung
Type of feature	Upland Log Structure
Condition of feature	Good
Recommendation	None
General Notes	1 root wad

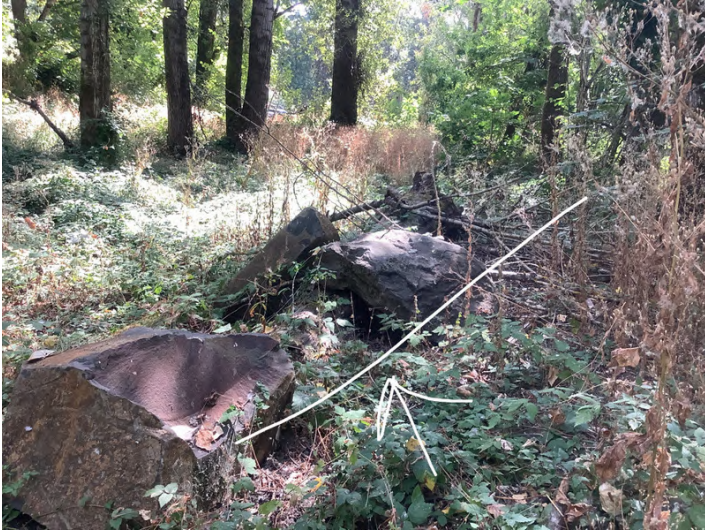
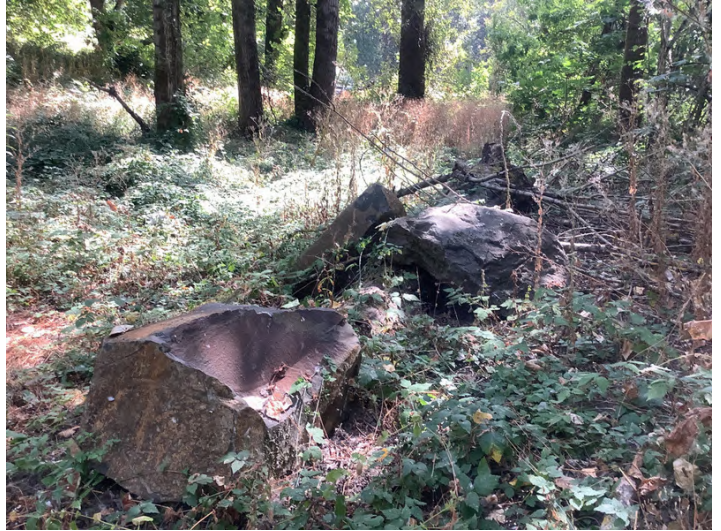
Date	August 31, 2021
Time	09:40
Feature ID	41
Observer	Hannah Smiley
Type of feature	Upland Log Structure
Condition of feature	Good
Recommendation	None
General Notes	Log and three boulders. Other woods debris in area but it looks natural

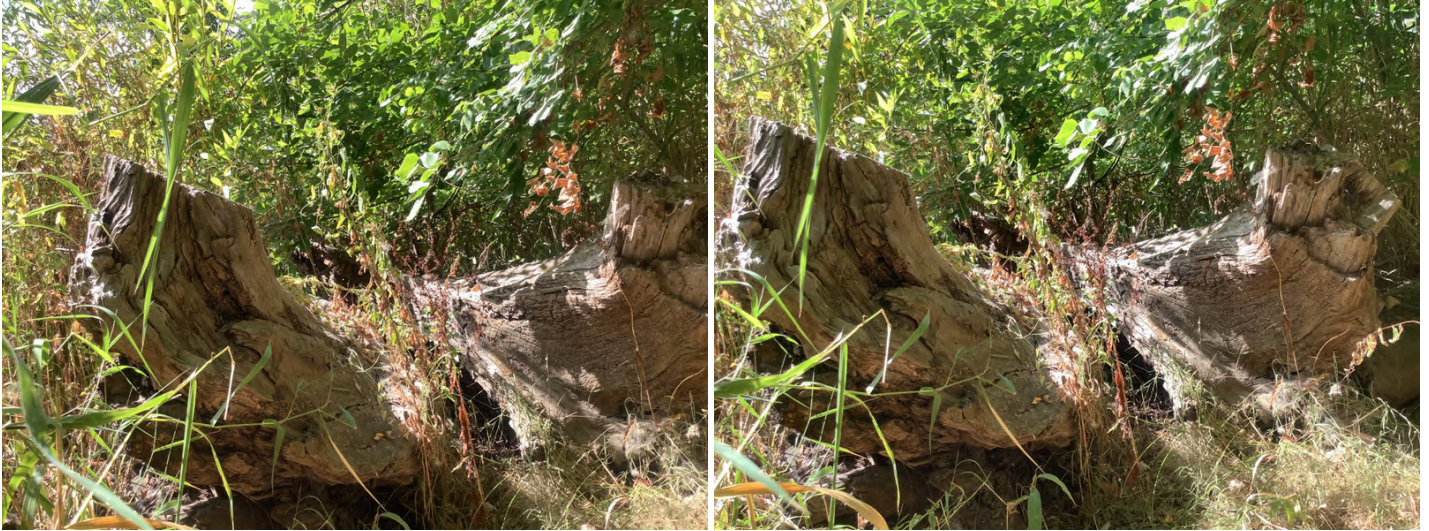
Date	August 31, 2021
Time	09:40
Feature ID	45
Observer	Hannah Smiley
Type of feature	Upland Log Structure
Condition of feature	Good
Recommendation	None
General Notes	1 large log, covered in vegetation.

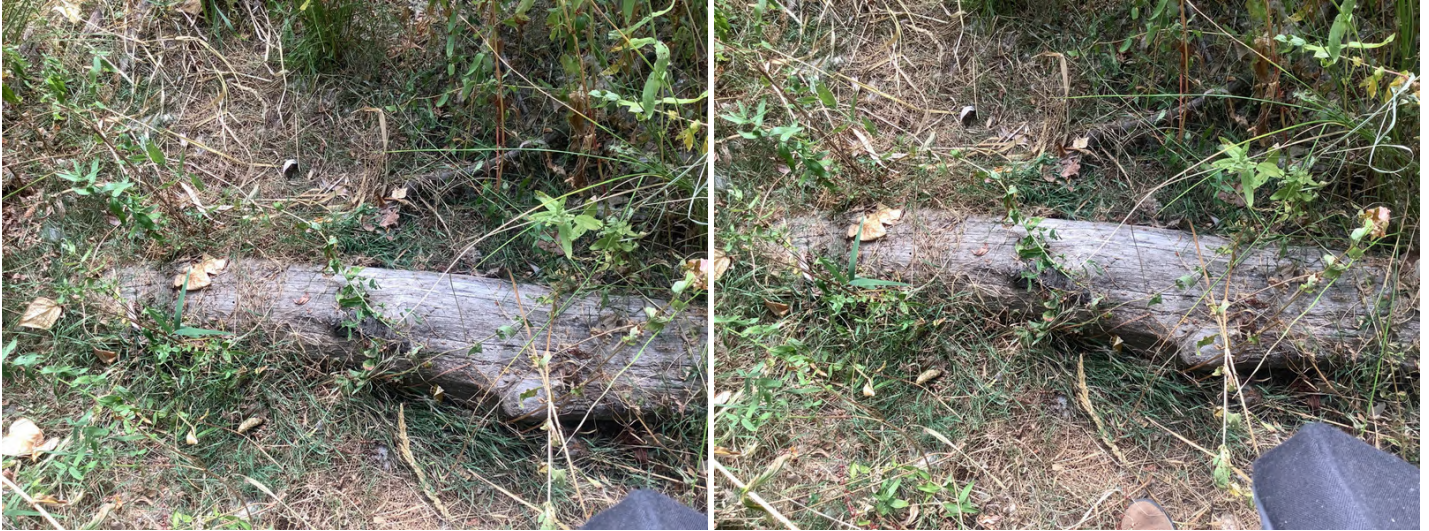
Date	August 31, 2021
Time	09:40
Feature ID	46
Observer	Hannah Smiley
Type of feature	Upland Log Structure
Condition of feature	Good
Recommendation	None
General Notes	1 large log, lots of woody debris.

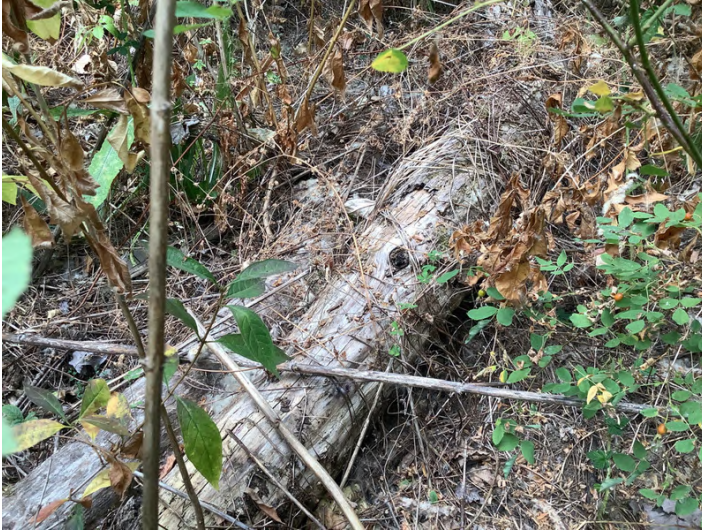
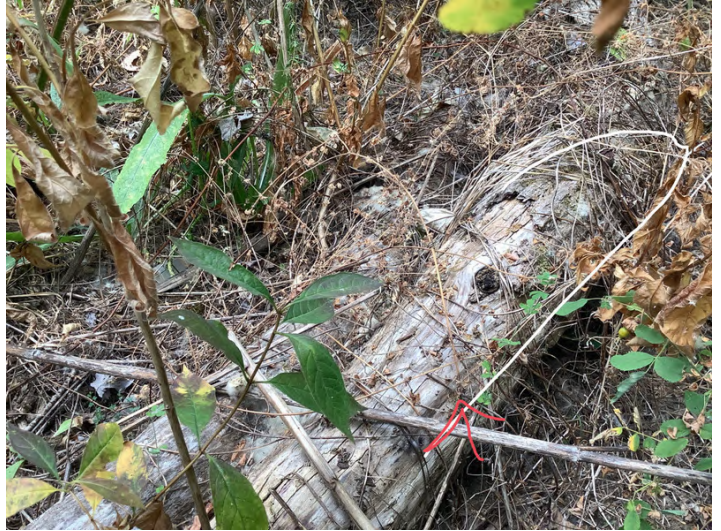
Date	August 31, 2021
Time	09:40
Feature ID	48
Observer	Sarah Hartung
Type of feature	Upland Log Structure
Condition of feature	Good
Recommendation	None
General Notes	2 pieces, lots of dense blackberry, needs machete, lots of woody debris

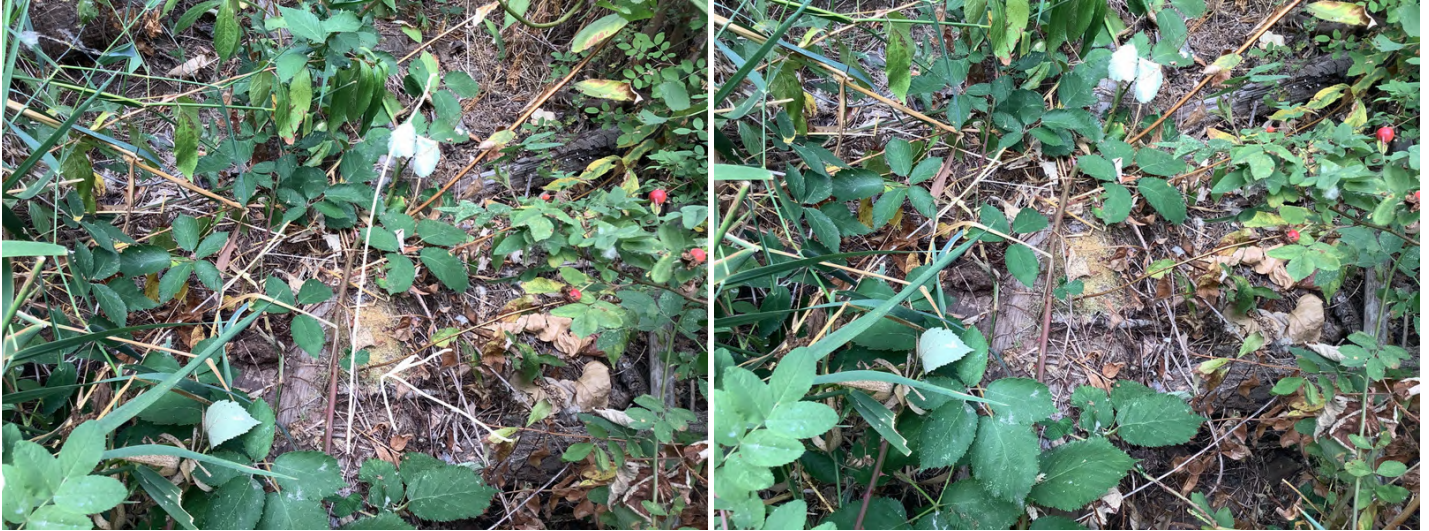
Date	August 31, 2021
Time	09:40
Feature ID	49
Observer	Hannah Smiley
Type of feature	Upland Log Structure
Condition of feature	Marginal
Recommendation	None
General Notes	2pieces, stood a big pile of blackberry, maybe a log structure was under it veg, needs machette

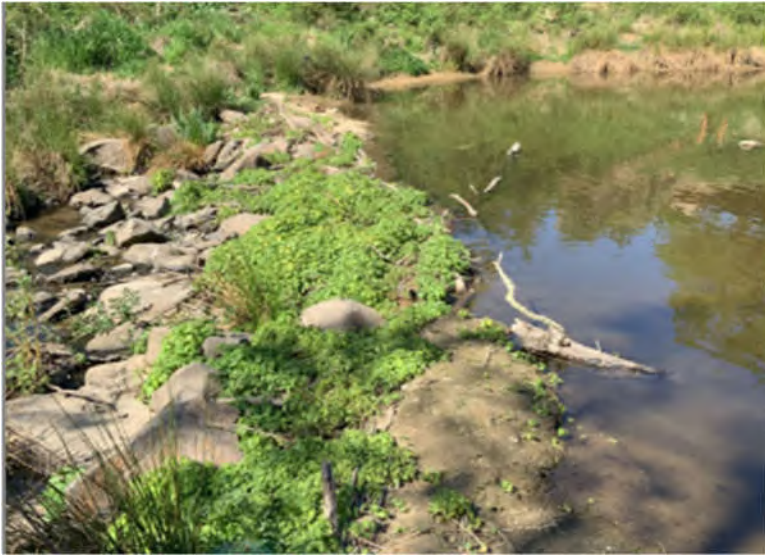
Figure D-1: Conditions at the pond outlet, April.

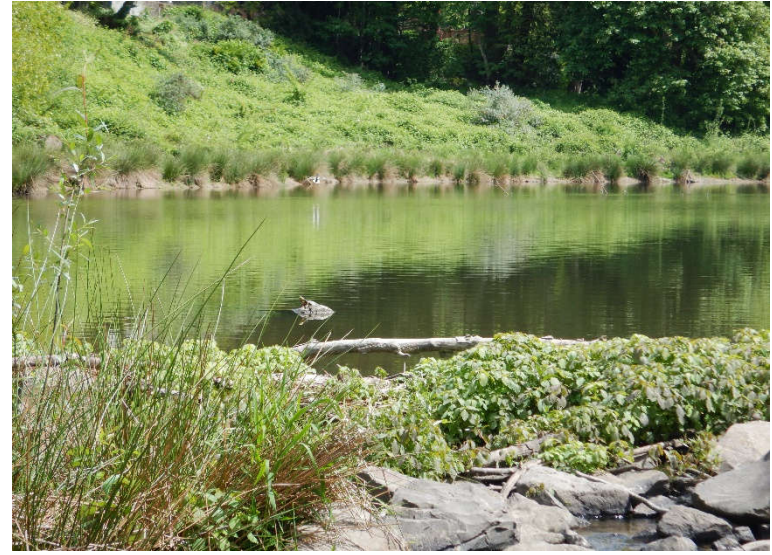
Figure D-2: Conditions at the pond outlet looking upstream from the roughened channel, April. Note the turtle on the short log behind the outlet.

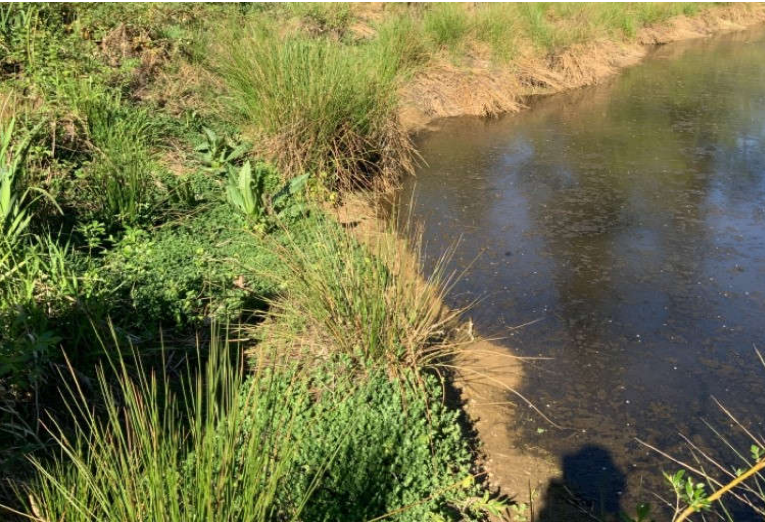
Figure D-3: Conditions at the pond outlet, May.

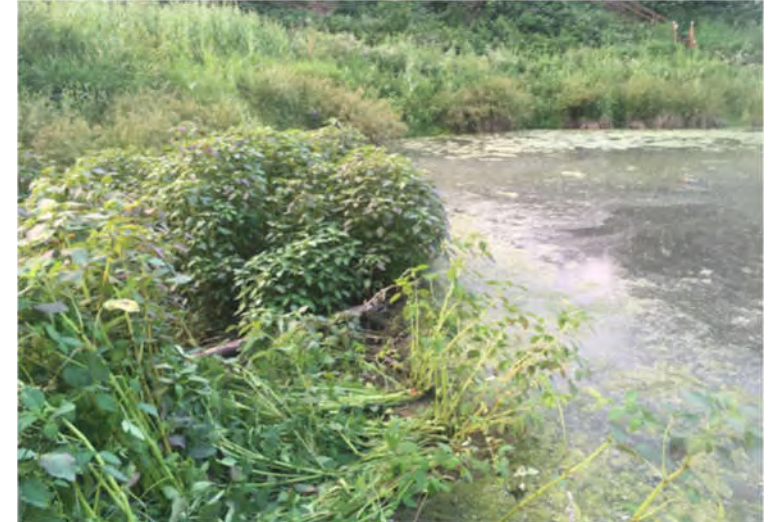
Figure D-4: Conditions at the pond outlet, June.

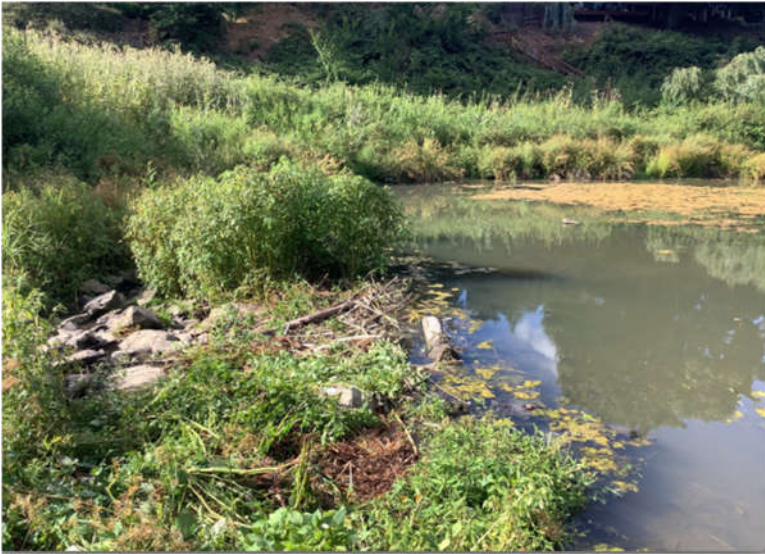
Figure D-5: Conditions at the pond outlet, July.

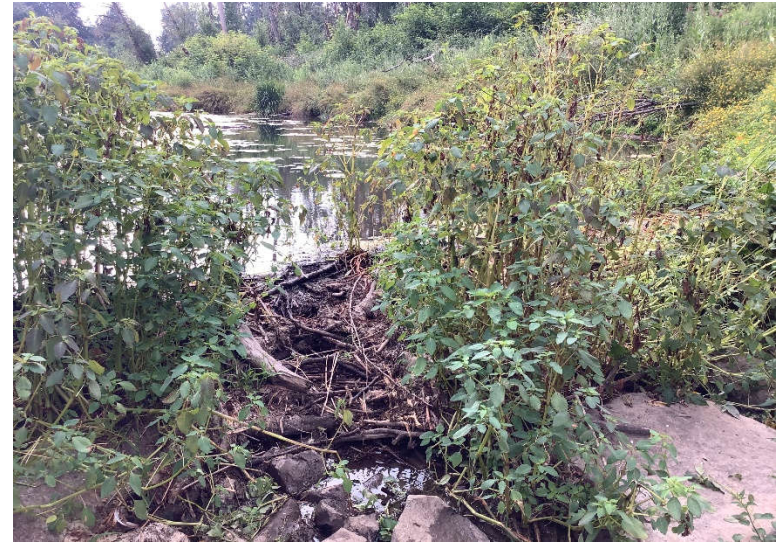
Figure D-6: Conditions at the pond outlet looking upstream, July.

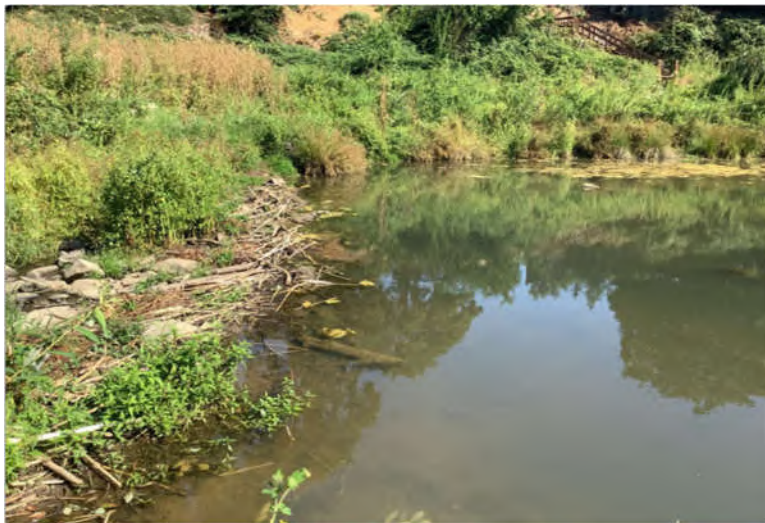
Figure D-7: Conditions at the pond outlet, August.

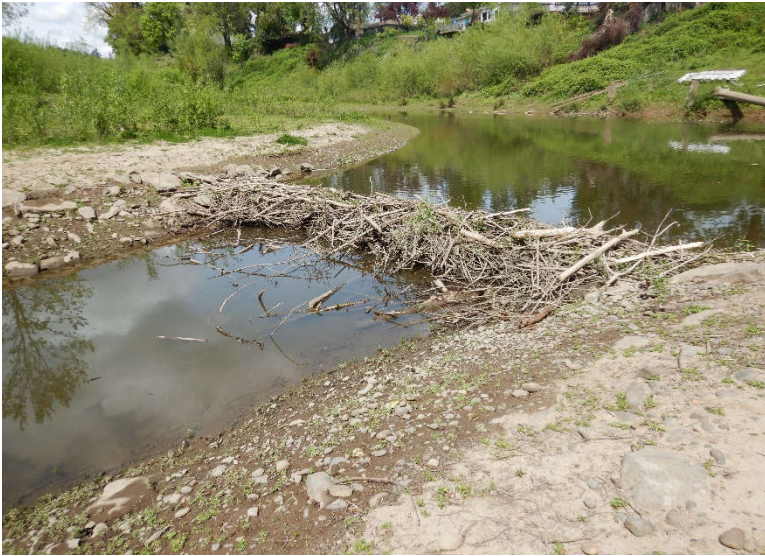
Figure D-9: Looking upstream at the lower beaver dam, April.

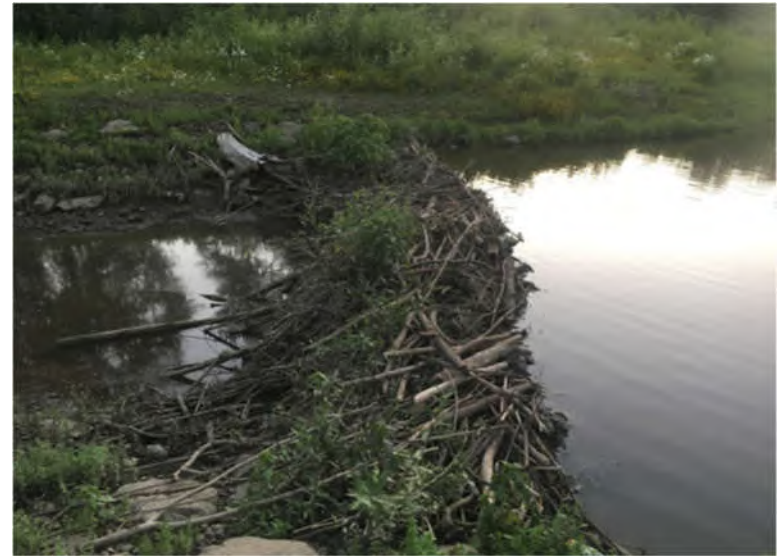
Figure D-10: Lower beaver dam, June. Note willow growth on top of the dam.
