**i. Mitigation Monitoring Report Cover Sheet  
Corps of Engineers**

## 1: Waln Creek/ Battle Creek Riparian Enhancement Project--- Identifiers:

<b>DSL Permit #</b>	47781-RF	<b>COE Permit #</b>	2011-100	<b>Permittee</b>	City of Salem
<b>County</b>	Marion	<b>Report Date:</b>	December 15, 2014	<b>Monitoring Year</b>	2
<b>Date Removal-Fill Activity Completed:</b>		Summer 2012			
<b>Date mitigation was completed:</b>		<b>Grading</b>	Summer 2012	<b>Planting</b>	Fall-Winter 2012-13
<b>Report submitted by:</b>		Pacific Habitat Services, Inc.

## 2. WALN CREEK/BATTLE CREEK MITIGATION PLAN PURPOSE AND OVERVIEW

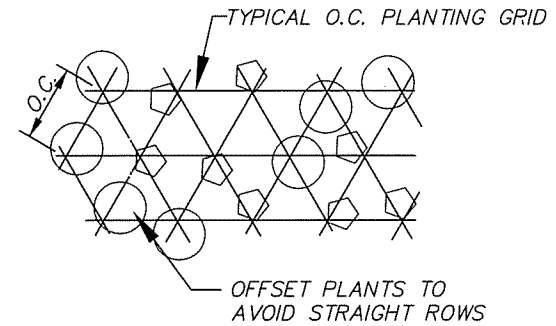
FIGURE  
3

Plant list and planting grid at the Waln Creek and Battle Creek enhancement project in Salem, Oregon. Provided by OTAK, Inc., 2011.

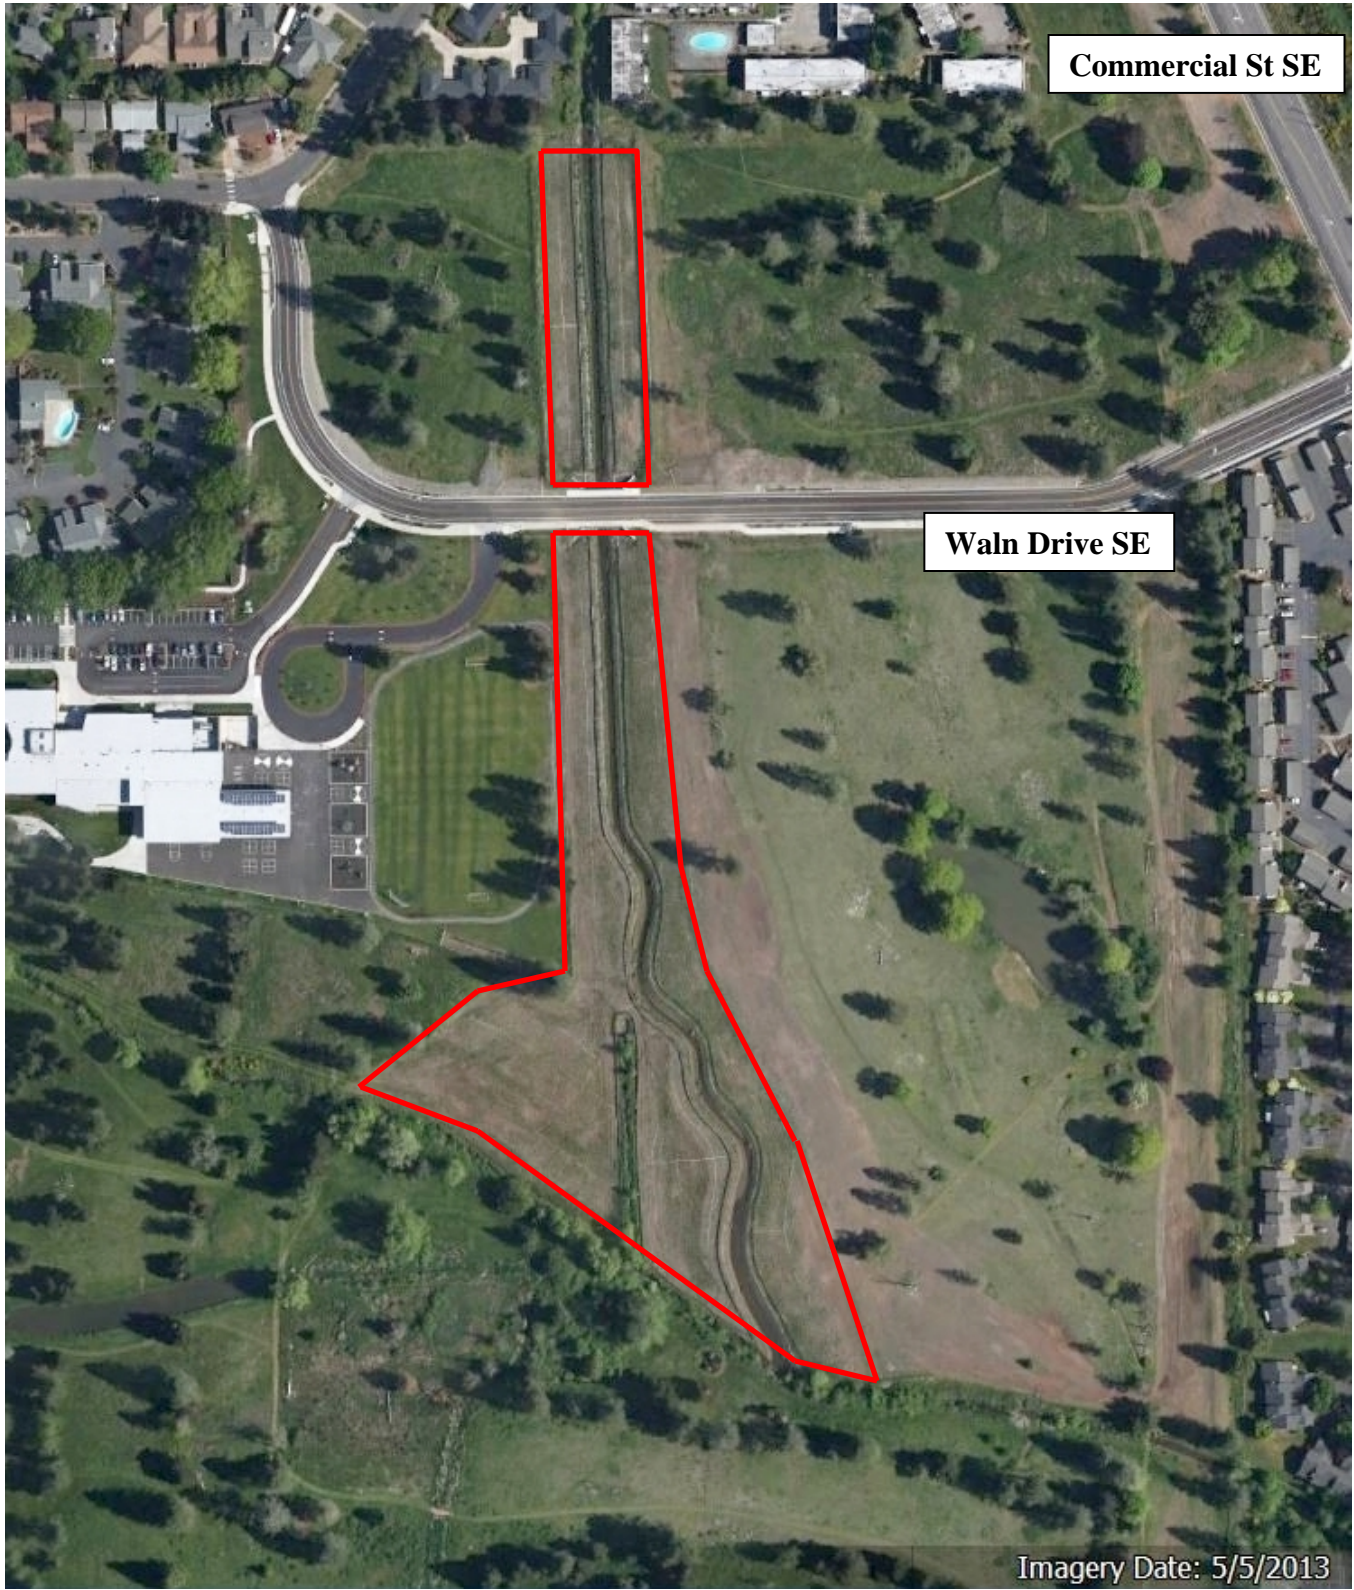
FIGURE  
4

2013 aerial photograph of the Wain Creek-Battle Creek riparian enhancement project area in Salem, Oregon. The riparian buffer planting area is outlined in red (Photo source: GoogleEarth).

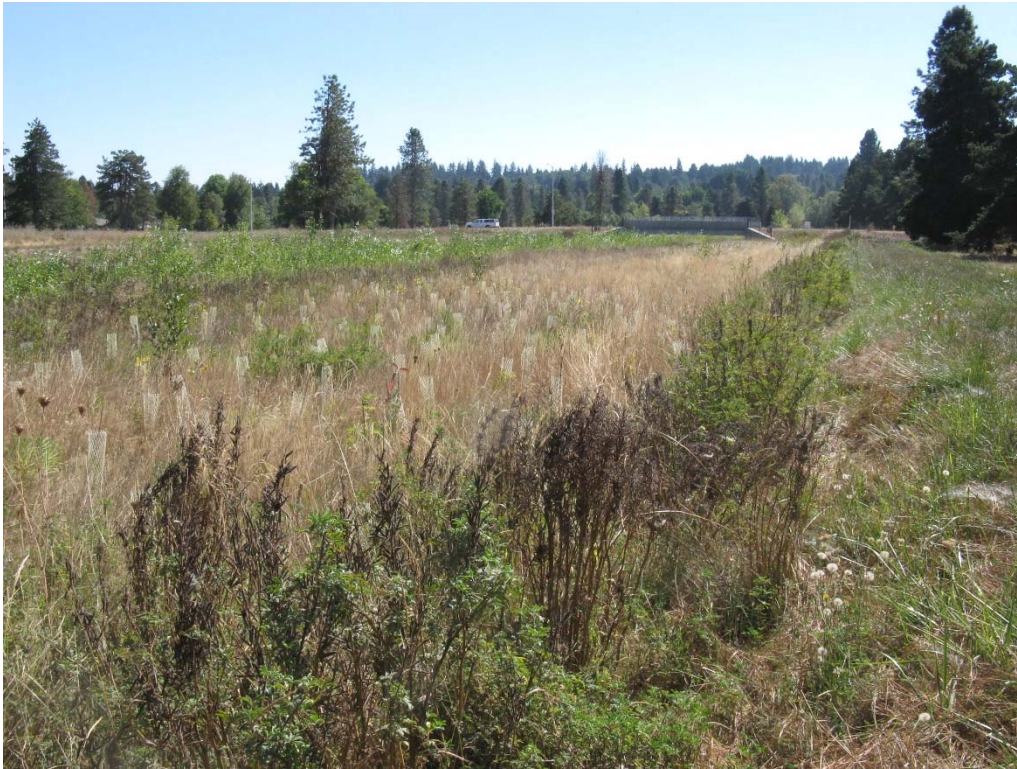
FIGURE  
5

**Photo A:**  
Looks south from northern boundary of mitigation area

Photodocumentation  
Wain Creek/Battle Creek riparian mitigation area in Salem, Oregon.  
Both photos were taken on August 28, 2014.

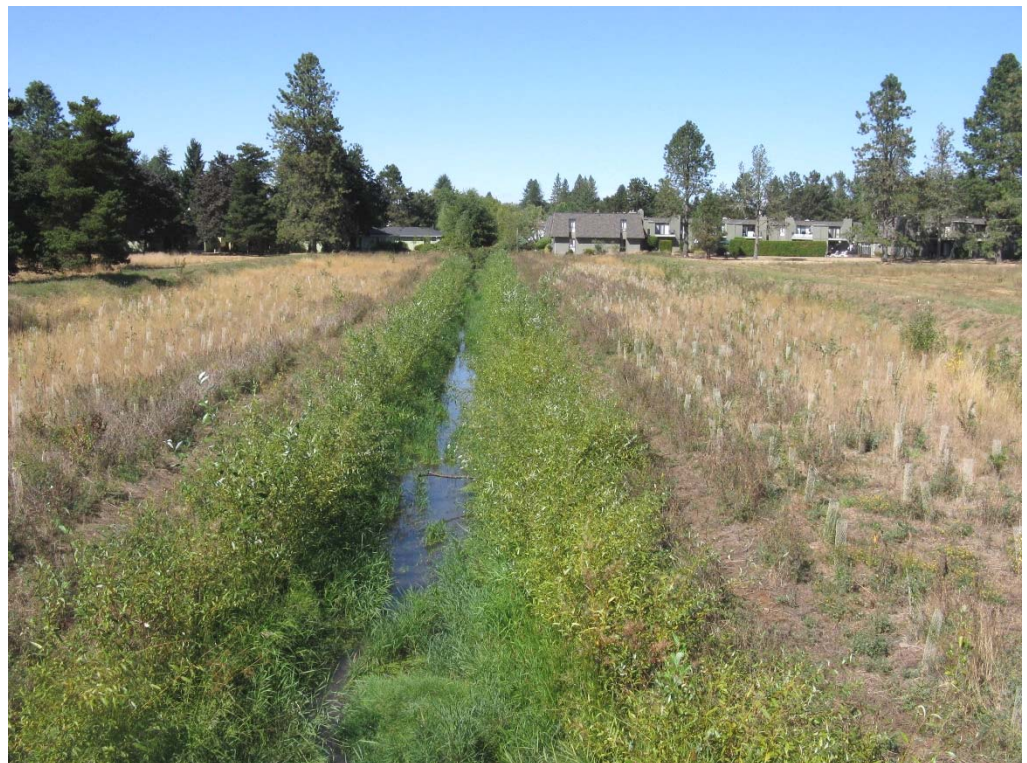
**Photo B:**  
Looks north from Wain Drive SE

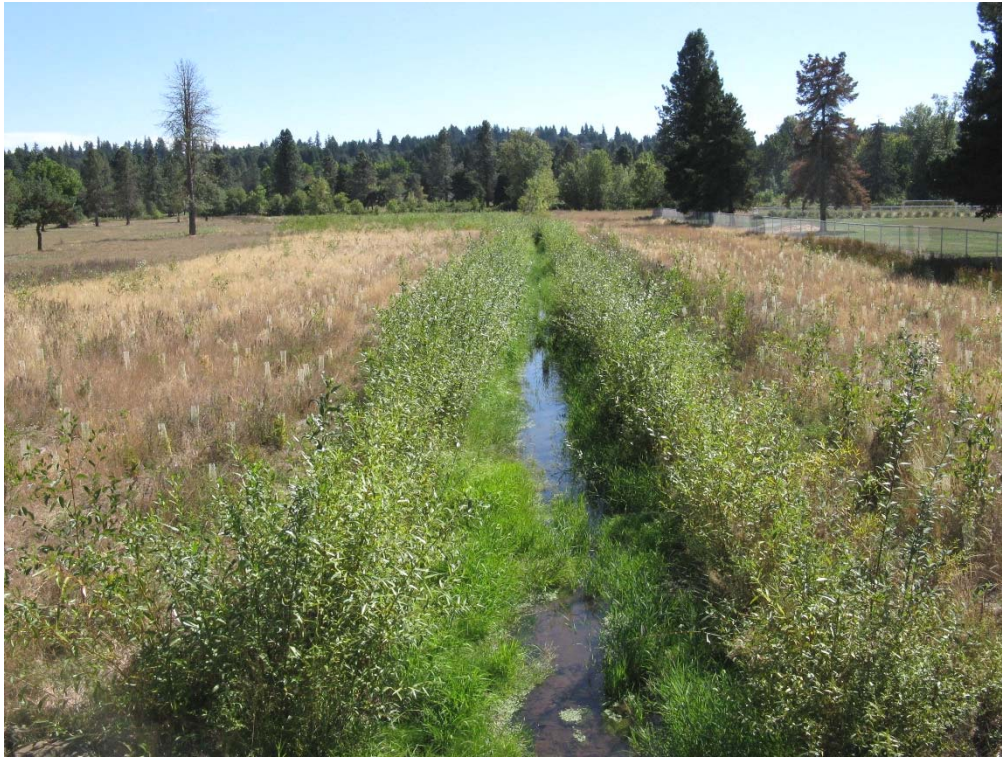
FIGURE  
6

**Photo C:**  
Looks south from Wain Drive SE

Photodocumentation  
Wain Creek/Battle Creek riparian mitigation area in Salem, Oregon.  
Both photos were taken on August 28, 2014.

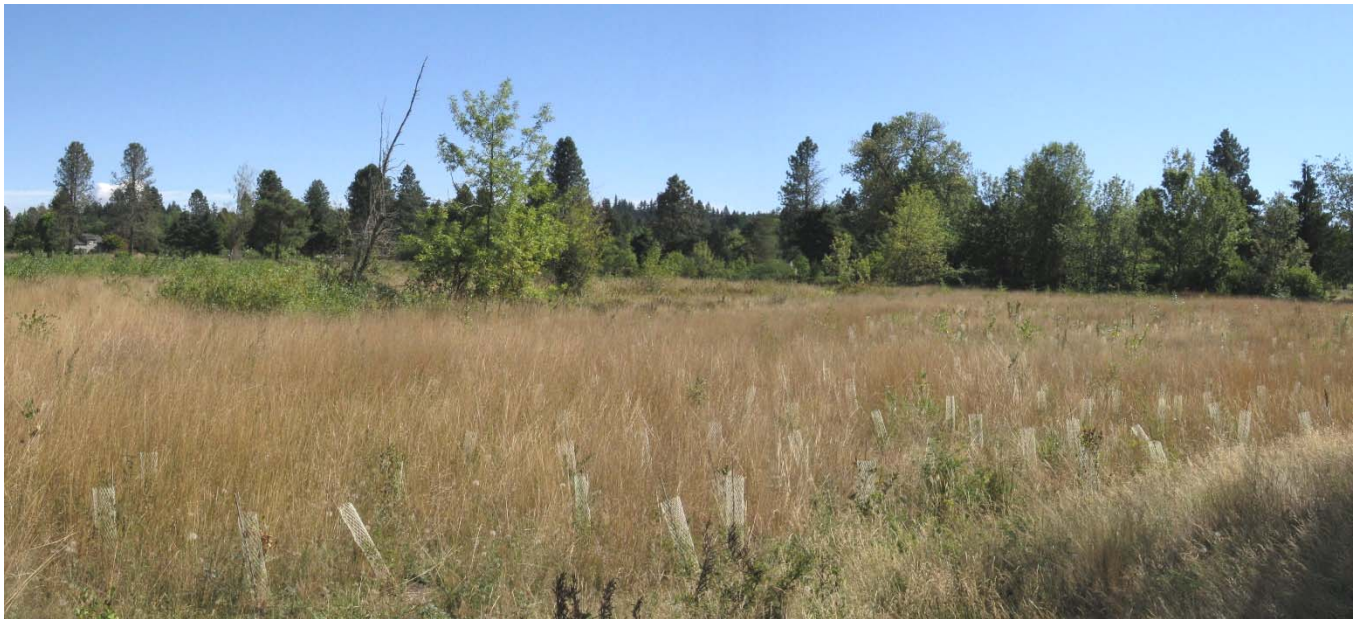
**Photo D (below):**

Looks south from west side of mitigation area.

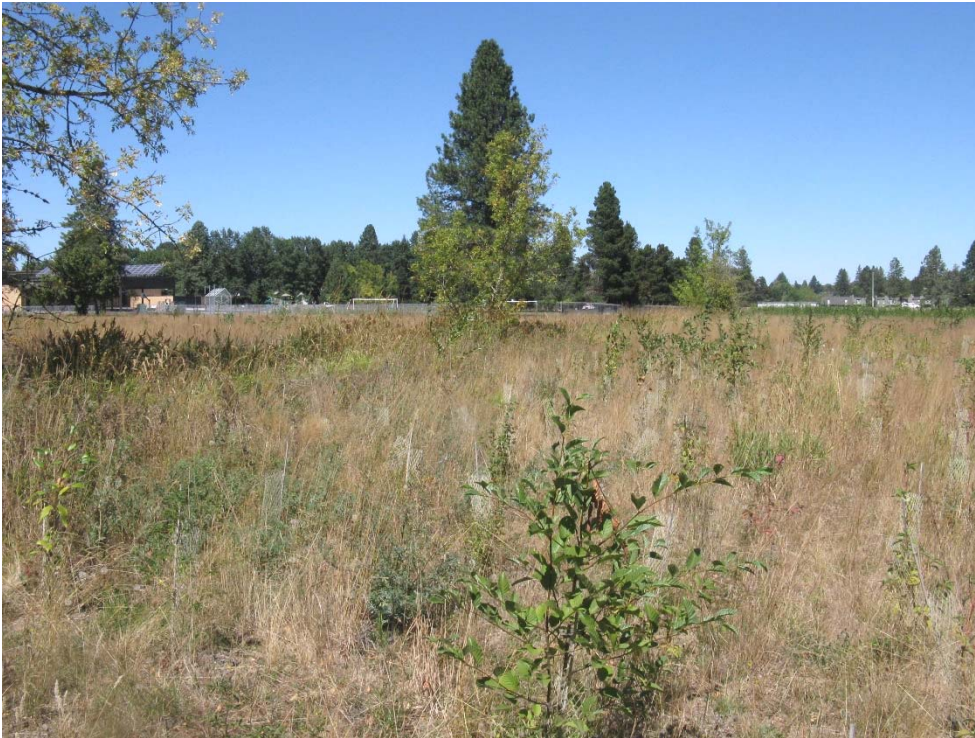
**Photo E:**

Looks northwest from southern portion of mitigation area

Photodocumentation  
Waln Creek/Battle Creek riparian mitigation area in Salem, Oregon.  
Both photos were taken on August 28, 2014.

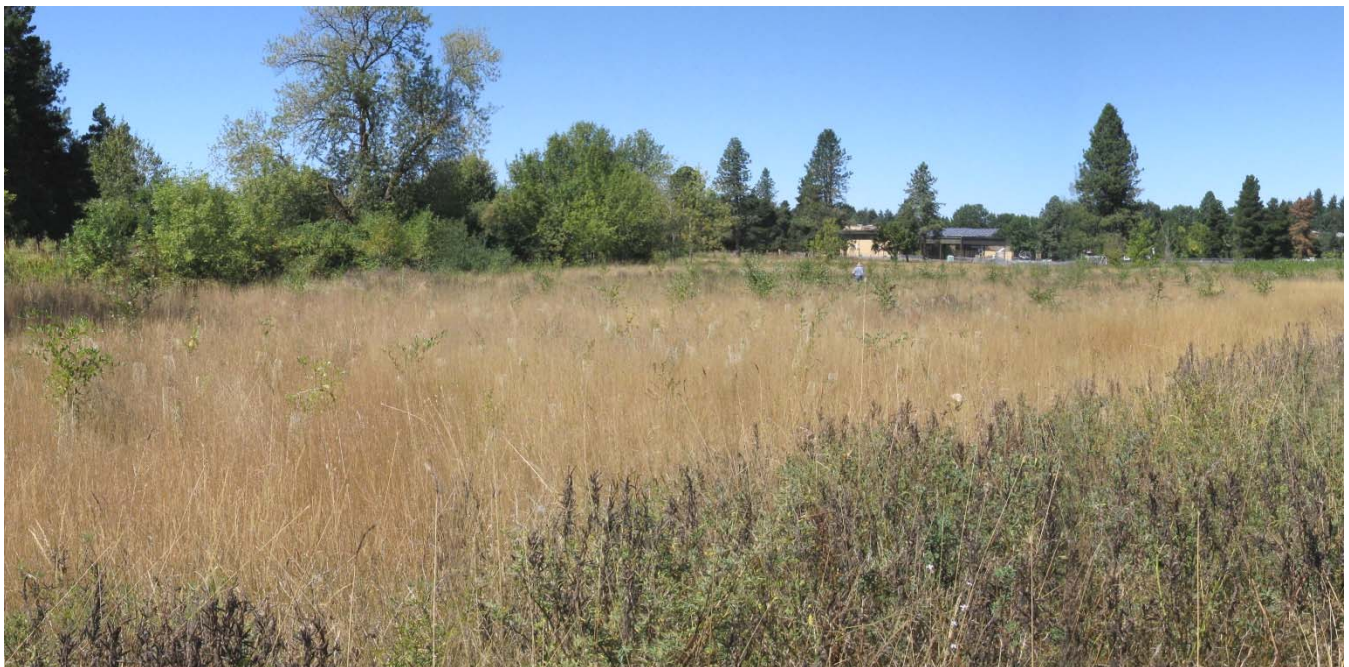
**Photo F (below):**

Looks northwest from southeast edge of mitigation area
