RE: Monitoring Report for Review

PHS Project No.: 5187 – Waln Creek/Battle Creek Riparian Enhancement Project

Mitigation Monitoring Report Cover Sheet Corps of Engineers

Corps Permit Number: 2011-100

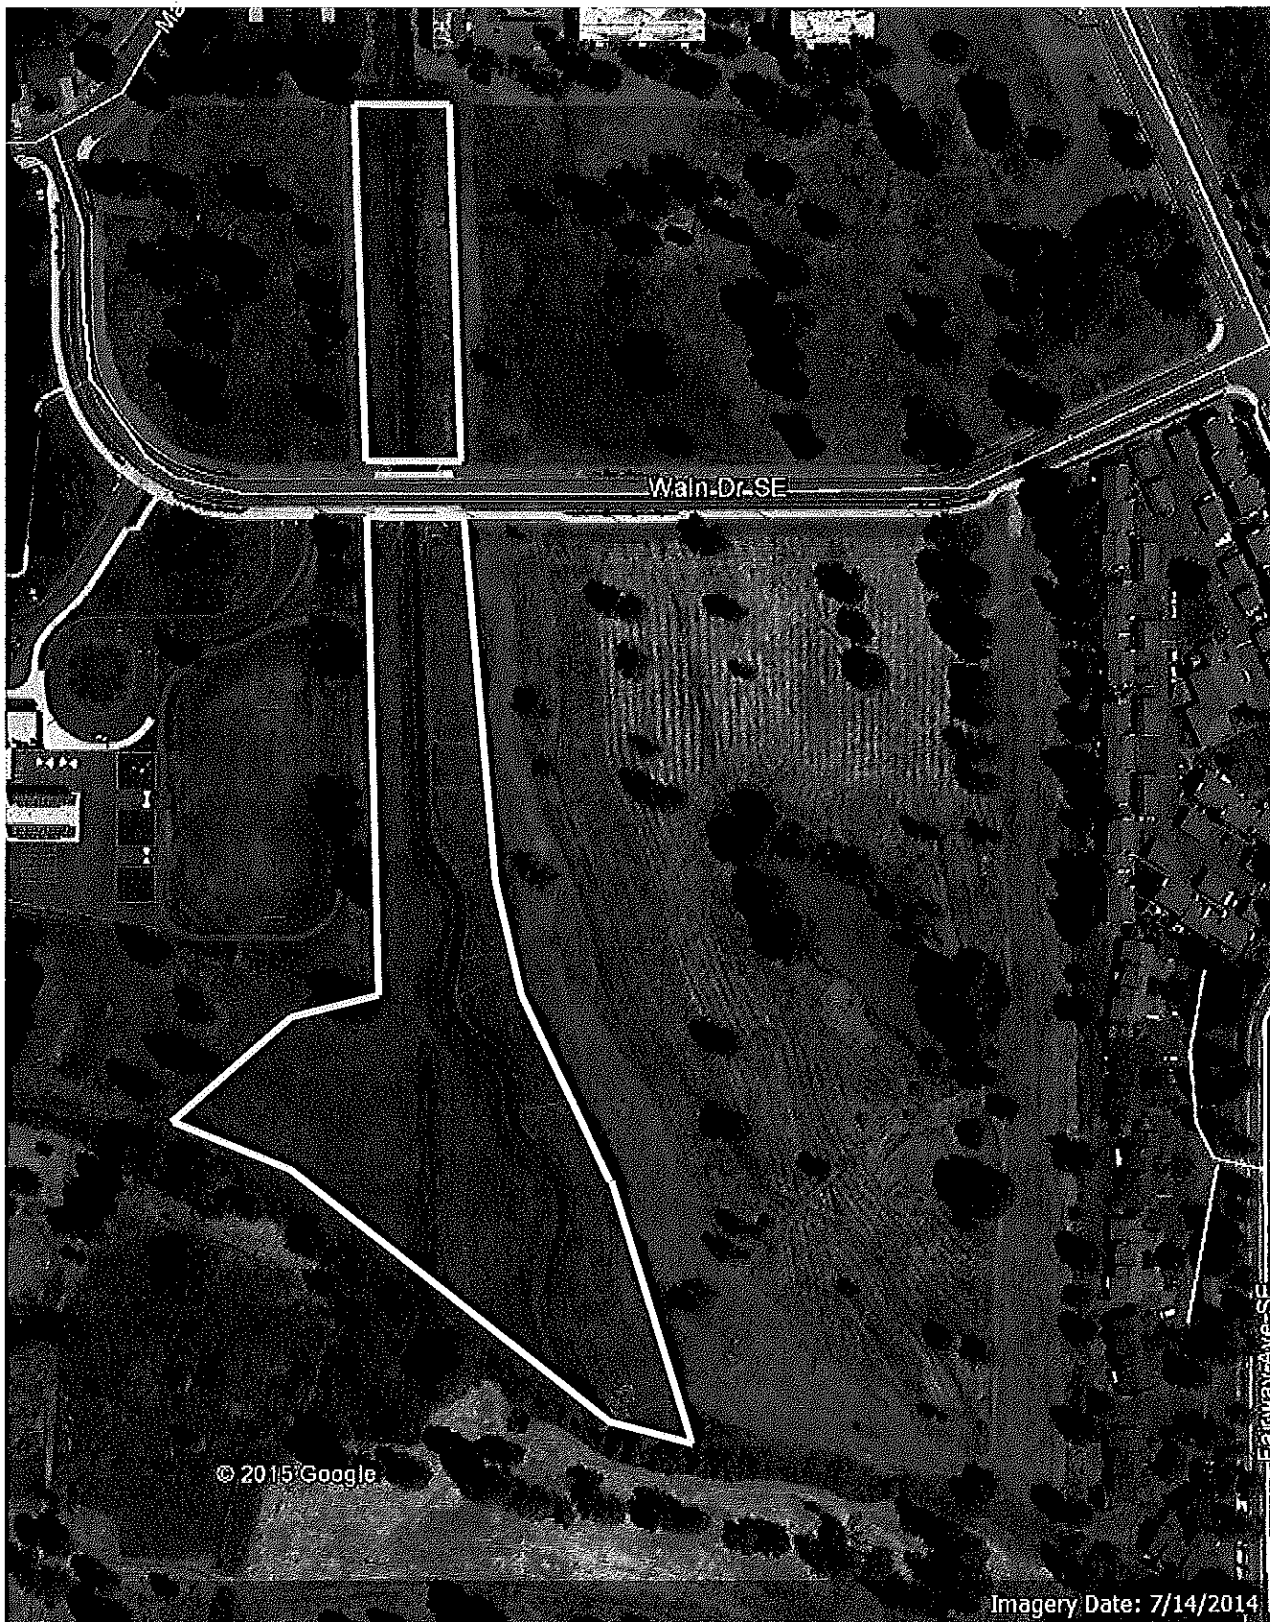
4

Aerial photograph (2014)
Wain Creek-Battle Creek riparian enhancement project area in Salem,
Oregon. The riparian buffer planting area is outlined in yellow.
(Photo source: GoogleEarth)

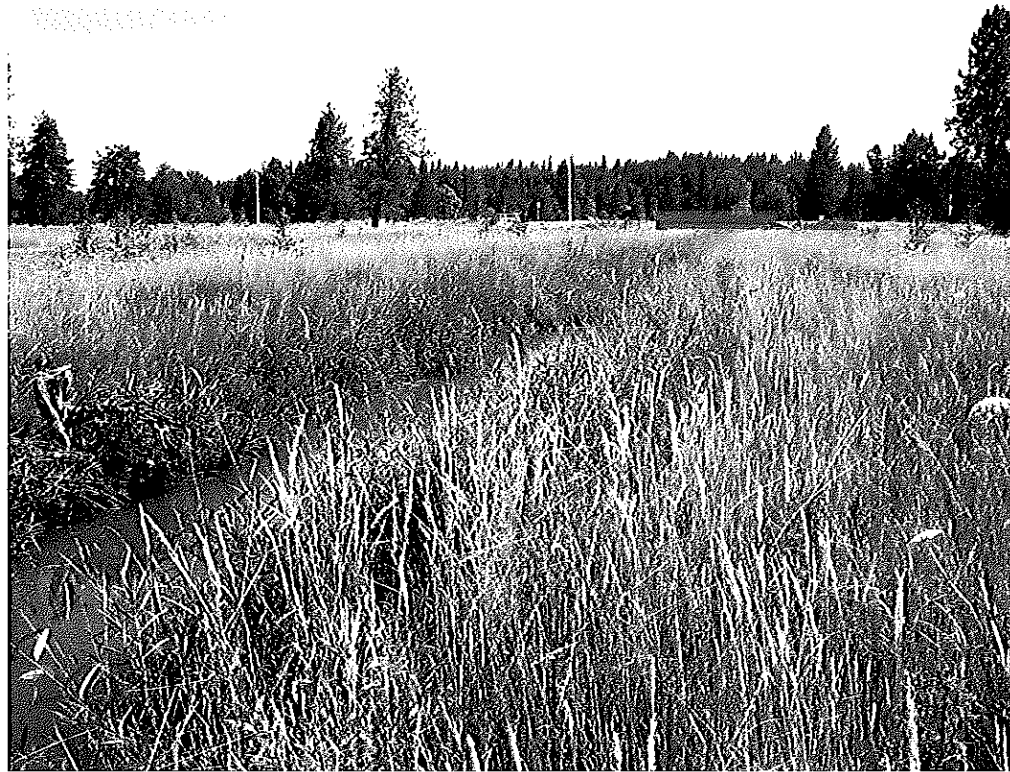
Photo A:
Looks south from northern
boundary of mitigation area

Wain Creek/Battle Creek riparian mitigation area in Salem, Oregon.
Photo A was taken on 7/16/2015; photo B on 7/8/2015.

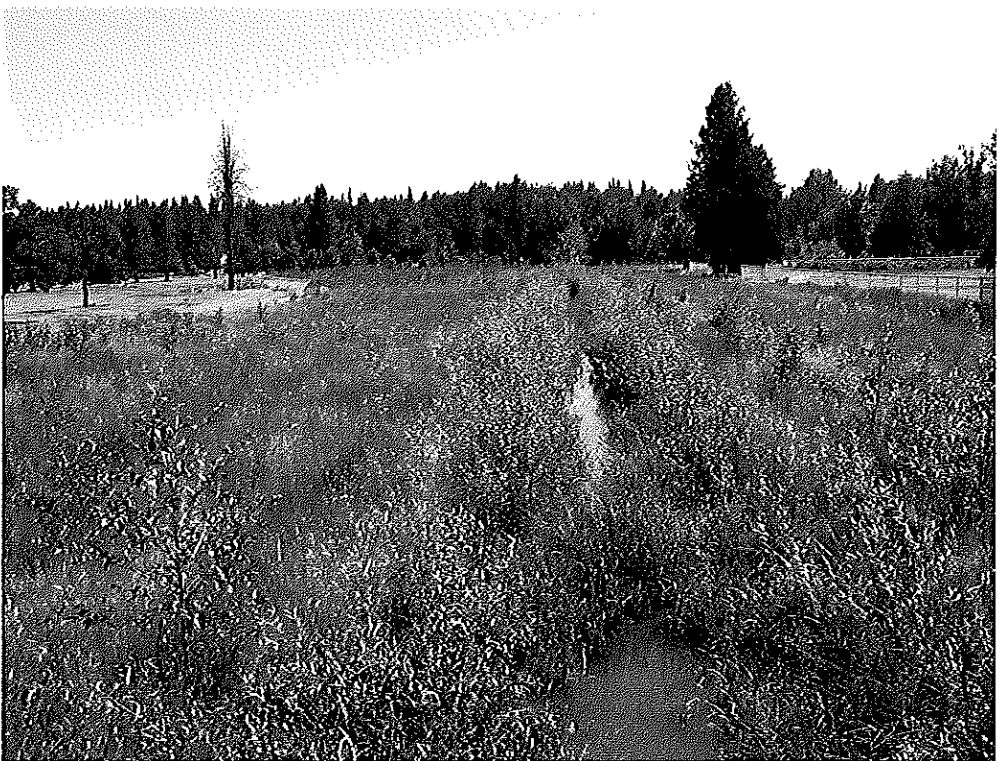
Photo C:
Looks south from Waln
Drive SE

Photodocumentation
Waln Creek/Battle Creek riparian mitigation area in Salem, Oregon.
Photo C was taken on 7/8/2015; photo D on 7/10/2015.

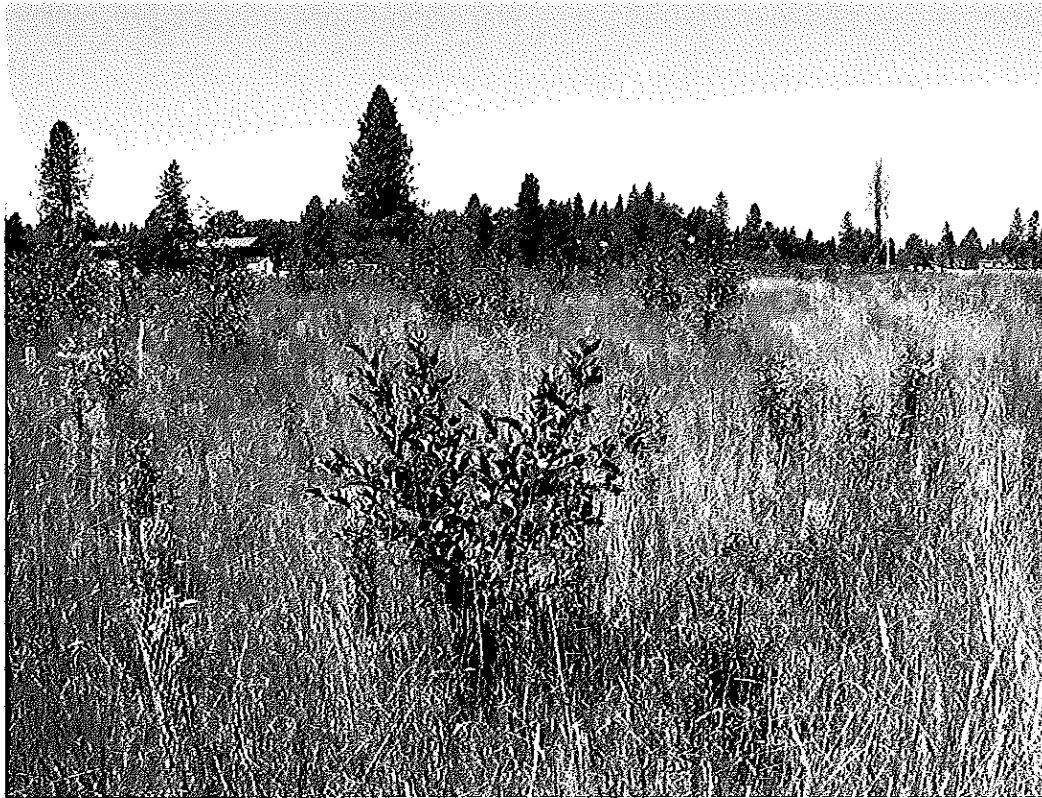
Photo E:

Looks northwest from southern portion of mitigation area

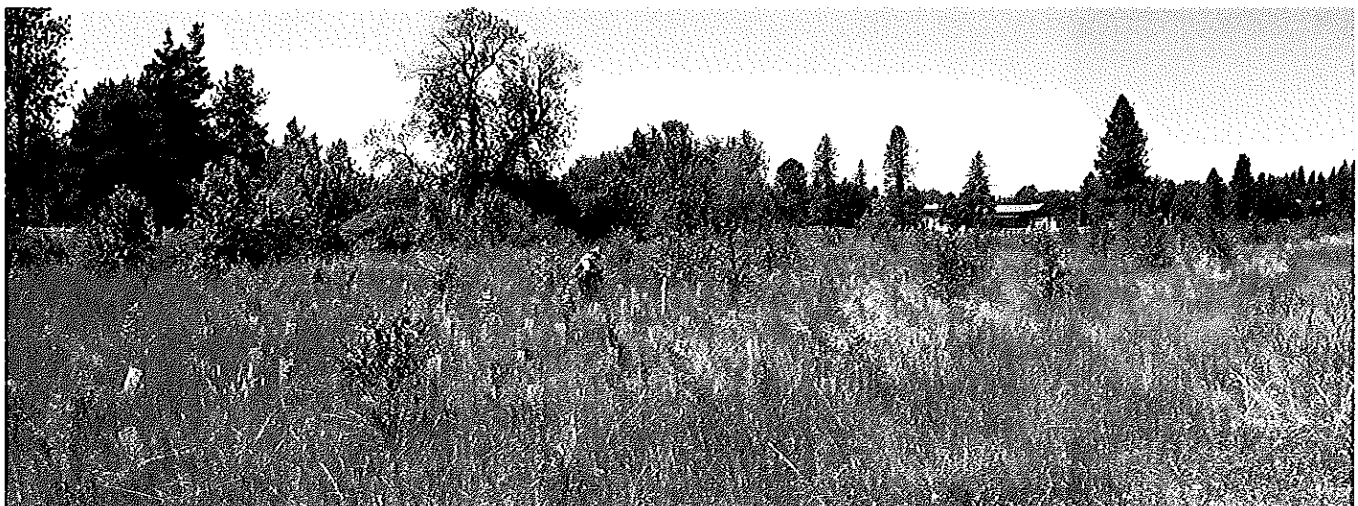
Photo F (below):

Looks northwest from southeast edge of mitigation area
