Mitigation Monitoring Report Cover Sheet
Oregon Department of State Lands

DSL Permit Number: 36703 COE Permit Number: *Nationwide Permit 27 -#200500701*
 Permittee: *Gilmour*
 County: *Benton* Report Date: July 15, 2009 Monitoring Year 3
 Date Removal-Fill Activity Completed:
 Date mitigation was completed Grading: *10/06* Planting: *5/07, 10/07*
 Report submitted by: Oregon Wetlands LLC

The purpose of this report is to summarize the progress of the Evergreen Creek Wetland Mitigation Bank (Bank). The Bank is located on the west side of Bellfountain Road, at the intersection of Bellfountain and 53rd Street in T12S, R5W, Sec. 19, Tax Lot 700. The letter of approval for the Bank was signed on February 27, 2007 and is permitted as ACOE permit #200500701.

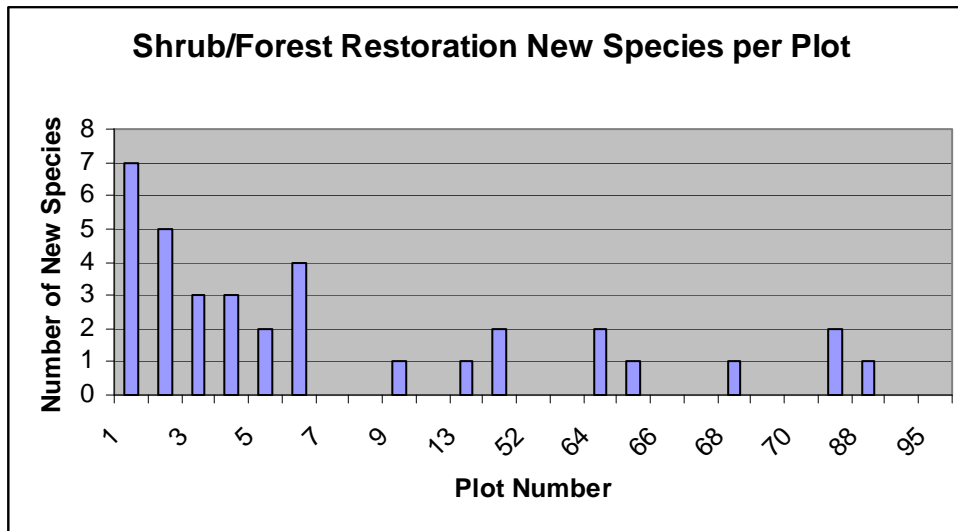
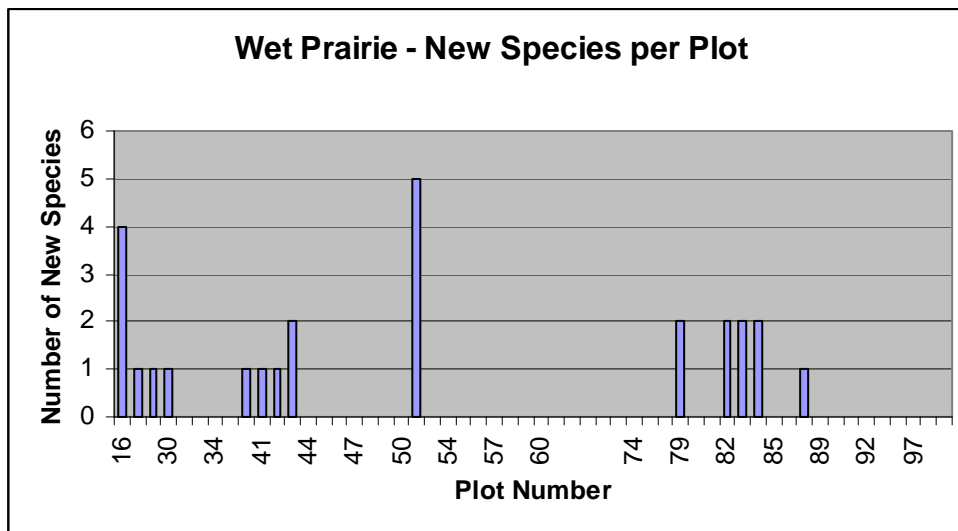
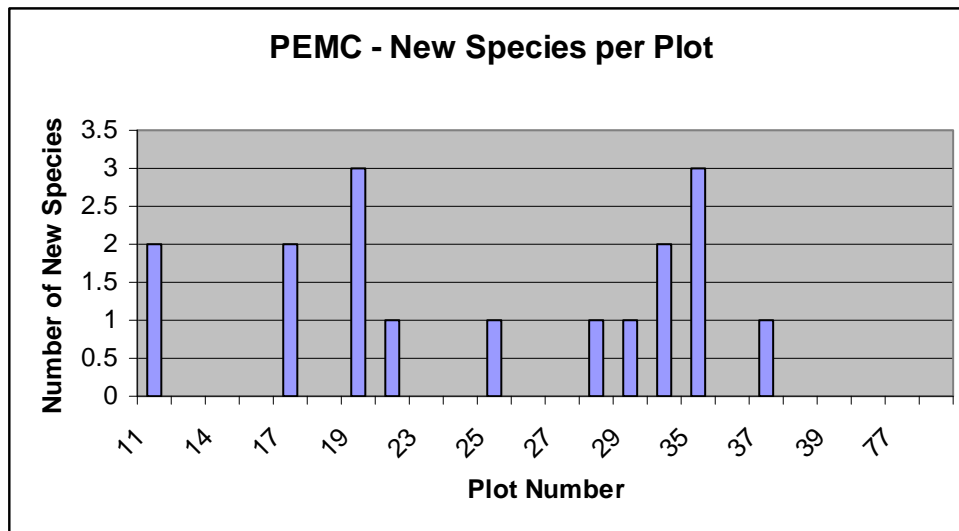
The species area curves for each of the major wetland types are included. It was the original plan to develop the species area curve for each of the habitat types and then analyze the data. The evaluating criteria was that after the curve flattens out it would be deemed a sufficient number of plots when there are three plots in a row, with one or fewer new species. A minimum of 50 plots were established.

The data on the 103 monitoring plots indicates that there is extensive plant diversity on the site. The curves for all habitat types is flattening out towards the end, which means there is a sufficient number of plots.

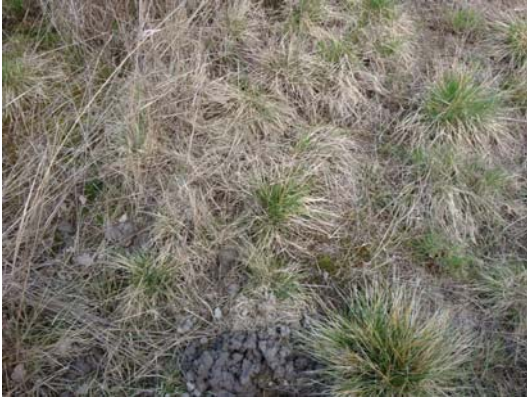
Pit # 1

Pit #	Free Water (in)*	Depth of Saturation (in.)
1	[-7"]	[-4"]
2	[-8"]	[-5"]
3	[-6"]	[-3.5"]
4	[-5.5"]	[-3"]
5	[-10"]	[-7"]
6	[-2"]	Surface
7	[-7.5"]	[-5"]
8	[-11"]	[-8"]
9	[-7"]	[-4"]
10	[-7"]	[-4"]
11	[-11"]	[-8"]
12	[-6"]	[-3"]
13	[-4"]	[-1"]
14	[-2"]	Surface

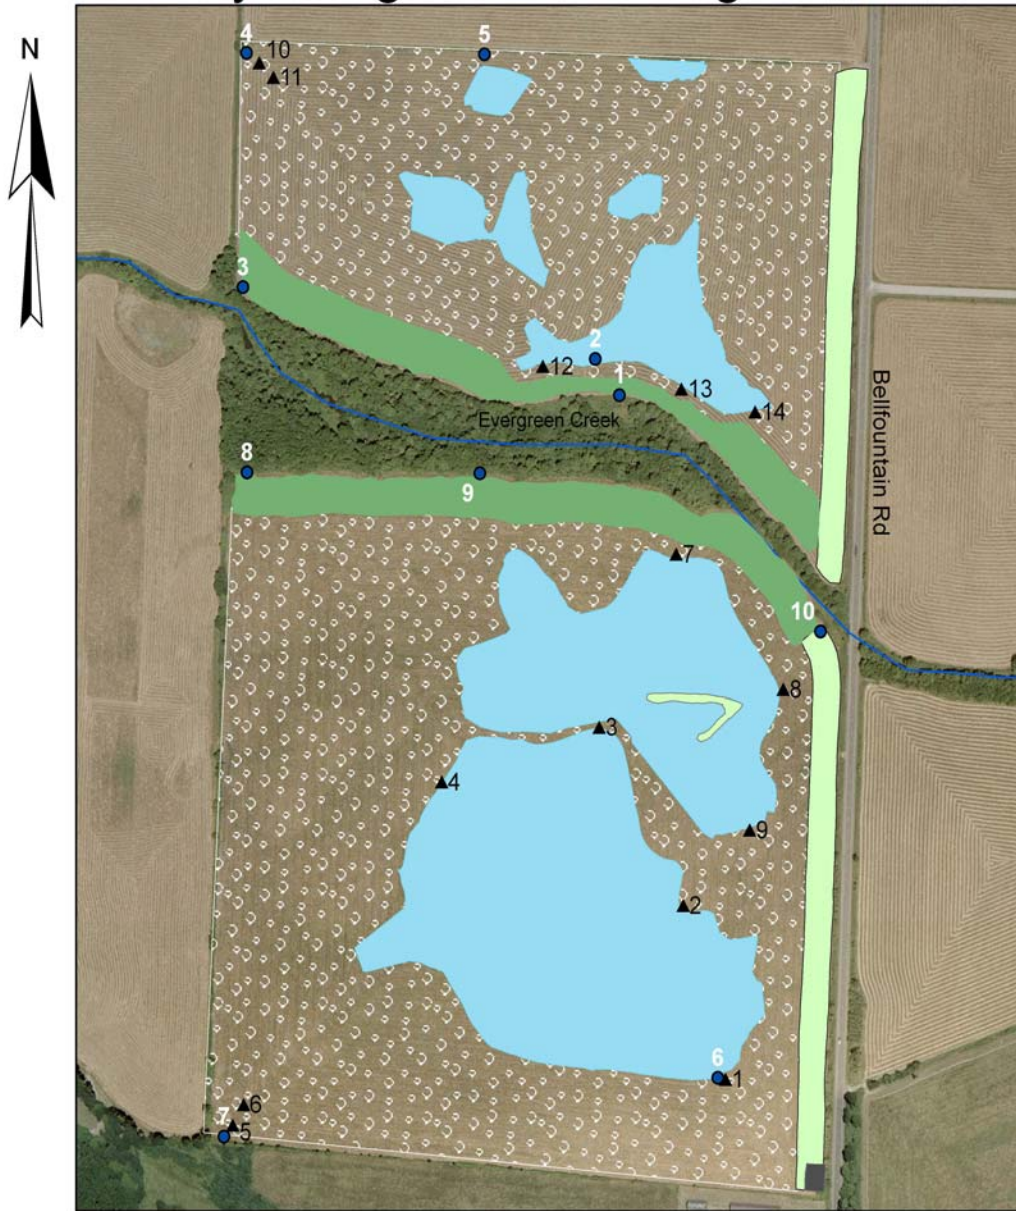
Evergreen Mitigation Bank Hydrological Monitoring Points

Water Monitoring Tubes: Ten monitoring tubes were installed and monitored in March, April and May 2009. The results (table 2) of the monitoring indicate that 100% of the planned Bank area is meeting wetland hydrology criteria with the entire Bank area having saturated soils. Saturation levels were determined by digging 18” pits adjacent to each monitoring tube. Each pit was then evaluated for depth to free water and saturation level in it.

Well #	3/16/2009		4/13/2009		5/8/2009	
	Depth to Free Water*	Depth to Saturation	Depth to Free Water*	Depth to Saturation	Depth to Free Water*	Depth to Saturation
1	Surface	Surface	Surface	Surface	Surface	Surface
2	[+16"]	Inundated	[+16"]	Inundated	[+16"]	Inundated
3	[+1.5"]	Inundated	[-3"]	Surface	Surface	Surface
4	[-3"]	Surface	[-10"]	[-7"]	[-13"]	[-10"]
5	[-1"]	Surface	[-2"]	Surface	[-2"]	Surface
6	[+6"]	Inundated	[+6"]	Inundated	[+6"]	Inundated
7	[-3"]	Surface	[-4"]	[-1.5"]	[-4"]	[-2"]
8	[-2"]	Surface	[-2.5"]	Surface	[-2"]	Surface
9	Surface	Surface	Surface	Surface	Surface	Surface
10	[-2"]	Surface	[-1"]	Surface	[-4"]	[-1.5"]
