**Mitigation Monitoring Report Cover Sheet  
Oregon Department of State Lands**

DSL Permit Number: 26208 COE Permit Number: Nationwide Permit -#2001-1031		
Permittee: Ken Reynolds		
County: Benton	Report Date: December, 2009	Monitoring Year 6
Date Removal-Fill Activity Completed:		
Date mitigation was completed Grading: 2002 Planting: 2004		
Report submitted by: Frazier Creek Wetland Mitigation Bank

The purpose of this report is to summarize the progress of the Frazier Creek Wetland Mitigation Bank (Bank). The Frazier Creek Wetland Mitigation Bank, owned by Ken Reynolds, is located in Corvallis, Oregon. The site is located in Township 11 South, Range 4 West, northwest quarter of Section 18, Tax Lot 400, Benton County, Oregon. The wetland mitigation bank is contiguous with the Jackson-Frazier Wetland. The letter of approval for the Bank was signed in 20023 and is permitted as ACOE permit #2001-1031.

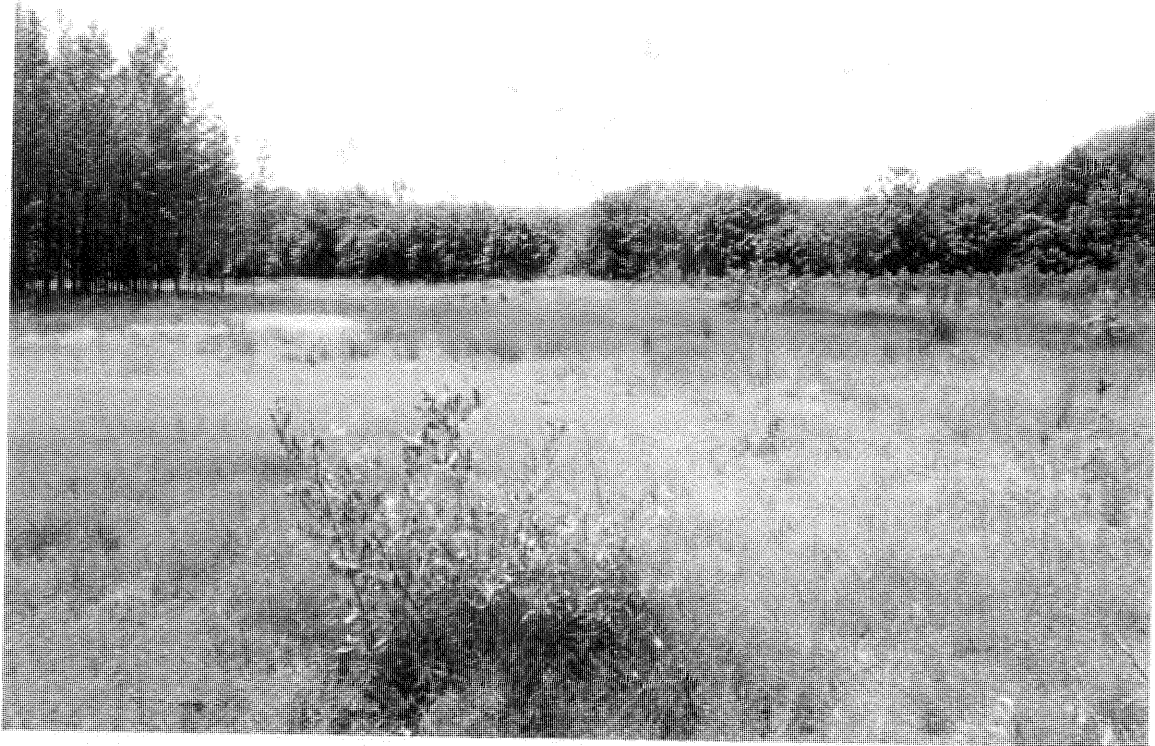
The willow planting area in the southwest portion of the Bank has been monitored since its initial planting in 2004 with 275 willows in the 0.2 acres area. Monitoring in 2005 and 2007 indicated an approximate 25% survivorship of the planted willows. The 2008 monitoring indicated a substantial increase in the number of willows to approximately 46% of the original planting rate. Since the area has not performed as anticipated, this year we counted all willows within the entire 0.2 acre willow area to determine the overall stem density. Twenty-six willows were counted within the 0.2 acres which is a 9% survival rate from the original 2004 planting. Suggested remedial actions are included in Section 7.0.

**Photo 7 willow area looking southwest across swale area with ash area in background**

In order for the willow area to be successful, additional hydrology is needed. The area without willows can be graded to remove 6 to 12" of soil to the approximate elevation of the adjacent swale area. Additional willows along with acceptable herbaceous cover can be replanted. A second possibility is that the willow area can be planted to wet prairie species, while leaving the existing willows in place. The performance standard for this area could then convert to the wet prairie standards. Suggested planting mix includes slough grass (*Beckmannia syzigachne*), tufted hairgrass (*Deschampsia cespitosa*), dense sedge (*Carex densa*), one-sided sedge (*Carex unilateralis*), slender rush (*Juncus tenuis*) and common camas (*Camassia quamash*).

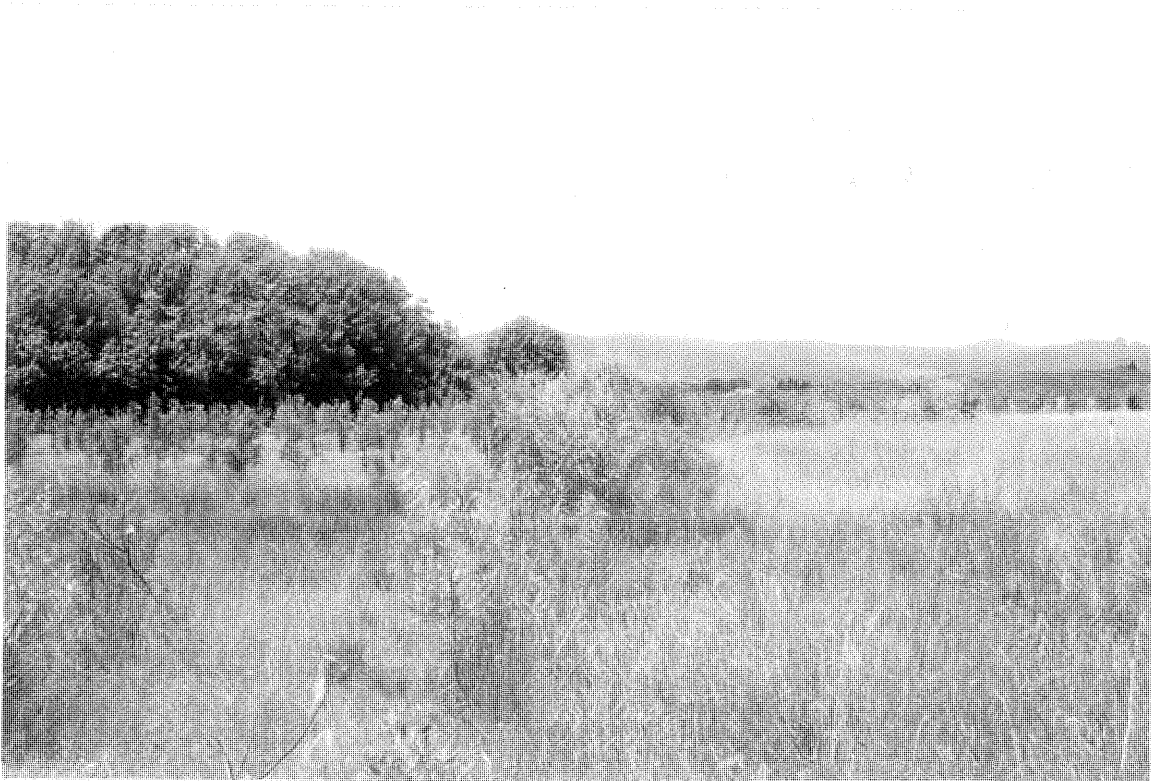
**Photo 8 willow area looking west across swale towards ash area**

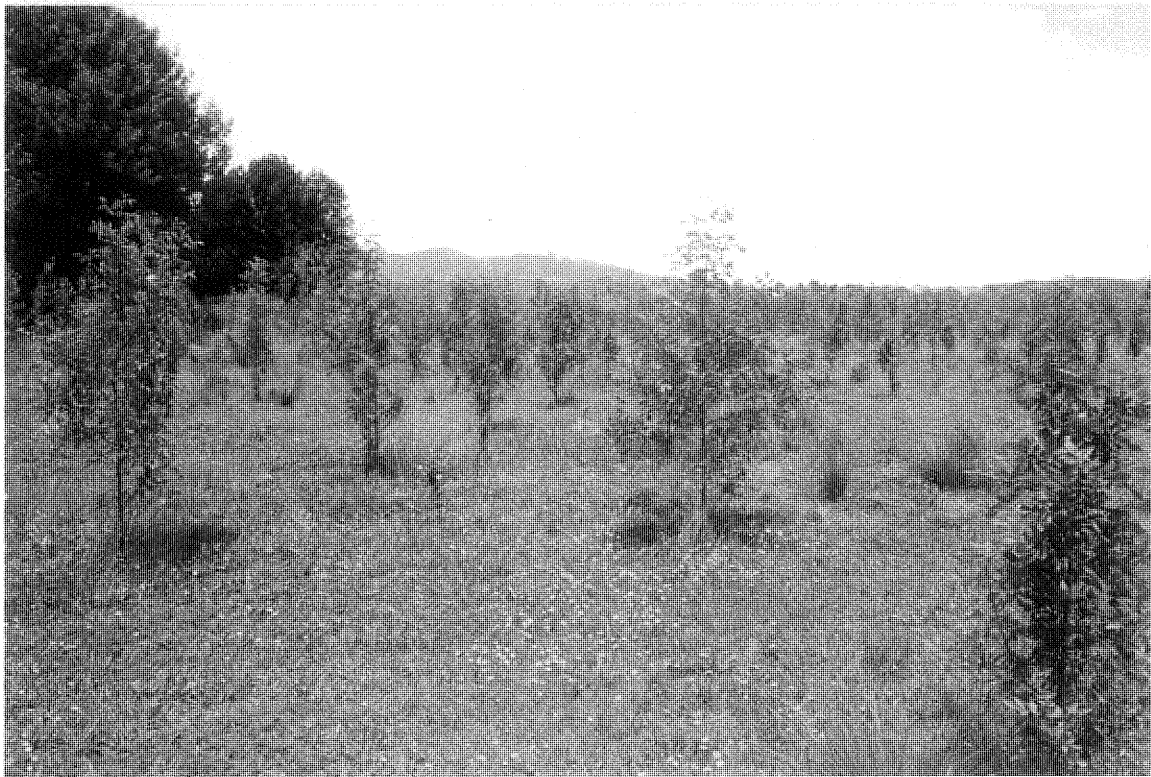
In 2009, there was an average of 16.8 trees per plot (314 square feet). This is a dramatic increase from the 2.4 trees per same sized plot in 2004. Many of the 16.8 trees are saplings, but even the average number of ash trees greater than 2 feet in height is 8.4 per plot. The ash trees continue to grow and reproduce and are meeting performance standards.

**Photo 10 ash area looking northwest across from ash 2**

Planting the ground cover in the forested wetland has not yet been completed. Up until now, the focus has been on controlling ryegrass, which is now complete. The native ground cover should be established next fall after spraying out the weeds that took over this spring. The planting plan includes planting slough sedge (*Carex obnupta*), California false hellebore (*Veratrum californicum*), skunk cabbage and water parsley were also on the list, but it is my personal opinion that these species will not survive at this location. I would substitute cow parsnip (*Heracleum lanatum*) and large leaf avens (*Geum macrophyllum*).

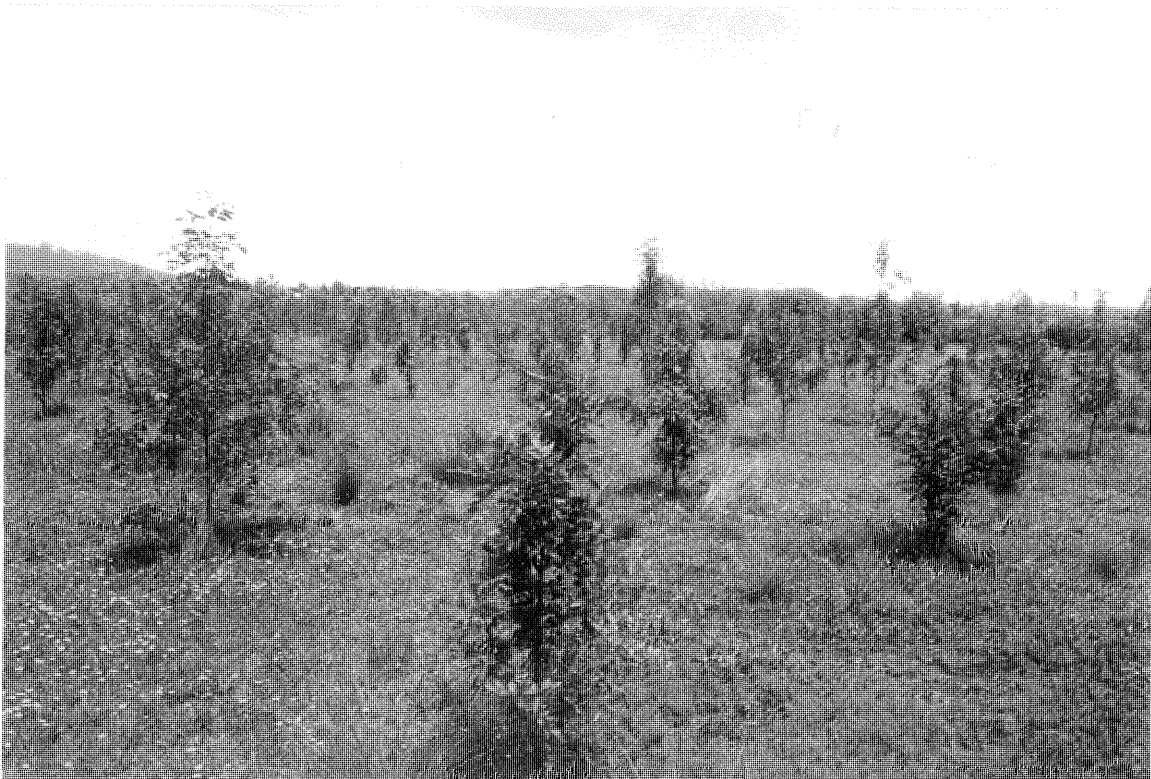
Photo 12 ash area looking northwest across from ash 5
