AS BUILT REPORT

Frazier Creek Wetland Mitigation Bank

Benton County, Oregon

May 2004

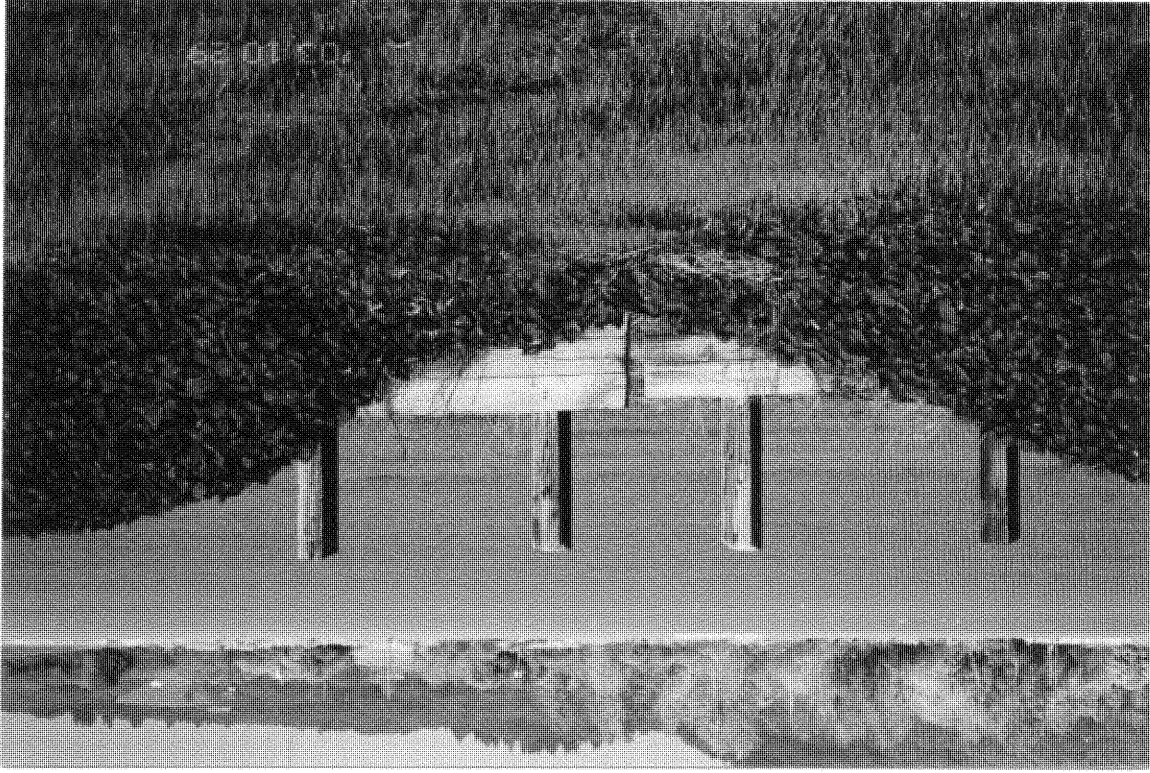
PHOTO DATE 10/29/03

ABOVE: Oregon ash planting (typical)
BELOW: Outlet structure, Swale # 1

Trees and shrubs were counted at 15 sample plots, each within a 10-foot radius. Two of the plots over-lapped the shrub edge. Stakes were placed in the center of each plot to identify locations for future sampling. Each plot was 314 square feet and had an average of 2.4 stems of Oregon ash per plot. The planting plan called for one tree every 12 feet and sampling indicated that trees were planted at a density of one stem every 11 feet. Trees were approximately three to five feet tall (see typical photograph, attached).

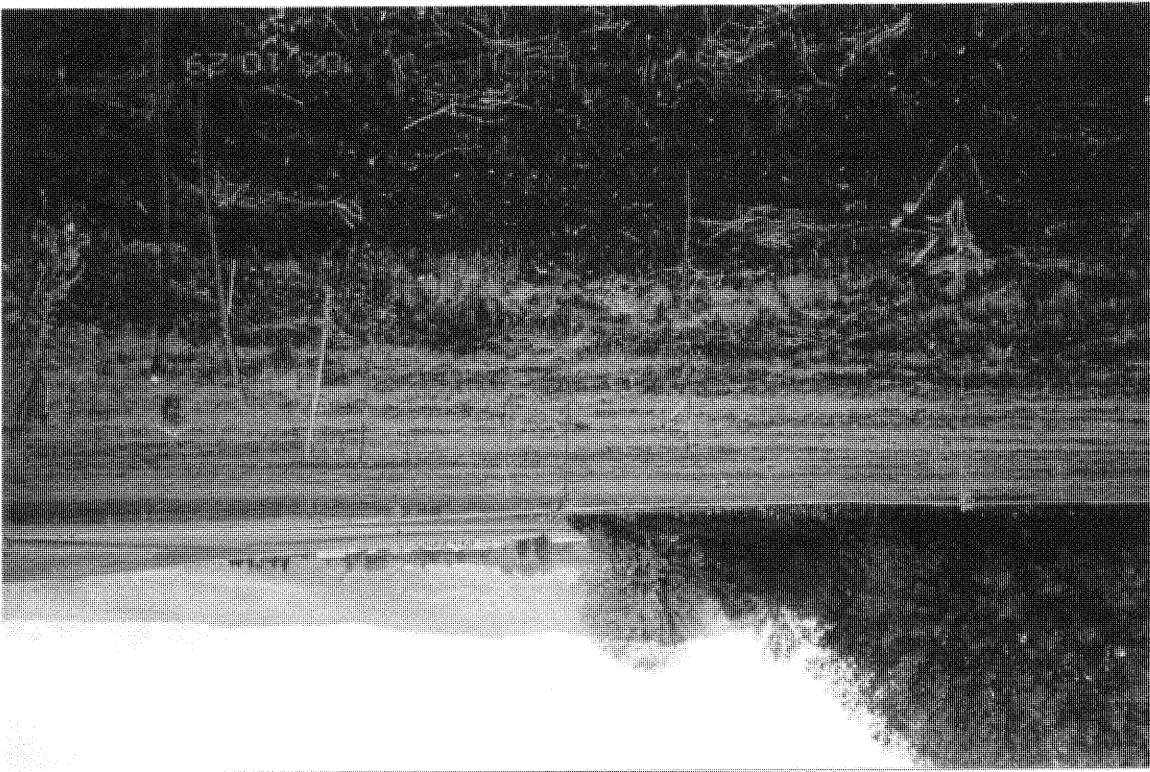
PHOTO DATE 10/29/03

Outlet structures were constructed at the north end of the two new distribution swales (see attached photographs). The structures were built to restrict (slow down) water exiting the wetland mitigation area. The outlet structures have a four-inch gap to permit fish passage.

Berms in the vicinity of the outlet structures were monitored during the winter of 2002 and 2003. Some bank erosion occurred in the winter due to the severity of the storms and soils that were not stabilized (compacted) enough to withstand high water. Breaches in berms were repaired and compacted in the summer of 2003. Repair work included additional armoring of the sides of the outlet structures with rip-rap.

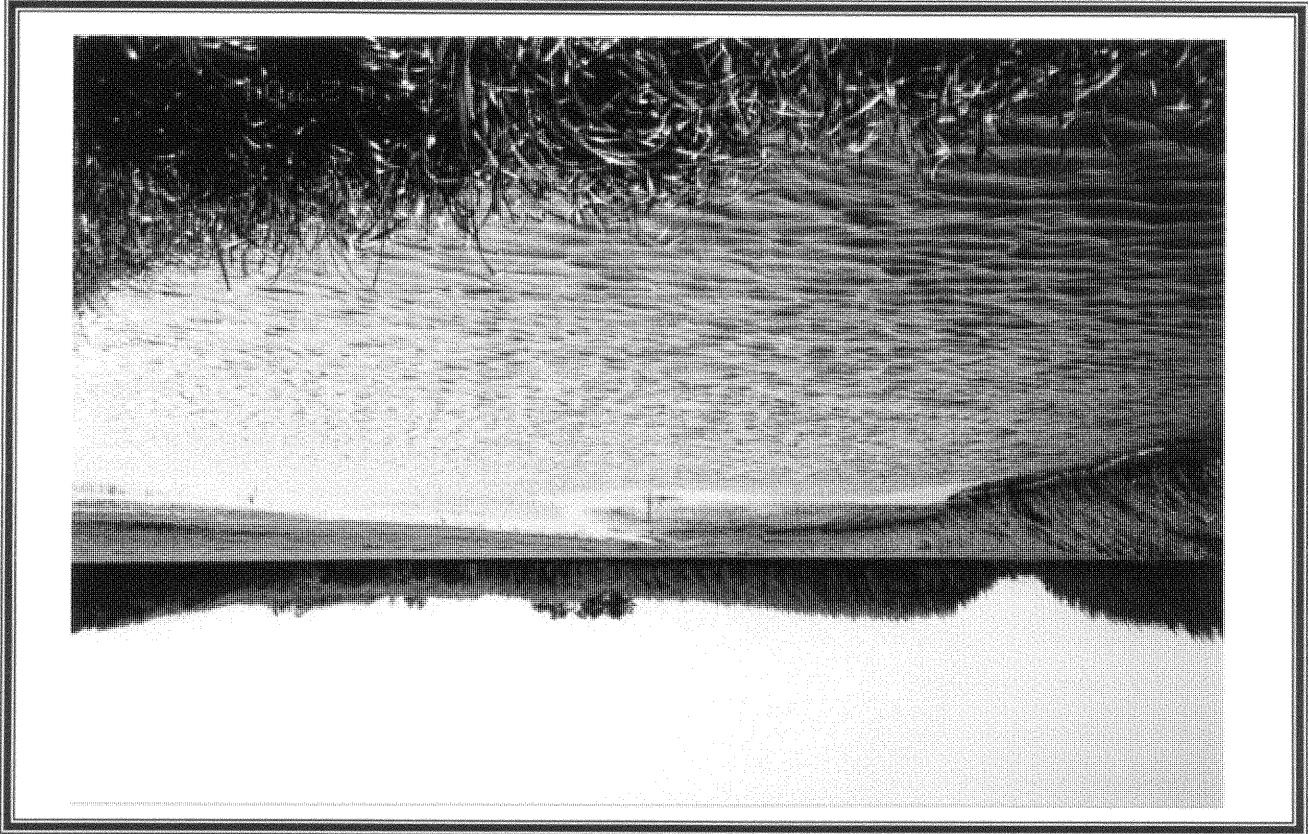
PHOTO DATE 4/27/04

BELOW: Swale #2 - After blocking of outlet structure.
ABOVE: Swale #1 - Looking south from northern berm.

Management and planning for additional plant installation have been a topic of frequent discussion between the Consultant and Sponsor. Priorities are to continue efforts to remove annual ryegrass, make adjustments to outlet structures, and to plant additional emergents in both the forest and wet prairie habitats.

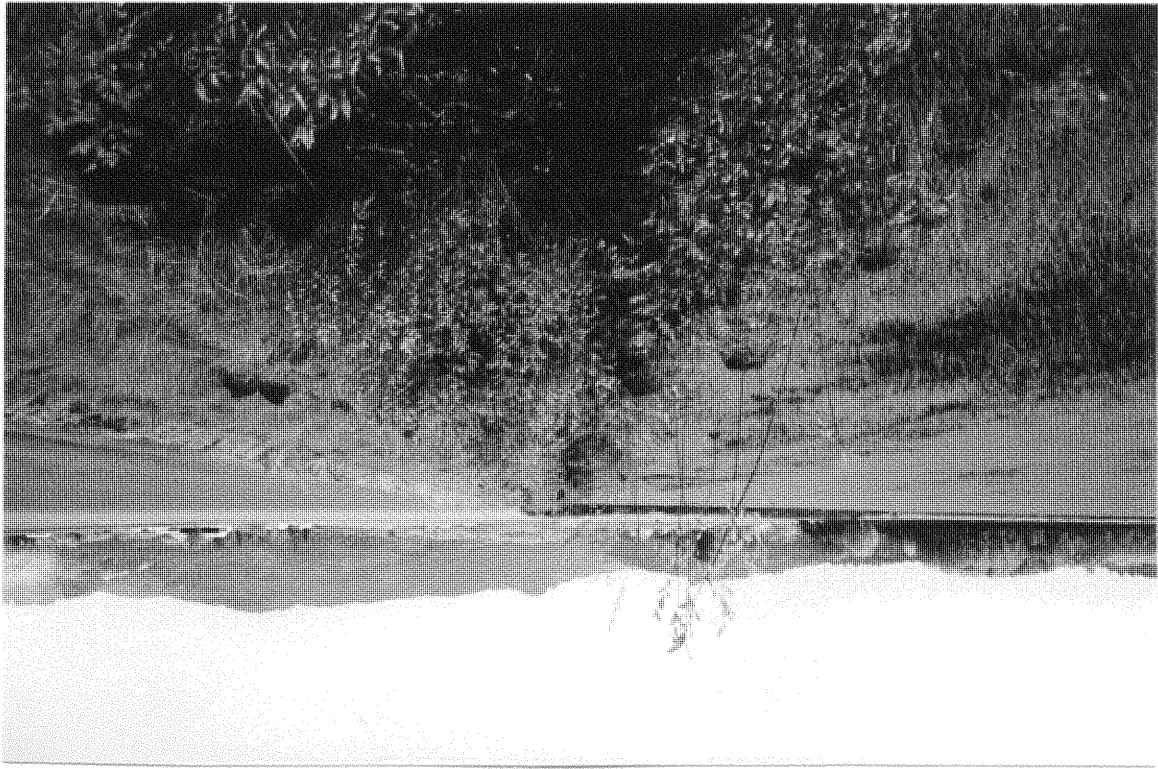
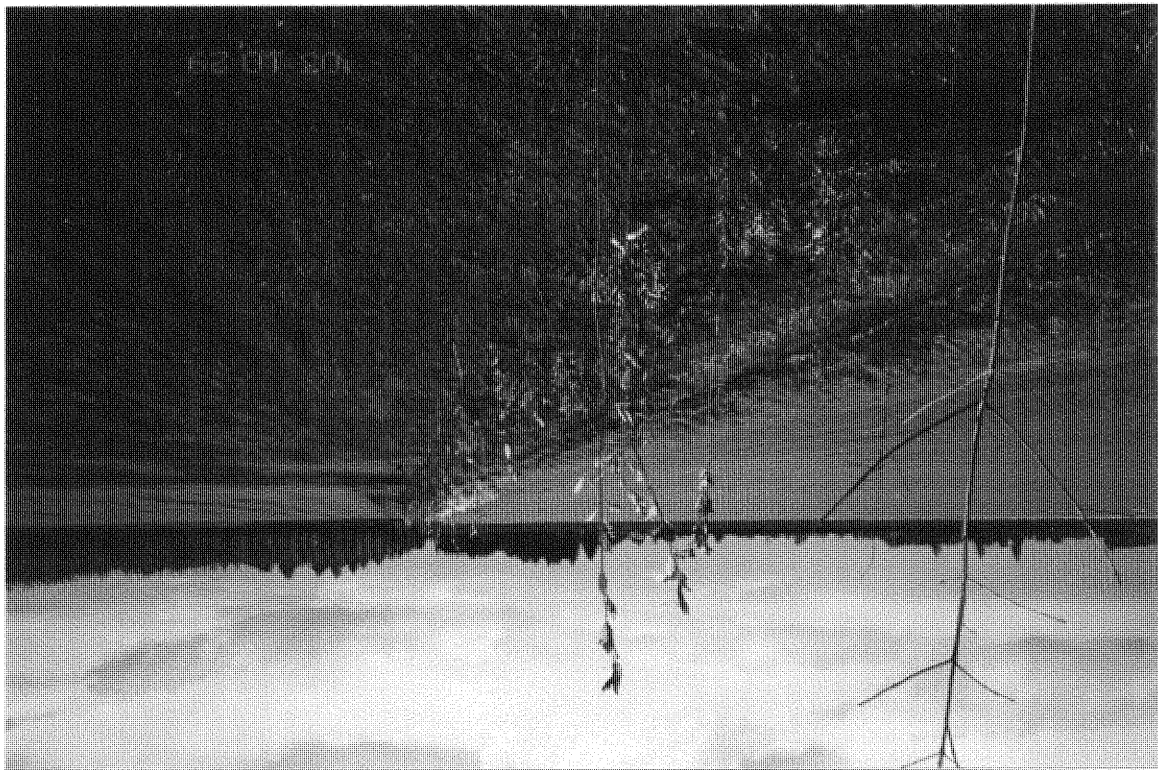
SHRUB HEDGEROW ALONG NORTHERN BOUNDARY

The shrub hedgerow was evaluated at 15 sample plots, one sample plot every 100 feet, along an east to west transect of the northern boundary. The number of trees and shrubs were counted within a 10-foot strip (or five feet either side of the center point). Species of shrubs and trees, approximate size, and estimate of areal cover were noted. Two of the sample plots fell at the outlet structures that were re-enforced with rip-rap and not planted. Data is summarized for the 13 and 15 sample plots in Table 4.

All species of trees and shrubs called for on the planting plan were present in the hedgerow along the northern property boundary. Himalayan blackberry was noted at two sample plots. They were brought to the attention of the Sponsor who was advised to institute control measures. About six dead plants were noted along the entire hedgerow. The planting density indicates that the numbers of plants called for on the plan (885 total) were installed and that survivorship was well above 95 percent.

ABOVE: Looking east from west end.
BELOW: Looking west from east end.

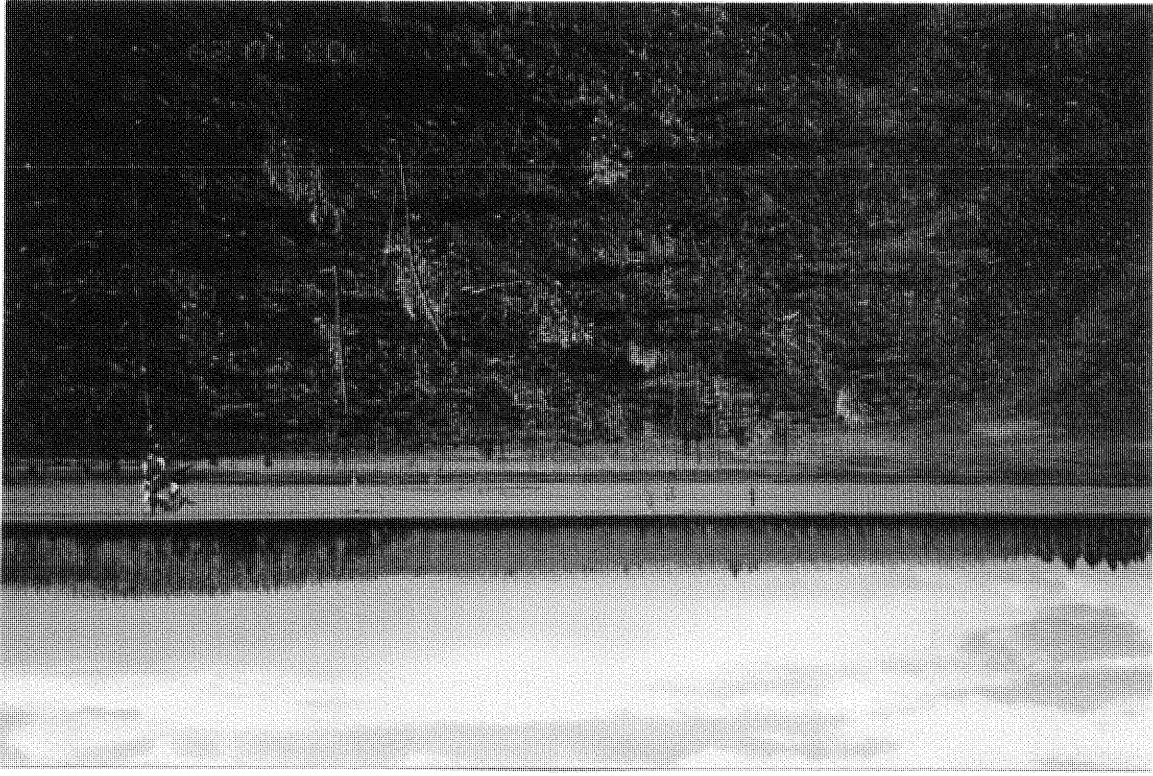
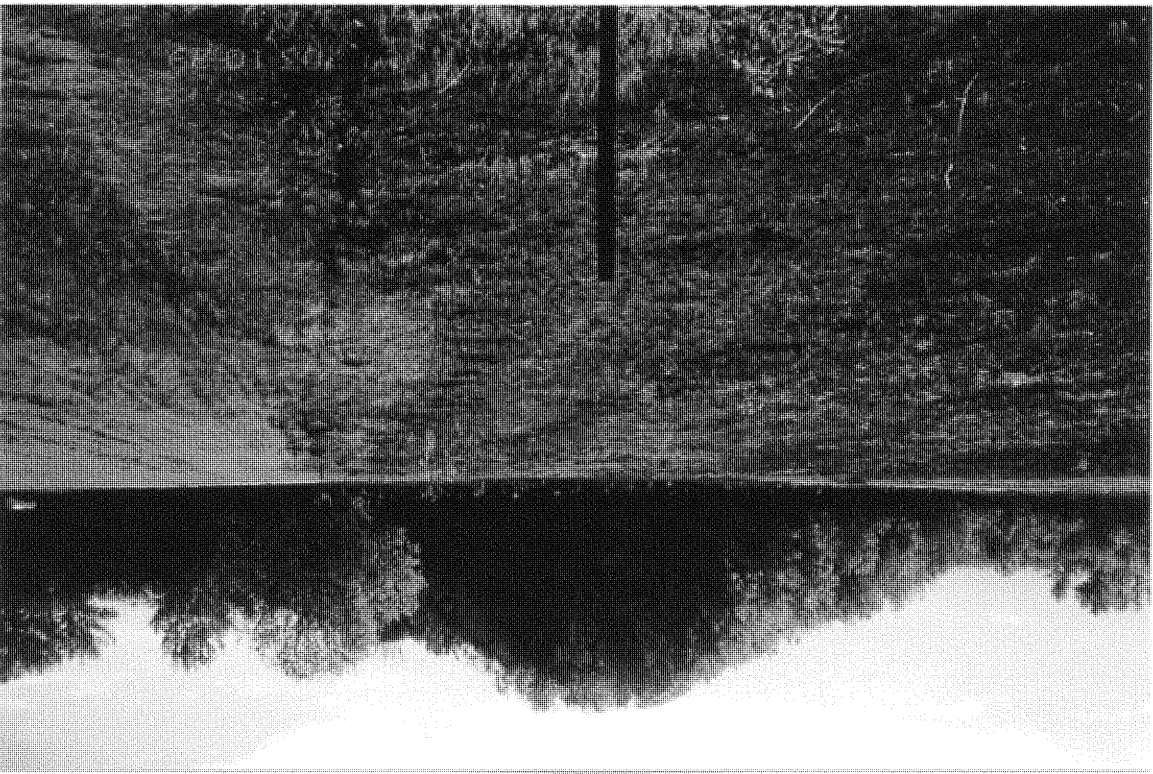
Most of the Oregon ash was still dormant on the date of sampling. Buds were beginning to open on some stems. Overall, Oregon ash were in good condition and dead plants were not apparent. Shrubs called for in the planting plan, rose (*Rosa* sp.), crabapple (*Pyrus fusca*), dogwood (*Cornus stolonifera*), spirea (*Spiraea douglasii*), and black hawthorn (*Crataegus douglasii*), were all present in the edge habitat.

ABOVE: Looking southwest from northeast corner of forest planting.
BELOW: Transitional shrub on edge of Oregon ash planting (typical).

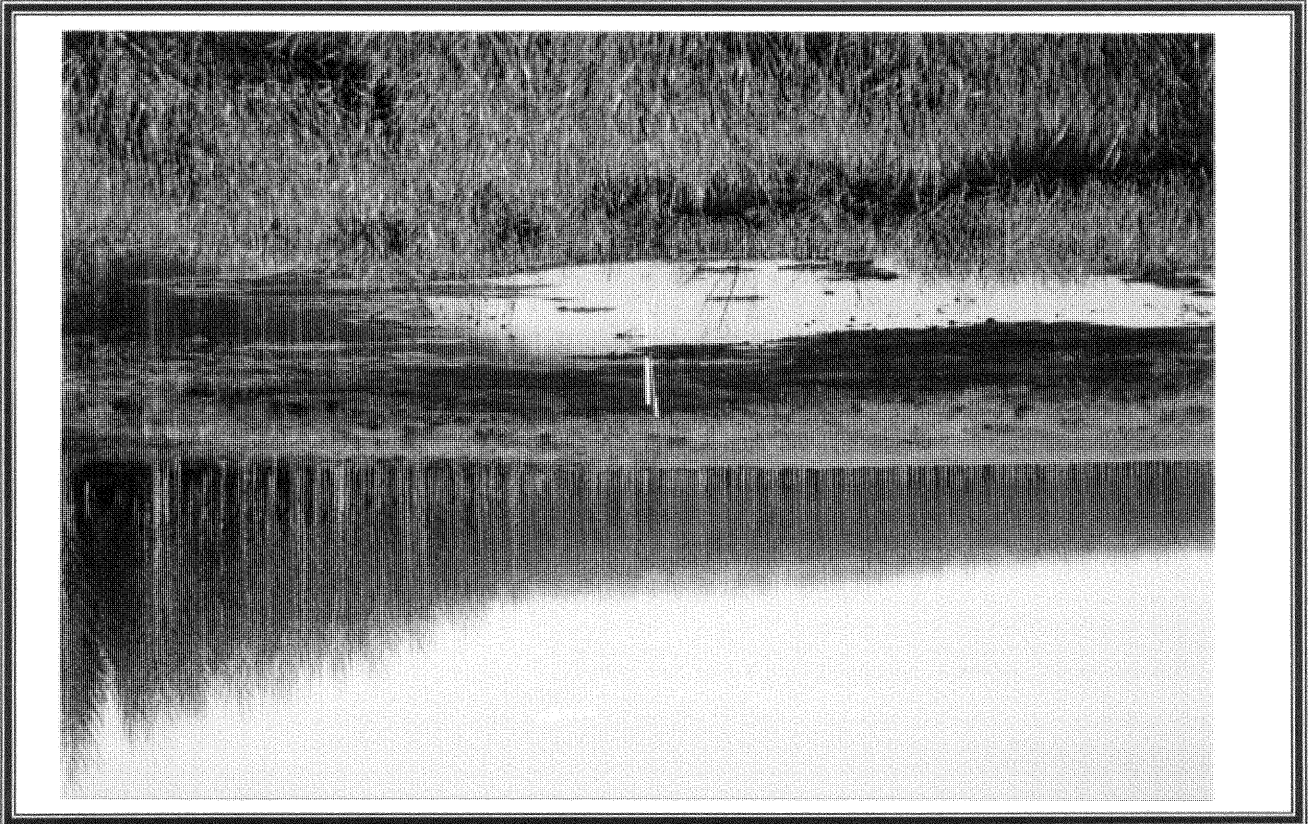
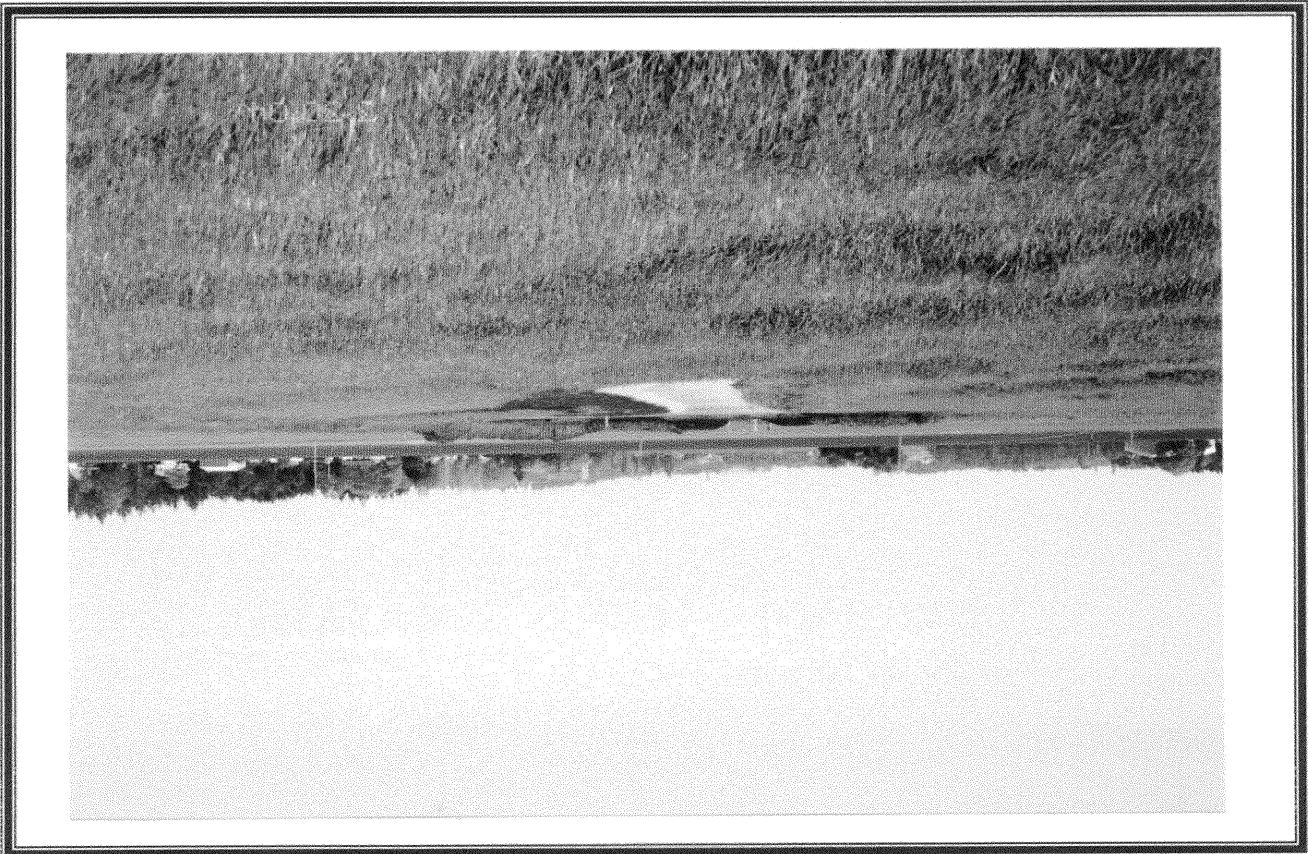
BELOW: Looking toward PZ 05 from southwest corner.

ABOVE: Looking north from PZ 03.

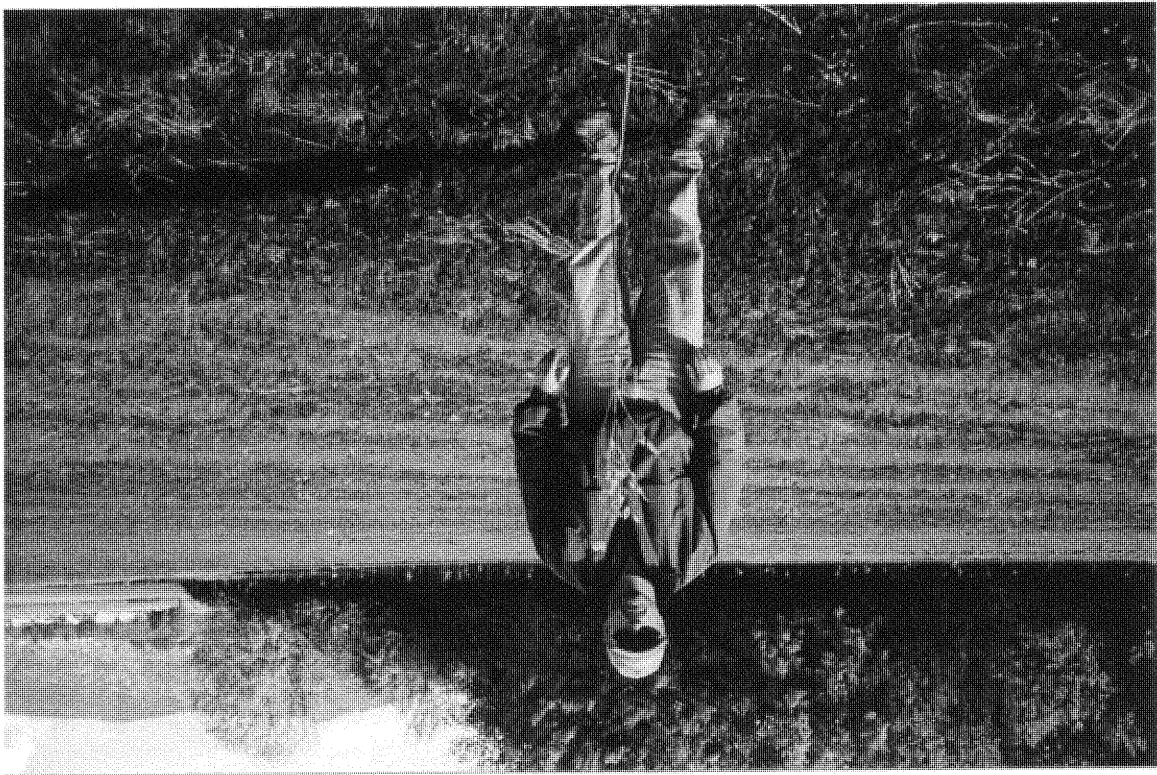
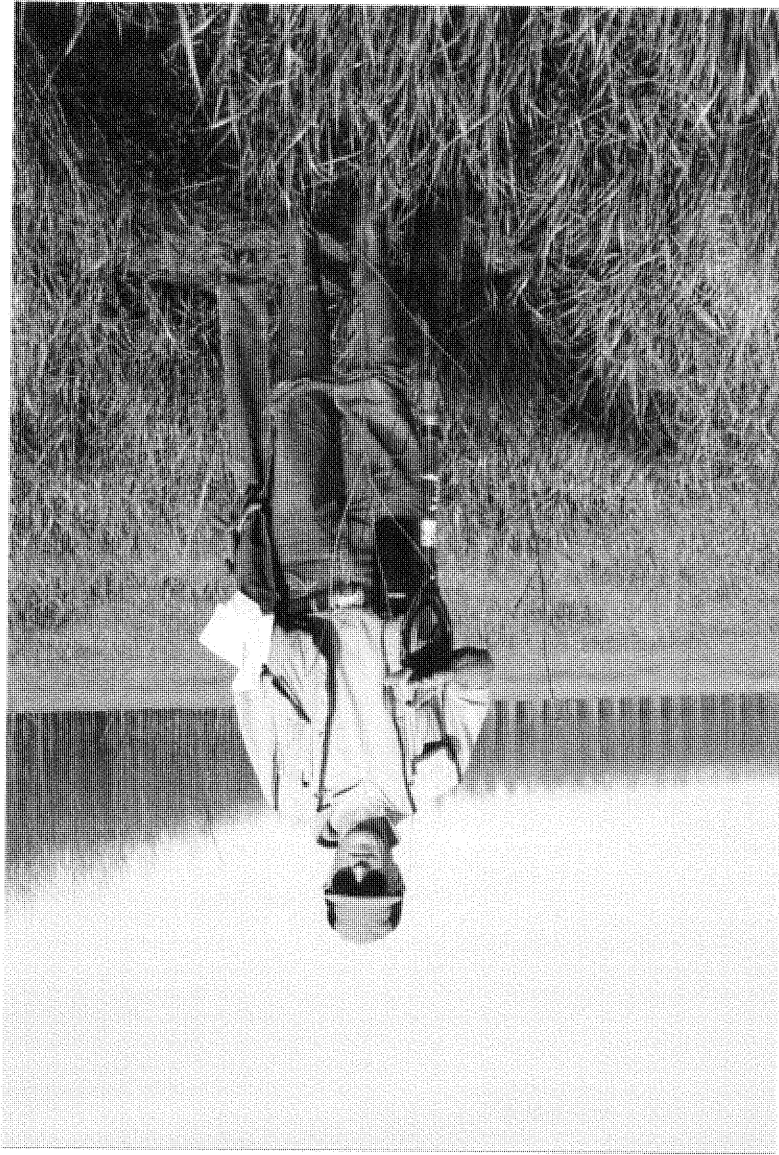
WILLOW - TYPICAL

The planting plan called for un-branched slips or stakes to be planted. The Sponsor planted willow stakes that were branched. Willows were in good condition in late April 2004 and the branching on stakes is not likely to be a problem. A photograph illustrating a typical willow is attached.
