YEAR 5 (2024) MONITORING REPORT Linnton Mill Restoration Site

DECEMBER 2024

RestorCap LLC
6210 Medau Place, Suite B
Oakland, CA 94611

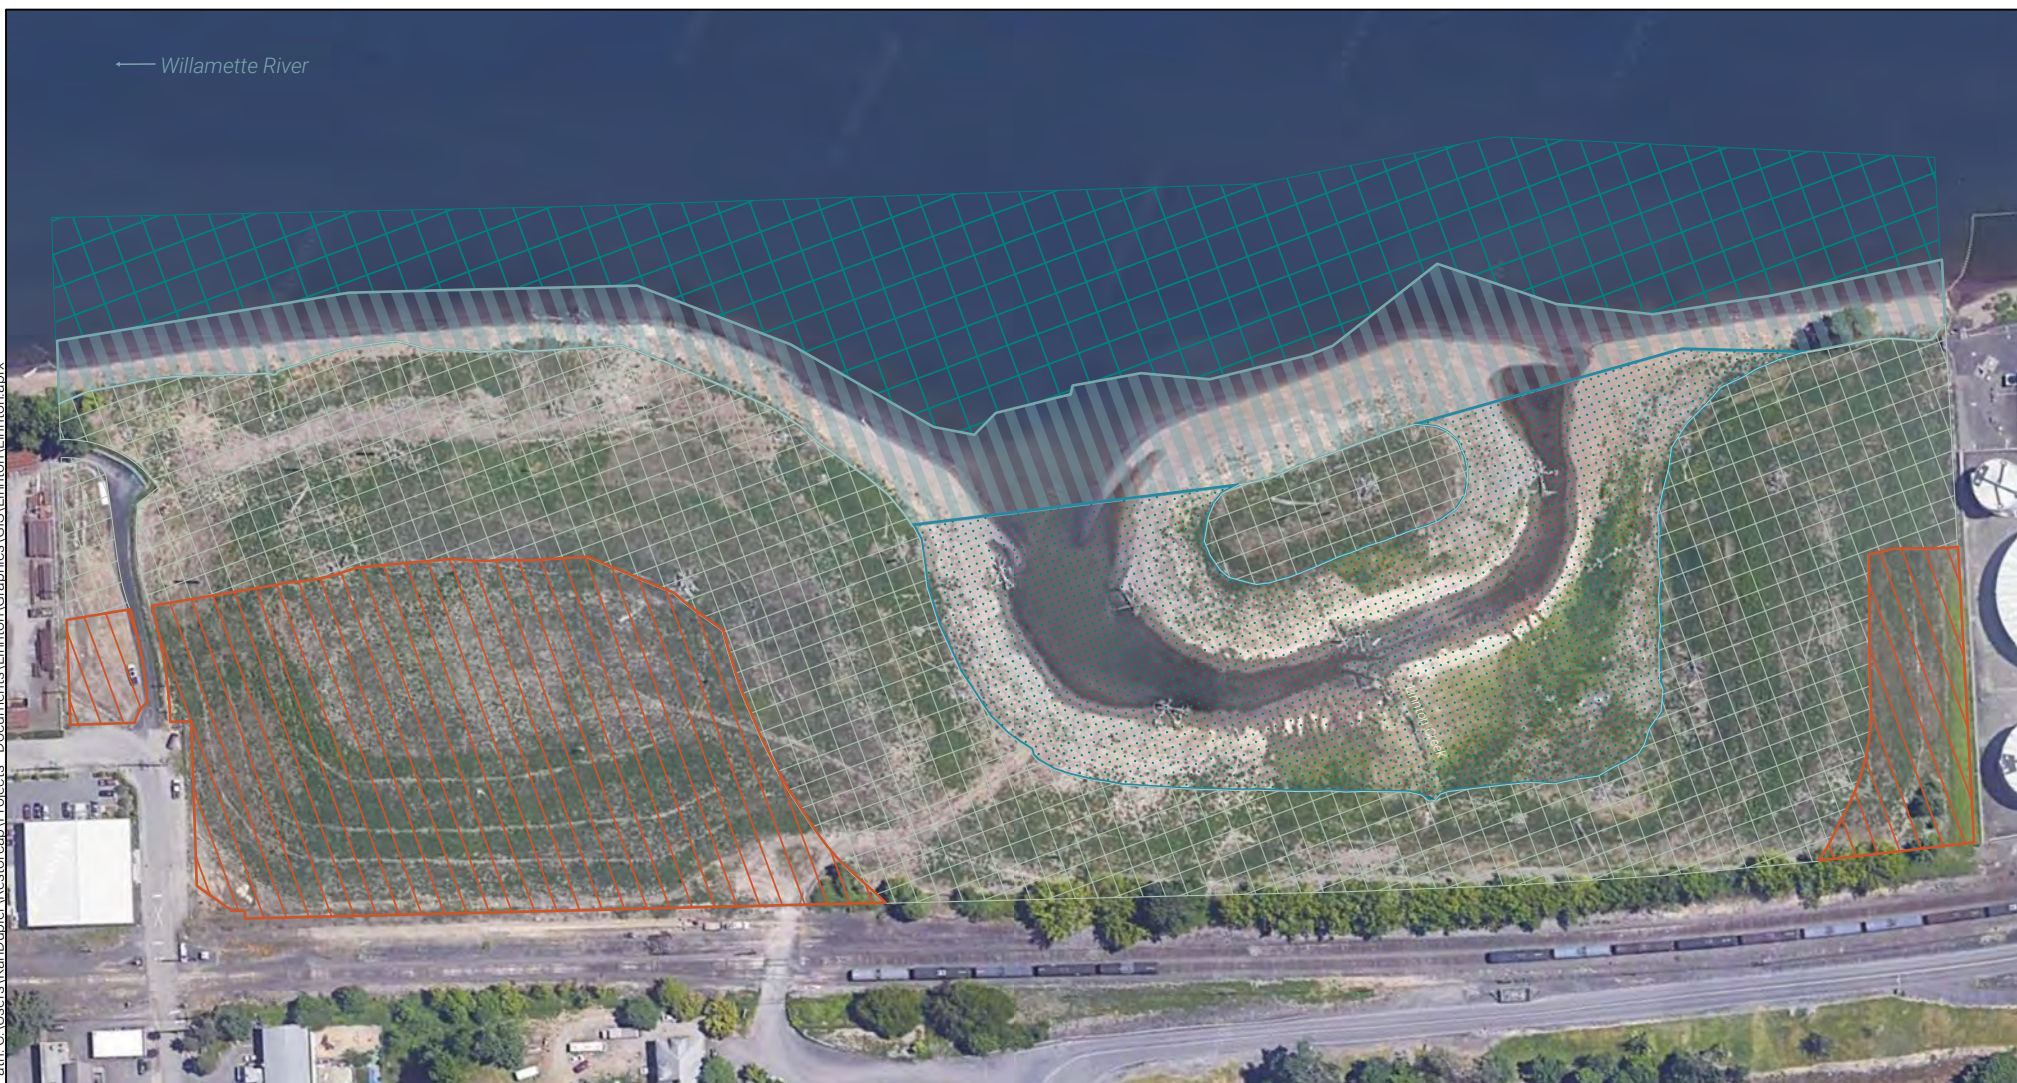
FIGURE 2

Linnton Habitat Types

Vegetation performance was assessed by sampling vegetation within established plots, analyzing and interpolating sample results, and comparing these to site performance standards. Pre-determined transects were established in the SSPP and spacing of monitoring plots varies by habitat type (Grette 2018b). RestorCap established permanent markers for each monitoring plot within the forested and scrub-shrub habitats (Figures 2

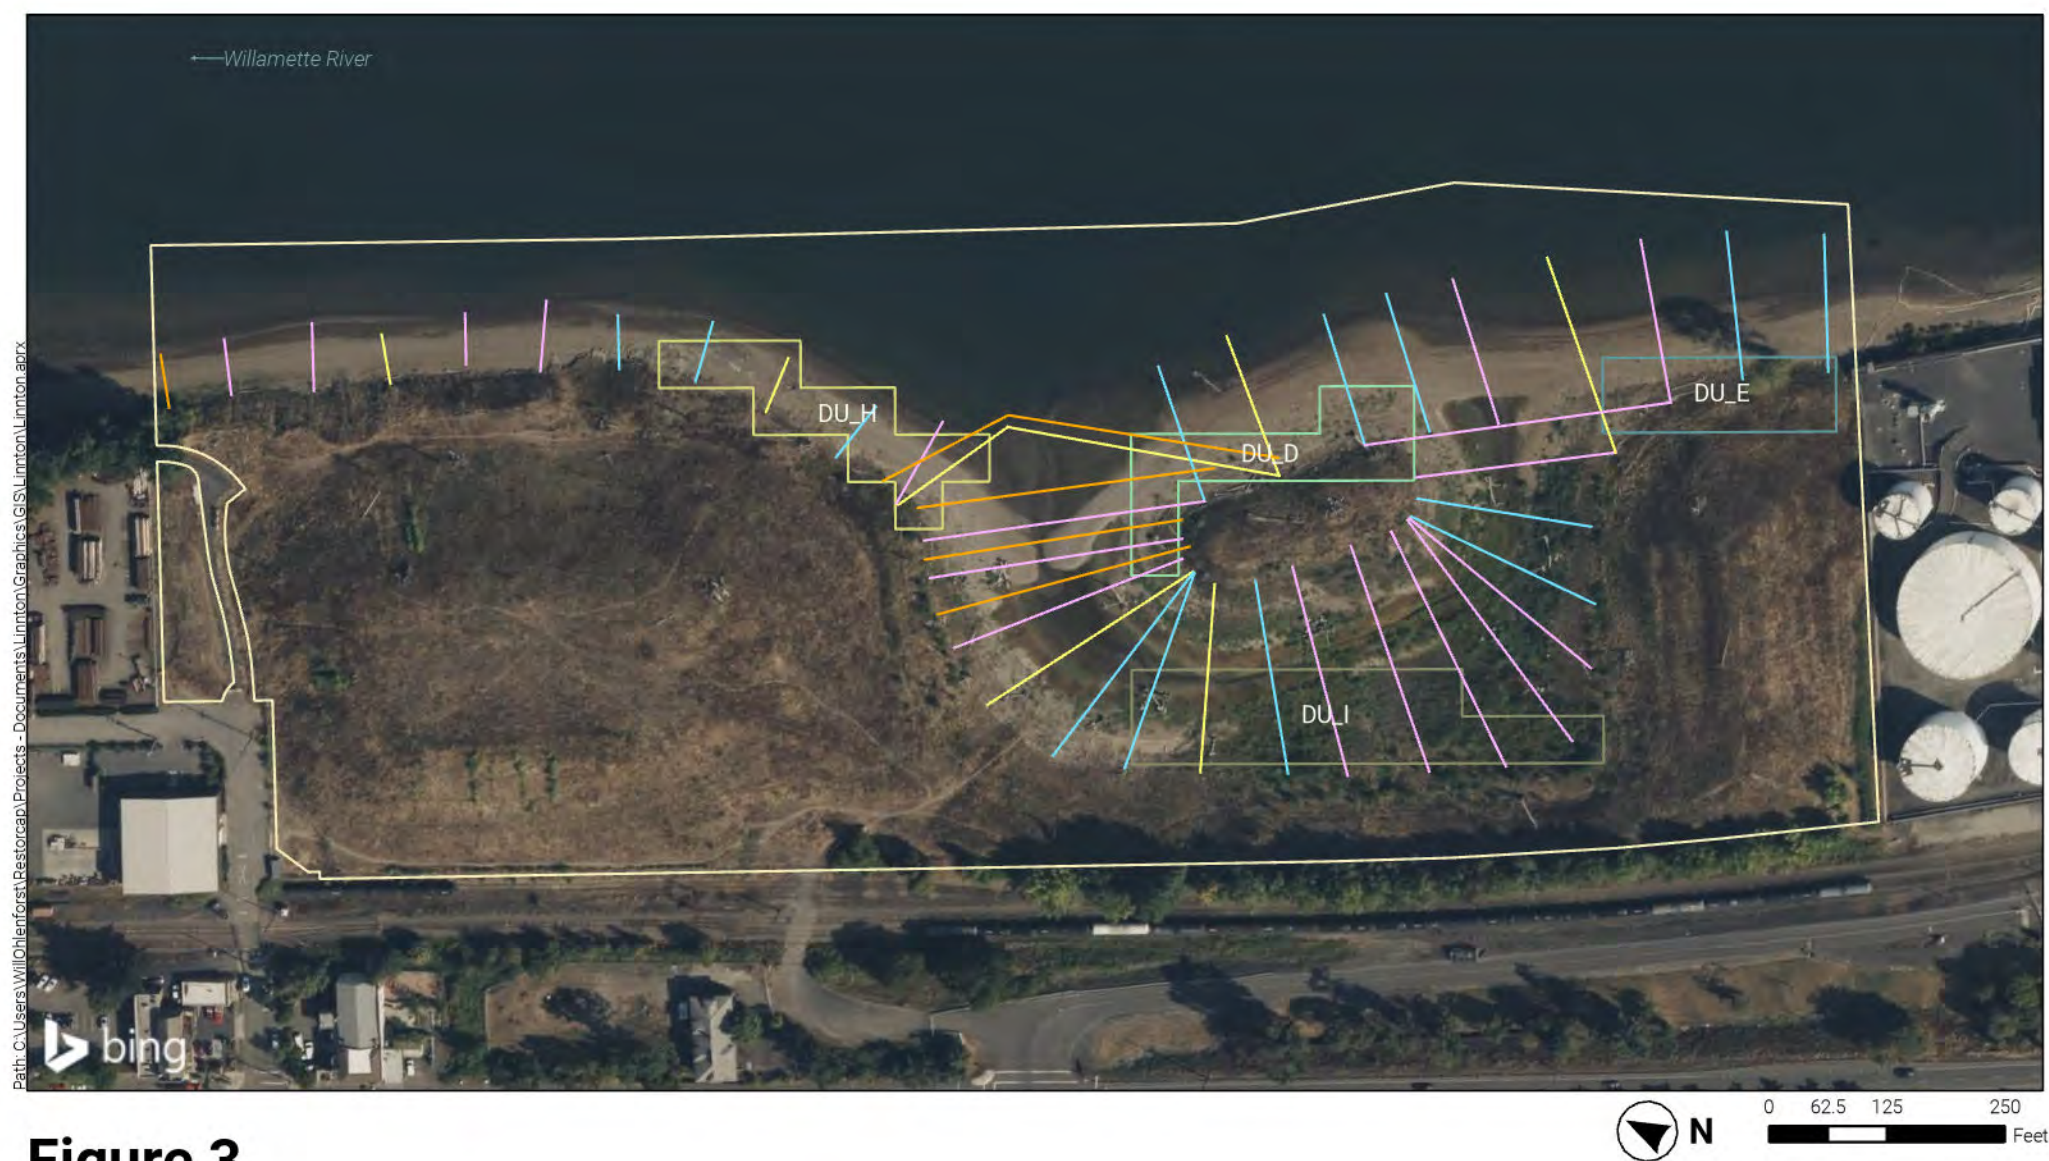
Figure 3

To assist in tracking elevation changes within the aquatic restoration area, those transects located within decision units D, E, H, and I are noted below and on Figure 3.

Topographic Monitoring Transects

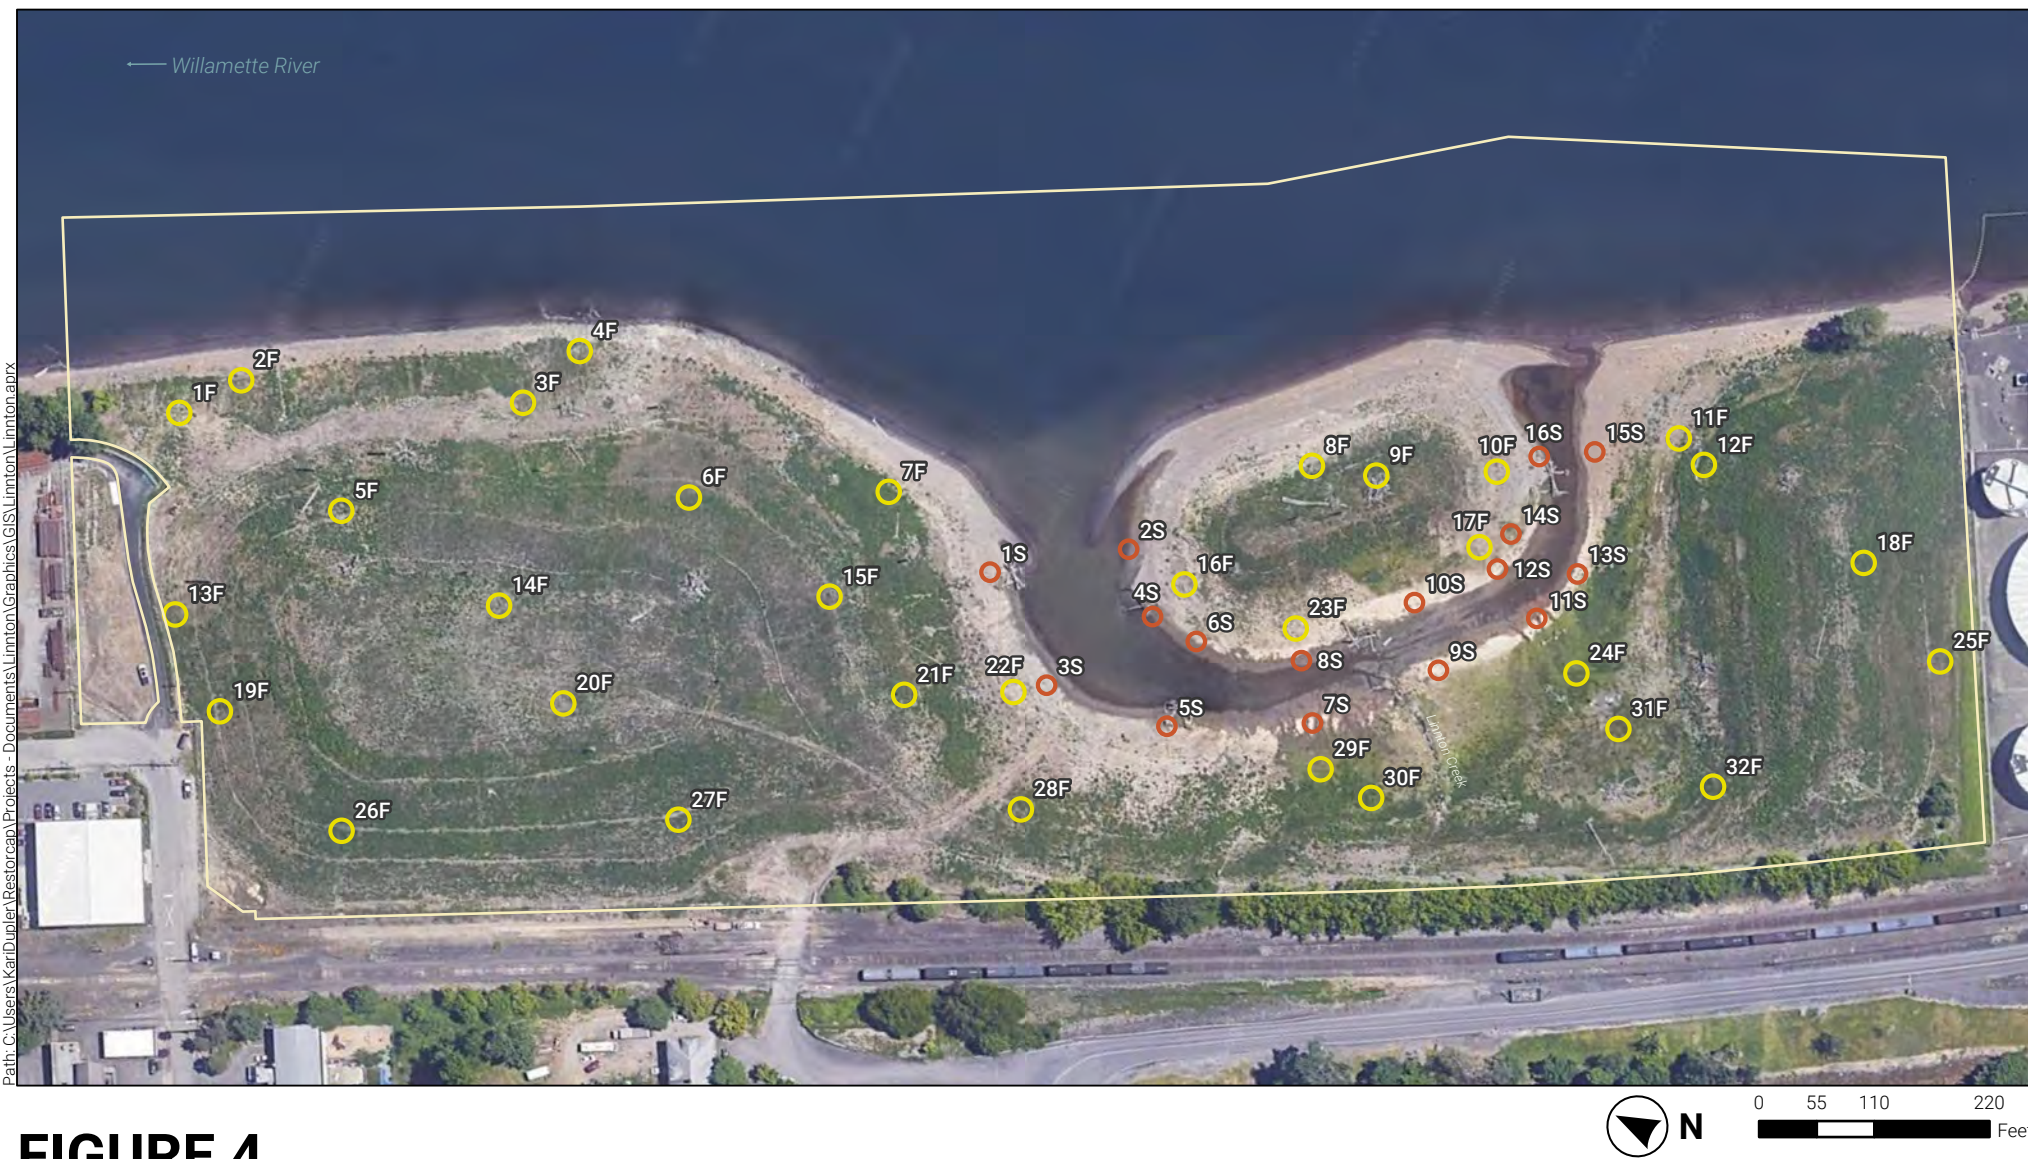
FIGURE 4

Vegetation Monitoring Plots

This zone includes all Upland and Riparian zones, and the area between the OHWM and +13 ft, as established in the SSPP (Grette 2018a). Within this zone, 32 plots (1F-32F) were permanently marked with rebar and locations recorded with GPS (Figure 4). Upland monitoring plots were initially established every 50 meters along established transects, beginning at a randomly selected starting point (Grette 2021).

The established scrub-shrub zone includes the portions of the OCH between approximately +13 ft and +10.5 ft. Within this zone, 16 plots (1S-16S) were permanently marked with rebar and locations recorded with GPS (Figure 4). At each plot ($n=16$), a three-meter radius plot was used to determine cover and stem counts of woody species. One herbaceous plot was sampled in the middle of each shrub plot and was assigned cover classes using the Daubenmire cover class method.

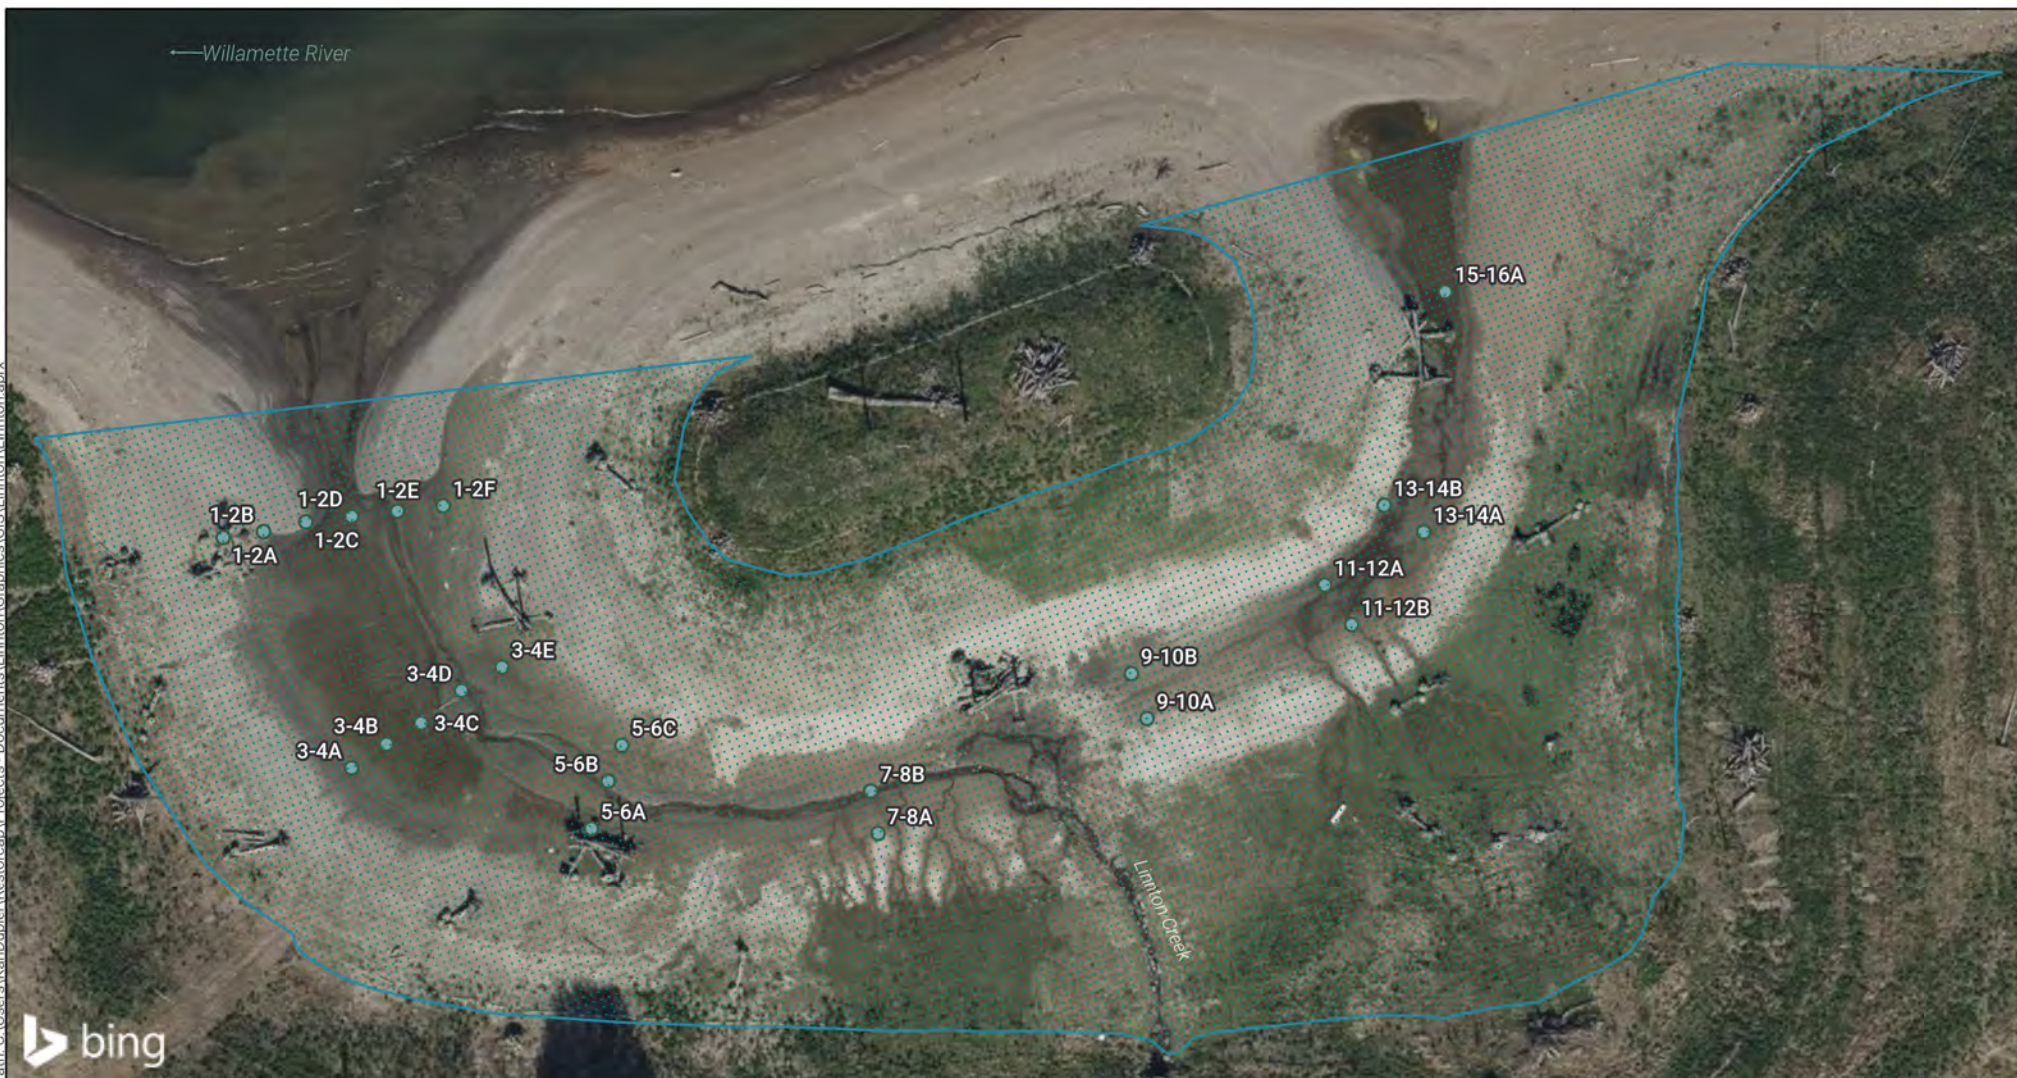
FIGURE 5

Off-Channel Emergent Monitoring Plots

The Off-Channel emergent zone was defined as the area between +10.5 ft and +8.5 ft. Based on observations in 2021, this zone was monitored later in the season to capture the diversity and cover of species. Plots were established approximately six meters apart along each scrub-shrub transect (Figure 5). These plots were not marked with permanent

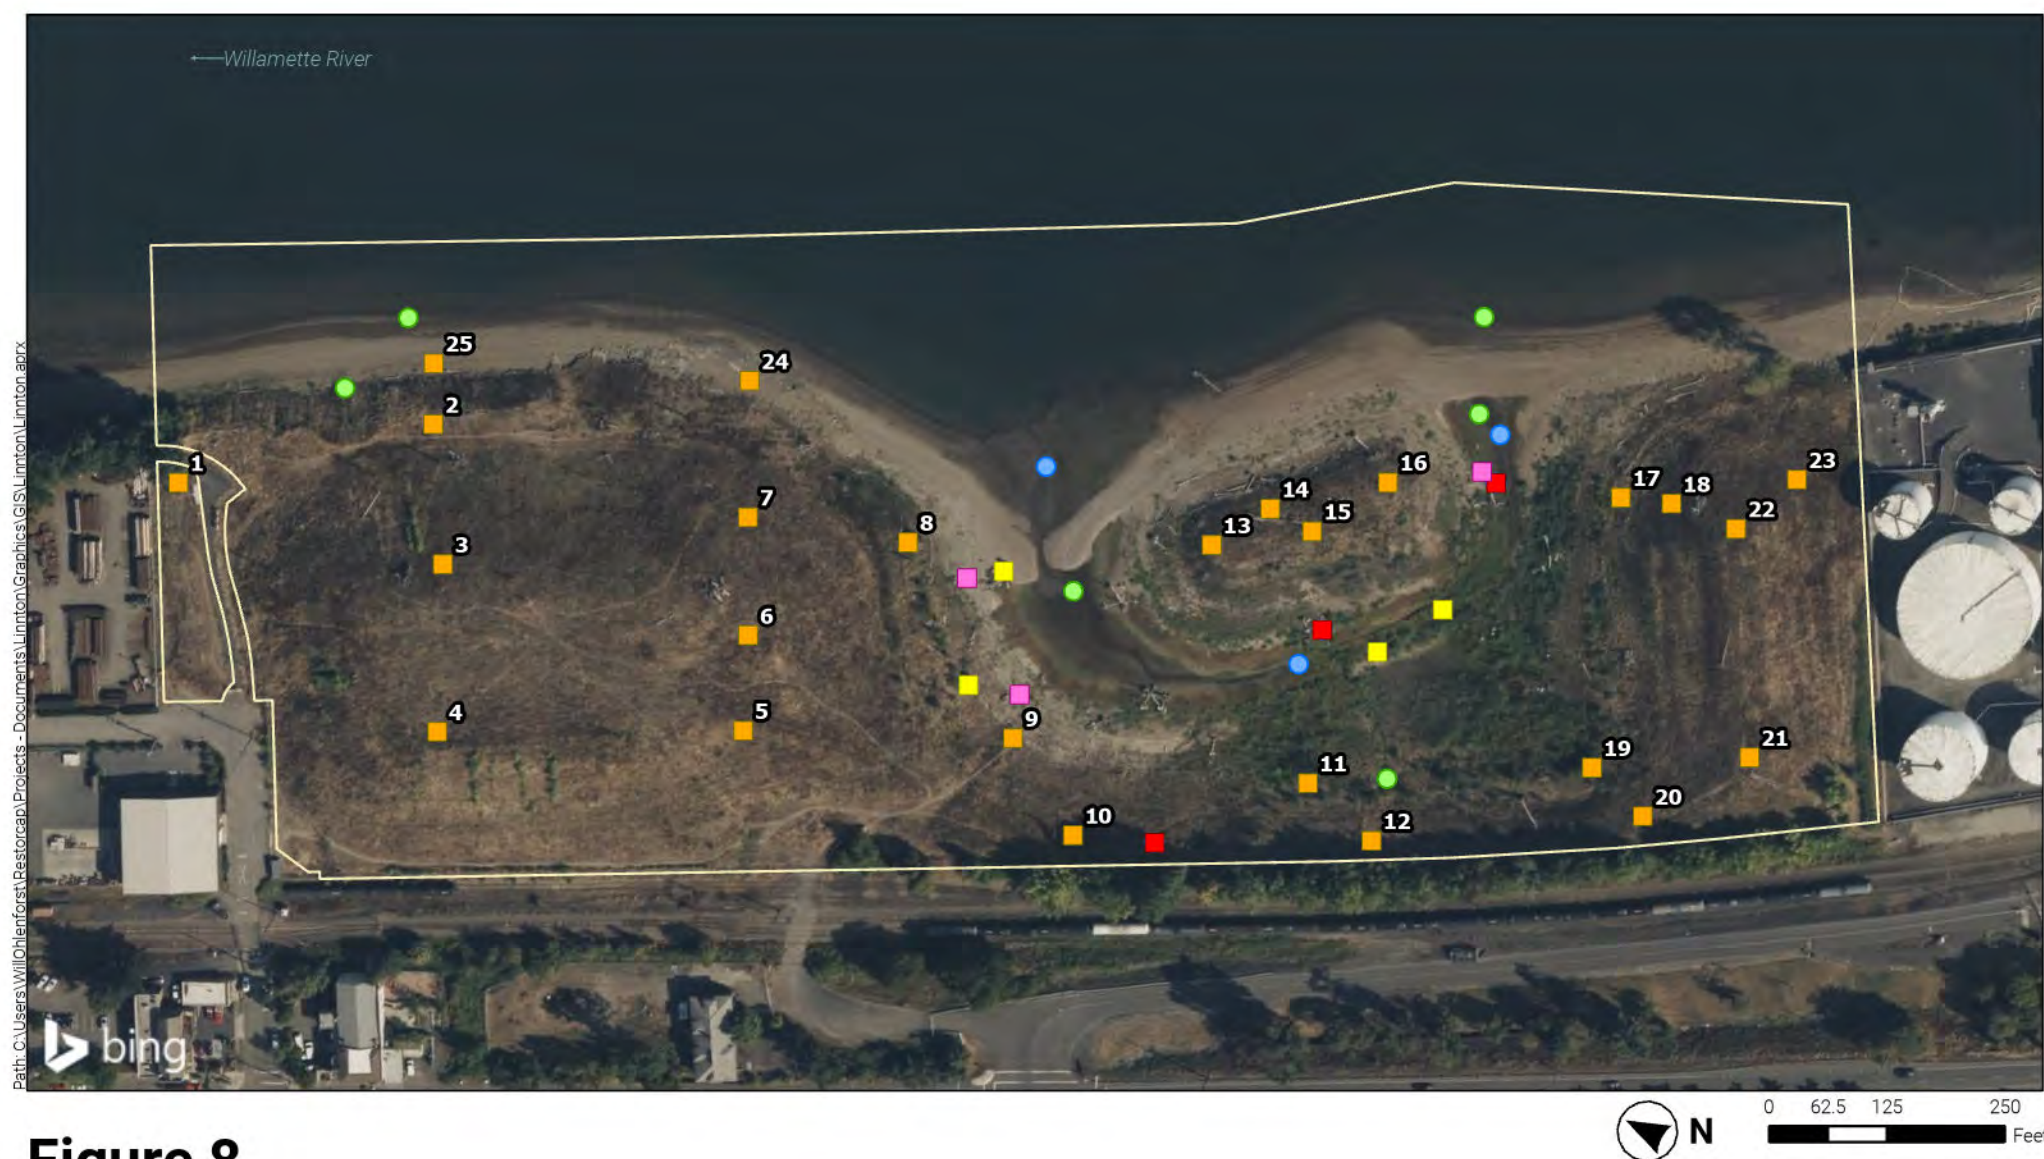
Figure 8

Wildlife, Photo, and Water Quality Monitoring Locations

Water temperature was measured using water level data loggers installed at the Site, one near the downstream mouth of the OCH, one at the confluence of Linnton Creek (“side channel”), and one within the at the upstream end of the OCH (“south island”) (Figure 8). The loggers also recorded water levels. For 2024, the side channel and south island loggers were installed in March, after discovering that the original side channel logger had been lost under sediment. On-site temperatures were generally recorded every 15 minutes with the installed loggers and are presented as monthly averages. Dissolved oxygen (DO) was collected monthly using an Extech ExStik®II EC400 portable meter rather than continuous probe data. Per the HDP, *DO will be compared to the Oregon Department of Environmental Quality’s standard: DO should not be less than 11.0 mg/l (OAR 340-0401-0101 to 340-04100340).*

Shoreline surveys consisted of visual surveys inspecting tracks in the sand and mud, scat, and partially eaten fish seen on site. Three camera traps were established to record wildlife and potential use by American mink (*Neovison vison*; Attachment 1, Figure 8). One

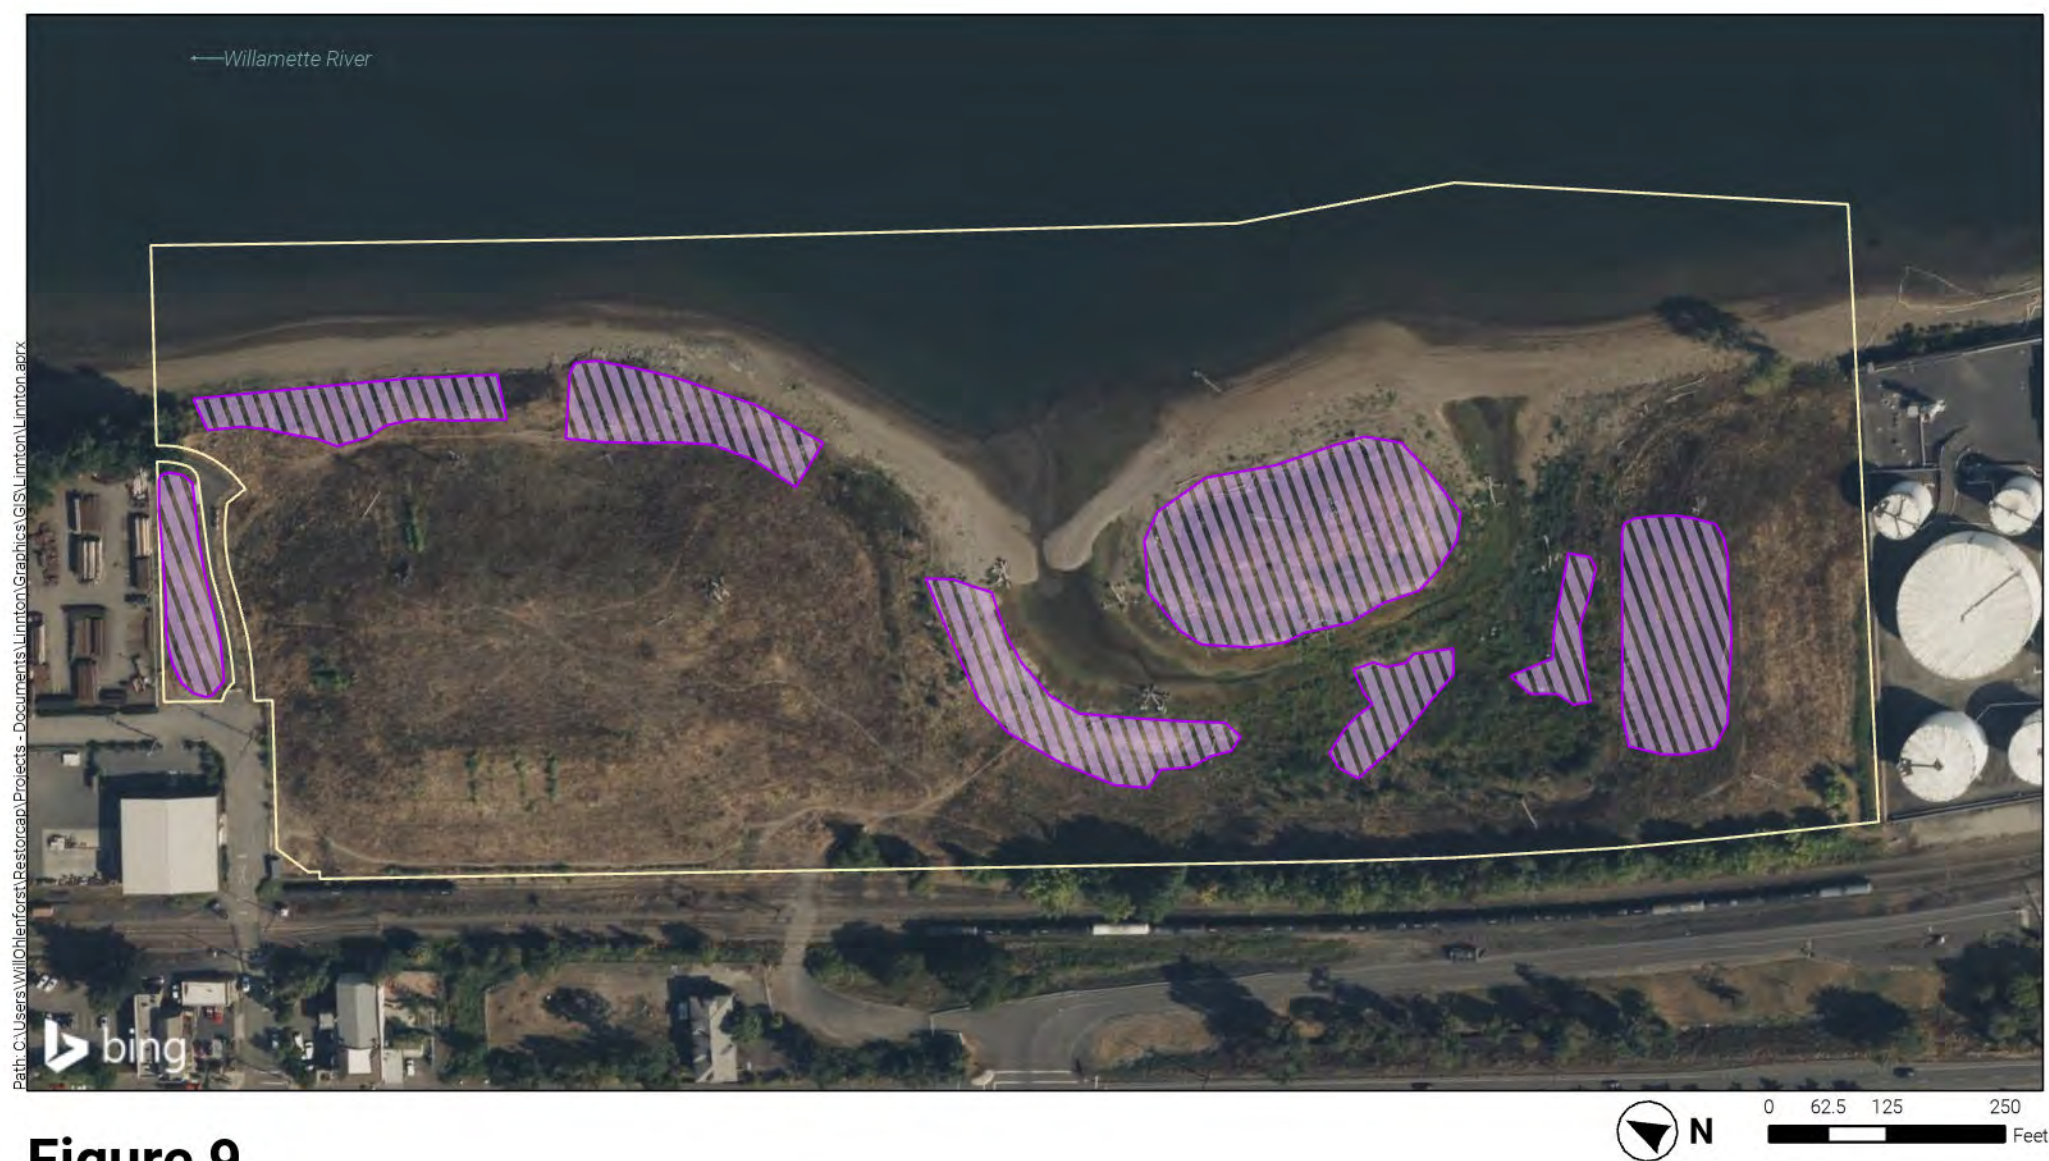
Figure 9

Supplemental Seeding Locations

Supplemental planting and seed were conducted at the Site during the month of November. The reseeding effort serves two primary objectives. The first objective is to outcompete non-native and invasive grasses and herbaceous species while enhancing native cover in areas where it is low. The Site saw an increase in the distribution of nonnative species like colonial bentgrass, creeping bentgrass, broadleaf plantain, and hawkweed (*Heracium sp.*) throughout the OCH, particularly in areas there is little to no canopy cover. Non-native grasses like velvet grass continue to pose a problem in portions of the Riparian/Upland Forested habitat. The second objective for reseeding aims to help stabilize soil and mitigate erosion along the shoreline of the north hill. Species for the reseeding effort were selected based on what is successfully established onsite, the growth structure of the species, and on the environmental and biological characteristics of the areas that need to be reseeded. Quantities for each species were determined based on the areas where the seeding will occur, and the application rates provided by the supplier of the seed. Seeding zones are mapped in Figure 9.

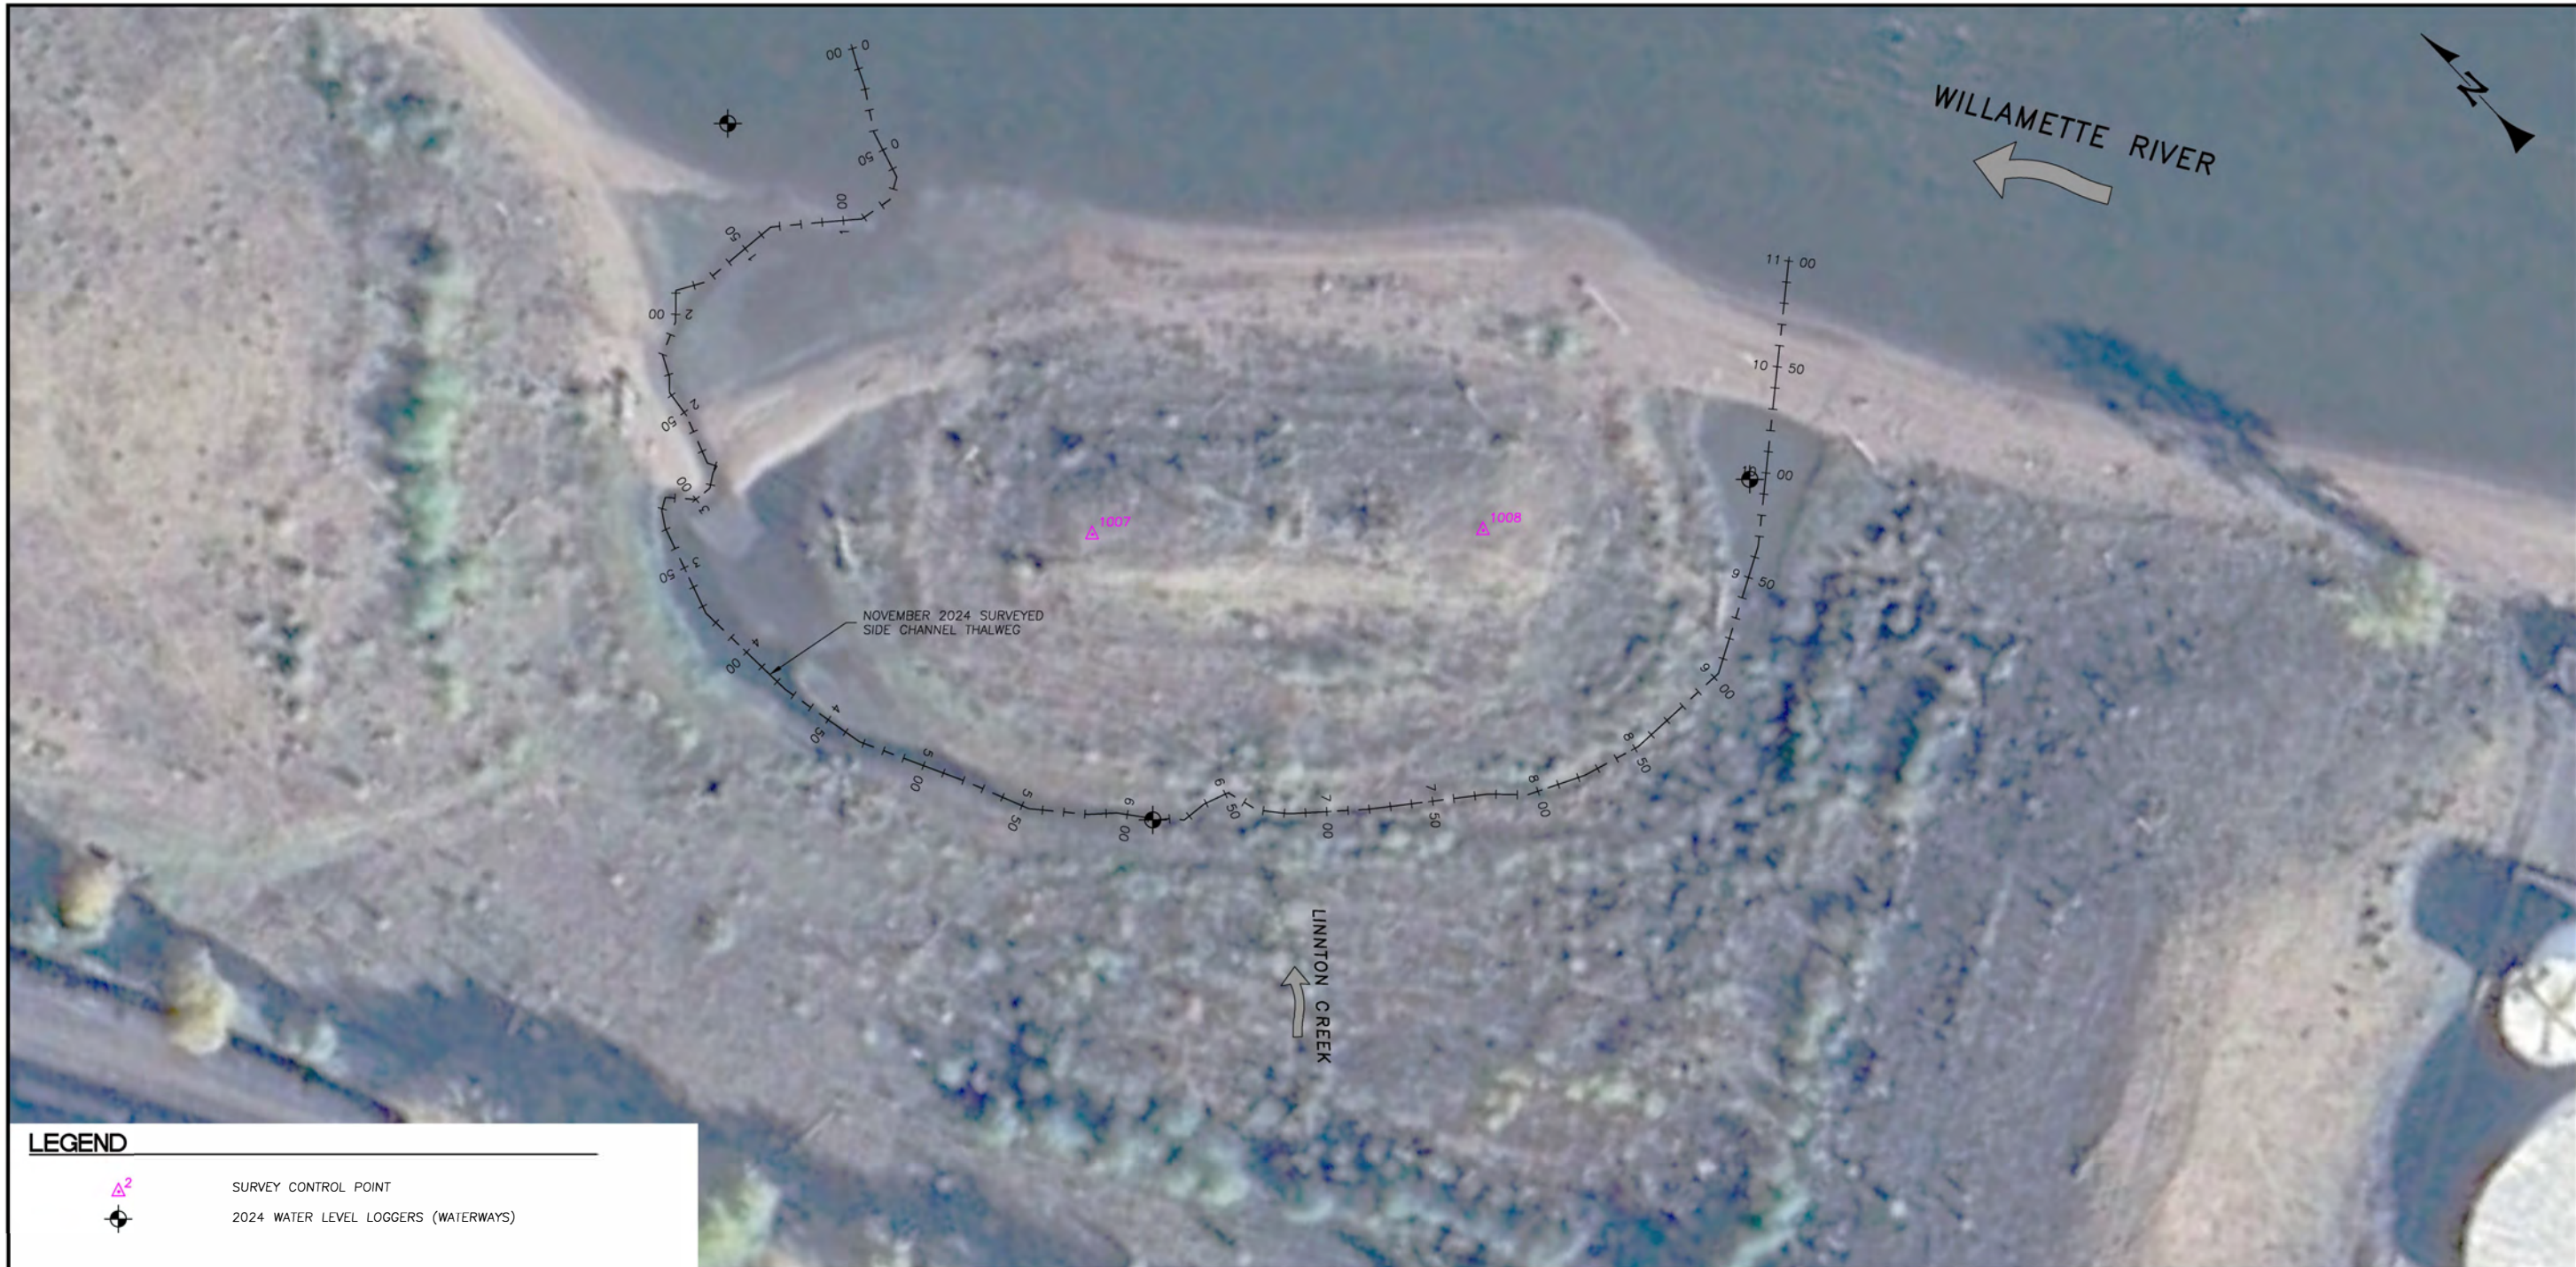
2024 EXISTING CONDITIONS PLAN
SCALE: 1" = 80'

NOTES:
1. MONITORING SURVEY COMPLETED BY WATERWAYS ON OCTOBER 2 AND NOVEMBER 26, 2024.

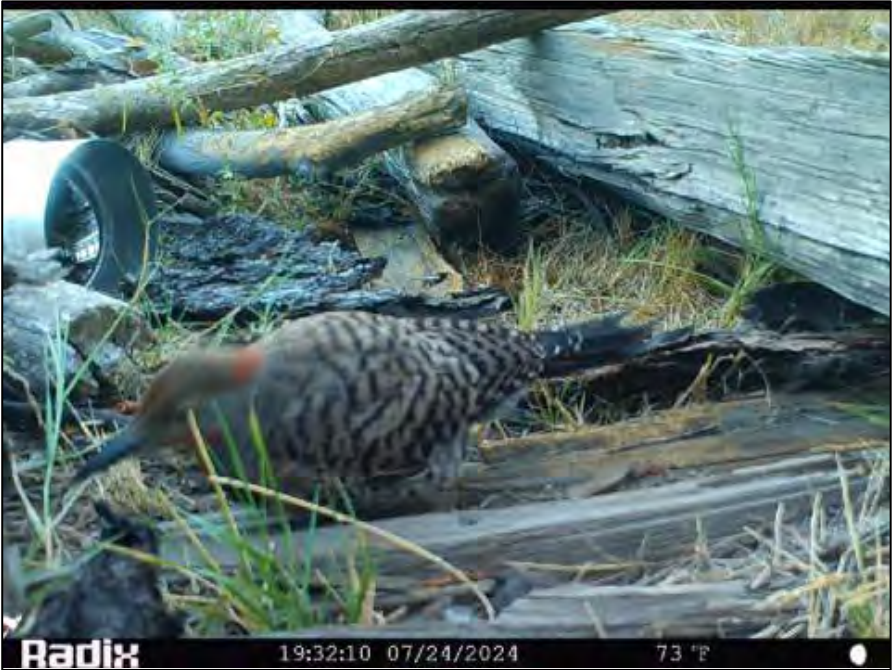
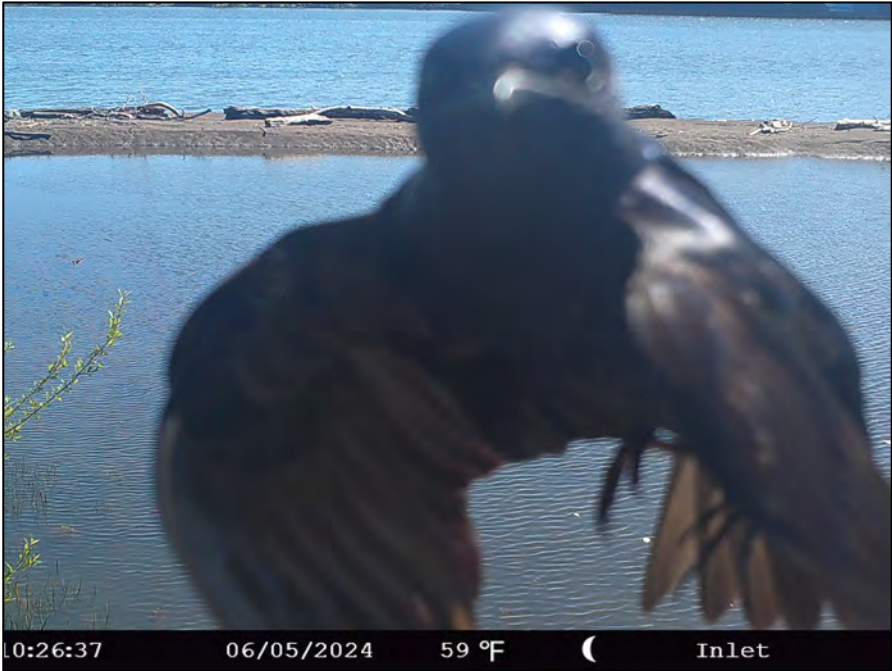
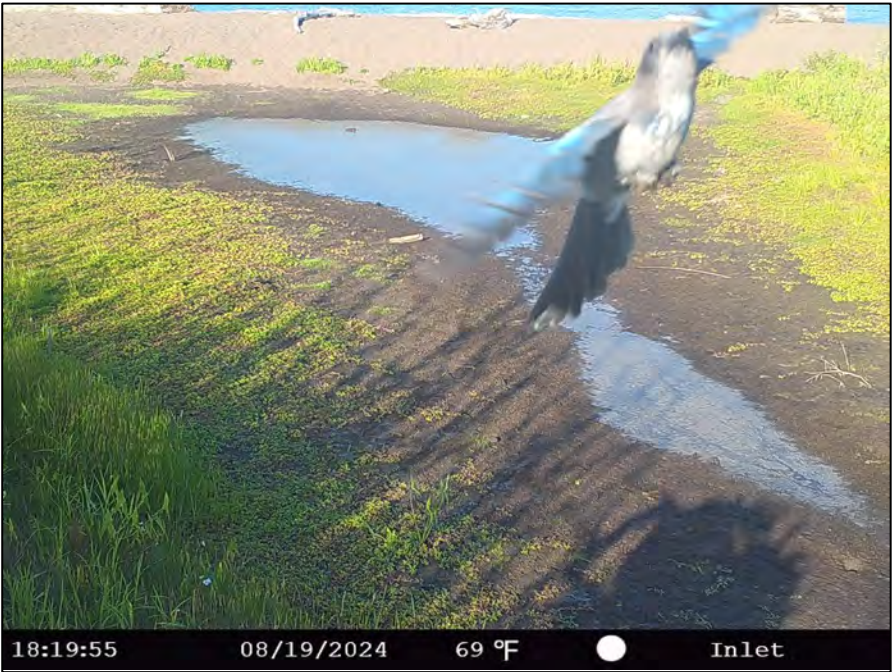
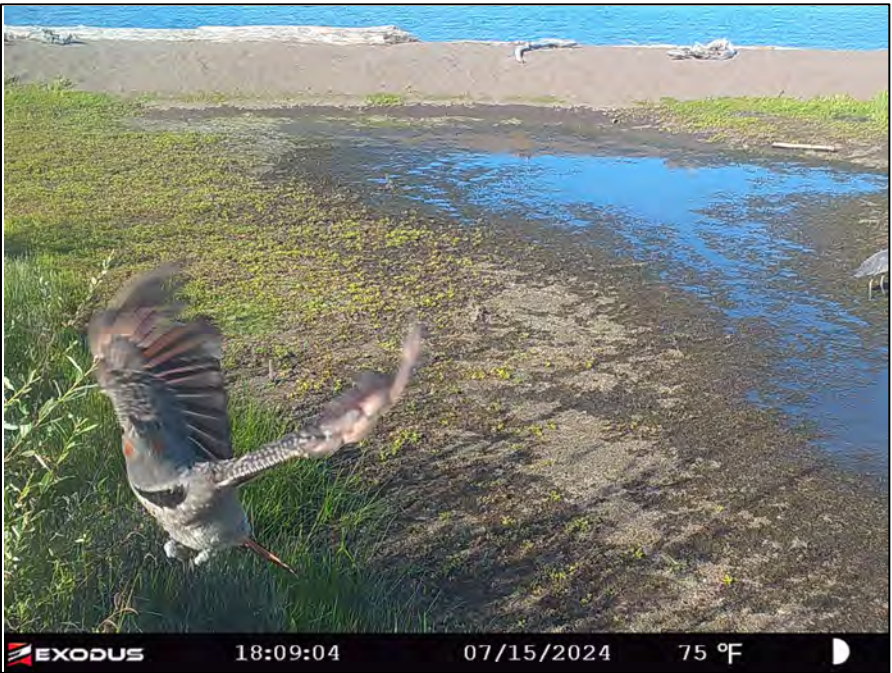
Photographs 117-120. Wildlife captured on wildlife monitoring cameras in 2024.

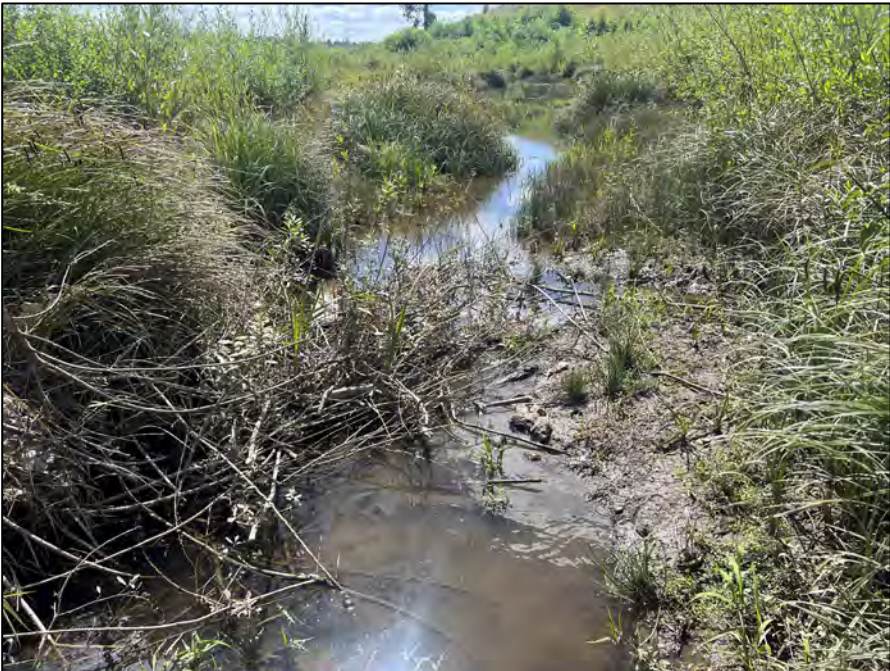
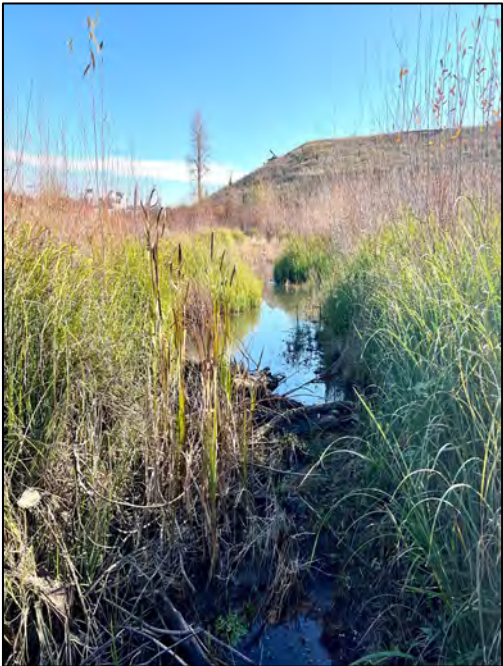
Photograph 125 (left): early evidence of beaver activity in upstream OCH immediately upstream of the Linnton Creek confluence. Photograph taken facing upstream.

Photograph 126 (right): recent (December 2024) beaver activity in same location as photograph 125. Photograph taken facing upstream.

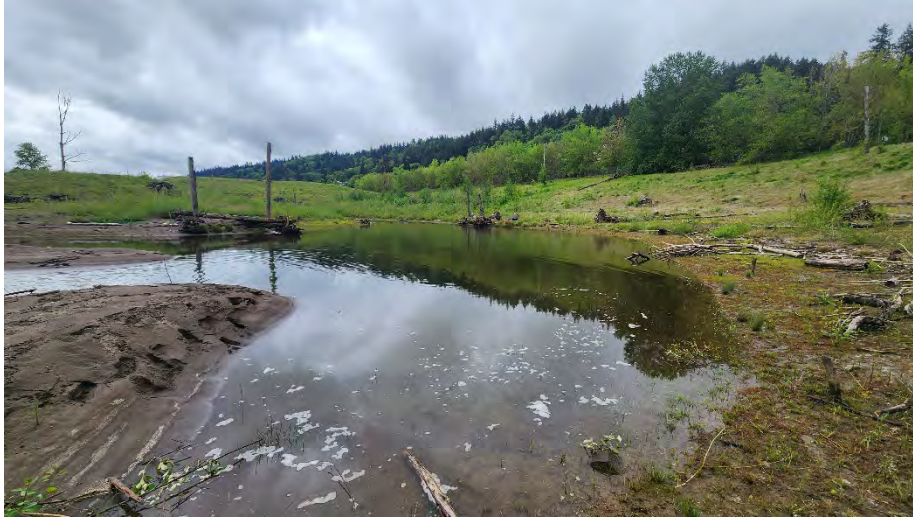
Figure 1. View looking upstream toward Linnton Creek. Water clarity was good in lower 1/3 of the side channel but became limited as we moved up the side channel

The water temperature in the Willamette River was 56.1°F and ranged between 54°F (Linnton Creek confluence) and 56°F (south ponded area of side channel) within the side channel at the time of the survey. The sky was cloudy throughout the survey. Water clarity (Figure 1.) had significantly improved from February and May but still was not ideal for snorkel survey efforts as the snorkeler could only see about 2-3 feet in front of their dive mask. Fish seen underwater were not identified due to low water clarity. Small schools of what appeared to be native minnows were seen along the shoreline in shallow water $<12''$ deep. Underwater video quality was poor due to turbidity level, and no fish were seen on video recordings.

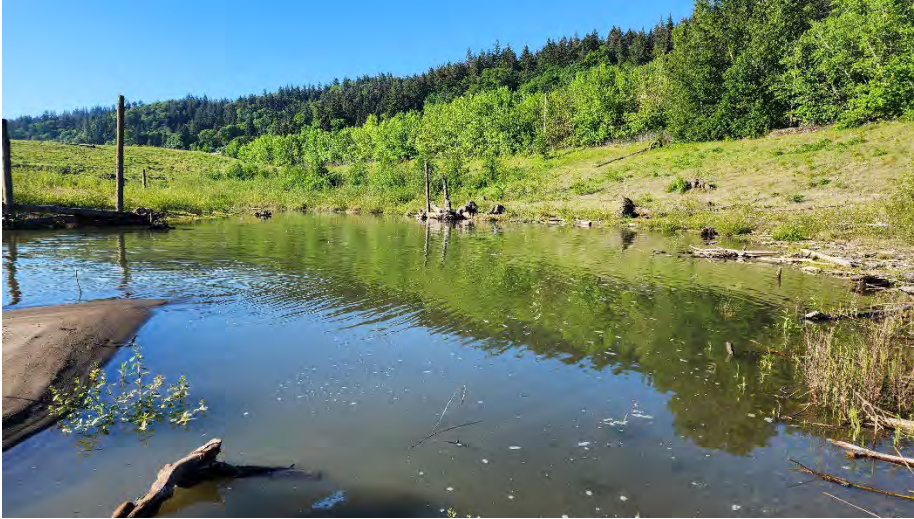
Figure 2. View looking upstream toward Linnton Creek. Water clarity continued to be good in lower 1/3 of the side channel. Water level was higher than 4/26 leading to all wood interacting with water
