YEAR 5 (2024) MONITORING REPORT Linnton Mill Restoration Site

DECEMBER 2024

RestorCap LLC
6210 Medau Place, Suite B
Oakland, CA 94611

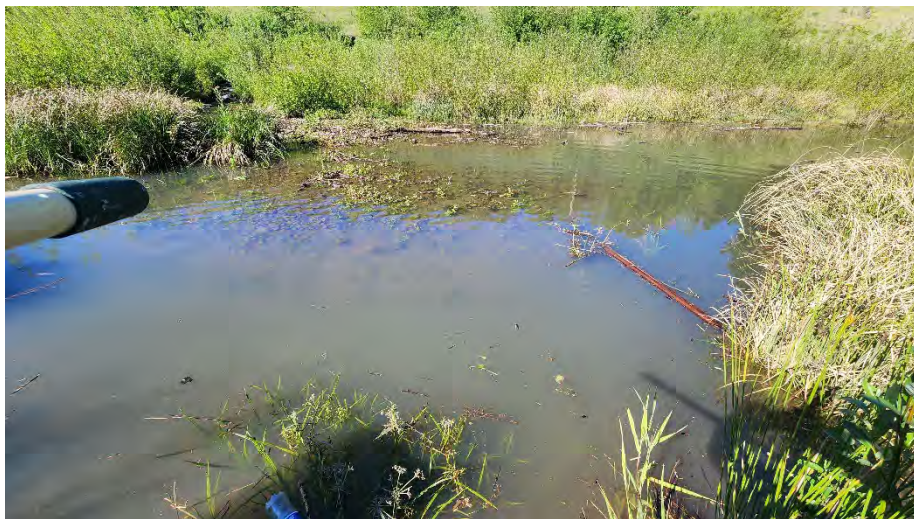
Figure 3. View looking toward mouth of Linnton Creek (gravel deposition). Water is clearer to the right (downstream) of the confluence due to influence of clear flow from Linnton Creek.

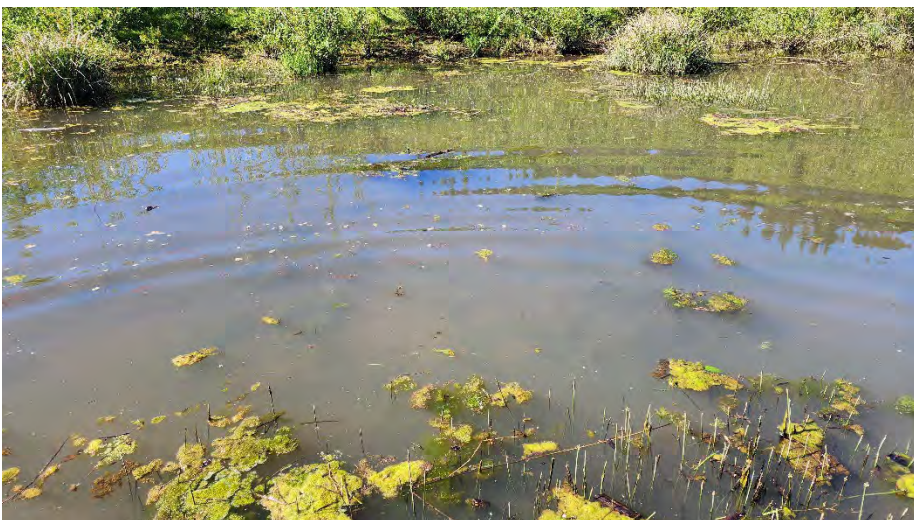
Figure 4. View of channel upstream of Linnton Creek. Turbid water often limits the opportunity to see more than 2 feet underwater.

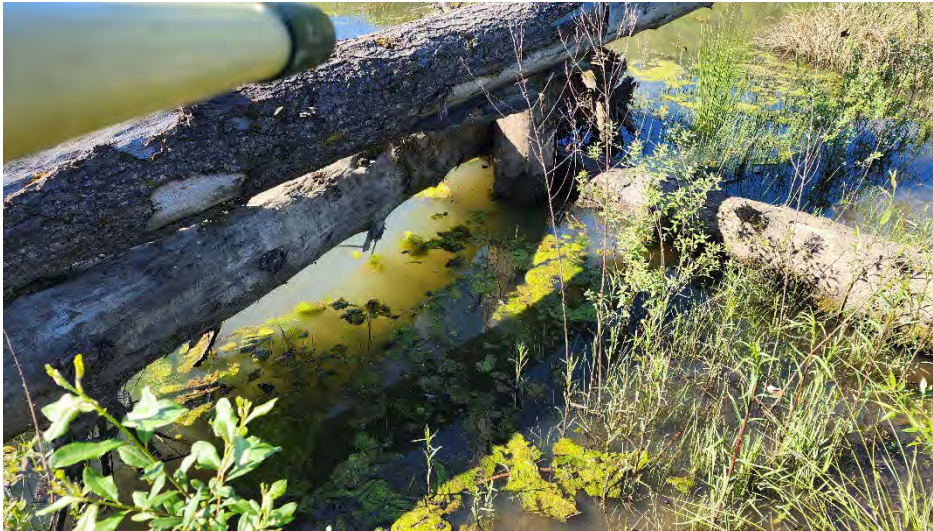
Figure 5. View under large wood structure at the upper end of the channel. Aquatic vegetation growth and algae create challenges for the snorkeler to access complex habitats and around log jams.

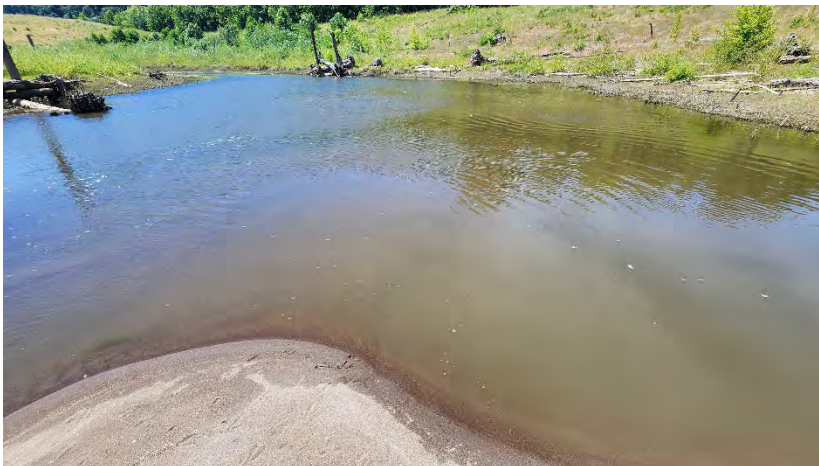
Figure 6. Photo showing turbid water that enters the site with boat wakes that create extensive inflow/outflow in the lower 1/3 of the side channel

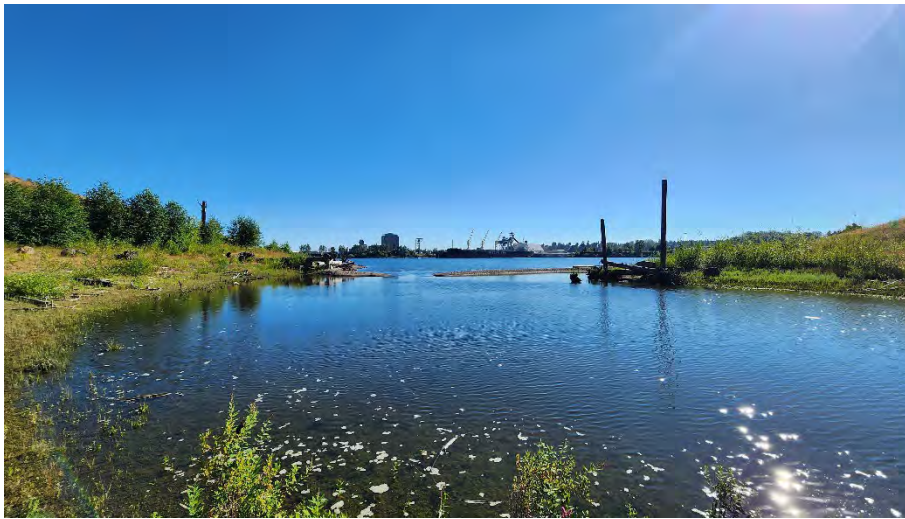
Figure 7. Conditions in June proved to be better than early in the season due to clarity of water that allowed for effective underwater viewing.

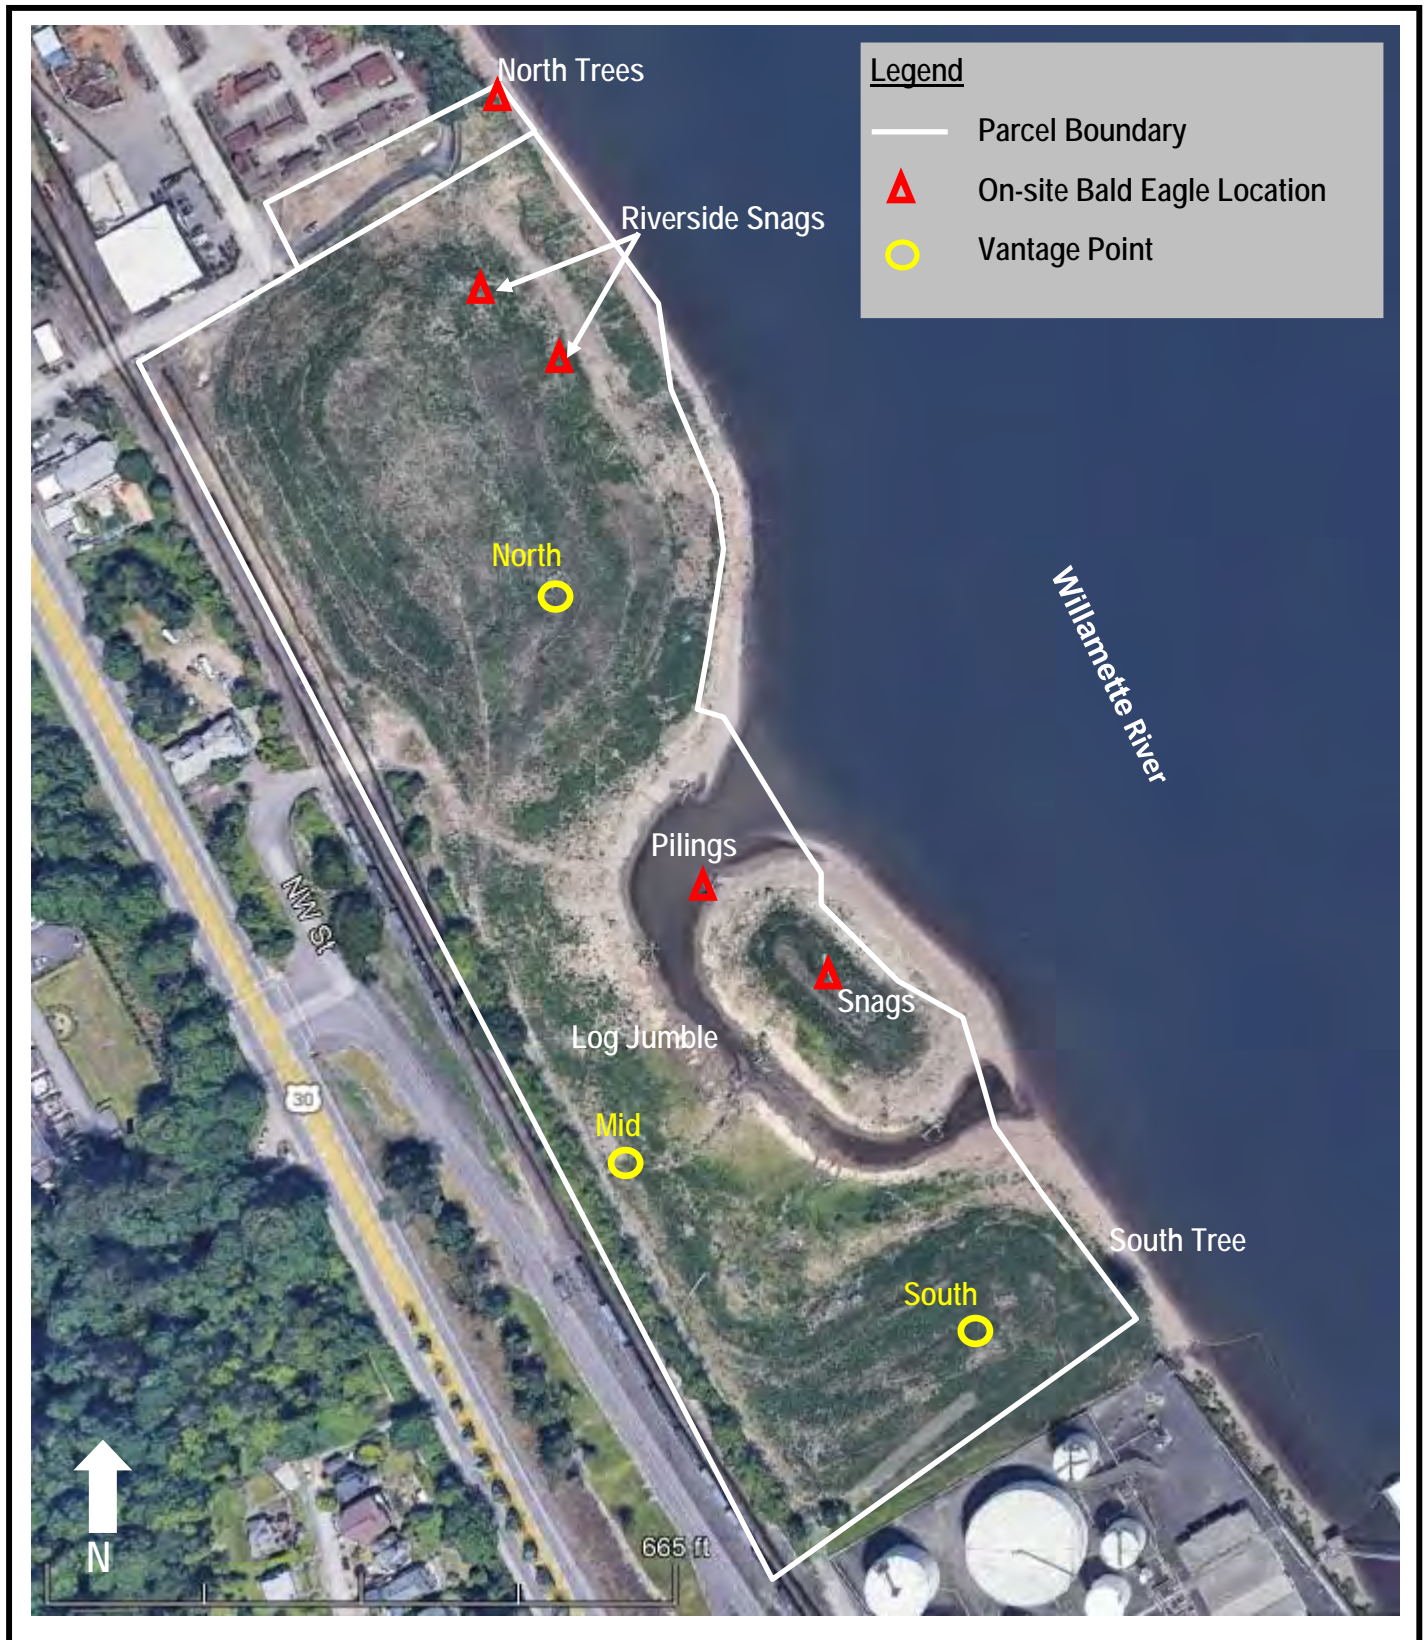
Figure 2 - Off-site Nest Grove, Roost sites, and Perches

Additionally, BAEA were observed in the vicinity during 18 of the surveys (64%) (Table 1). These included at minimum the resident pair of adults and one offspring, at least one sub-adult, and a second pair of adults that roosted and perhaps nested on the slope about three quarters of a mile north from the Linnton nest grove (Figure 2).

A pair of BAEA occupied the same nesting area that was used in 2022, located on the forested ridge approximately 0.3 miles west-northwest of the site (Figure 2). They were seen multiple times perched on that slope and flying to a spot just out of view beyond the 2022 nest, including once carrying food and twice carrying nest material. The exact location of the nest was not determined despite repeated observations outside the 2 hour/week survey period. In addition to using live trees, snags and pilings on-site, these adult BAEA flew over and past the site, and hunted from light poles, trees and railings across the river to the east. A begging hatch-year BAEA was perched on-site on the island snag and north upland riverside snags on August 8, 2024. It then flew to join an adult BAEA across the river. Based on this and the behavior of the adults on previous surveys, egg laying and incubation is estimated to have started in early mid-March, hatching in early May and fledging in mid-late July. Given the proximity of the nest to the Linnton Mill Restoration site it is reasonable to assume that BAEA use of this site during nesting season may be limited to this pair and their offspring.
