**Mitigation Monitoring Report Cover Sheet
Oregon Department of State Lands**

DSL Permit Number:	COE Permit Number: <i>Nationwide Permit 27 - 200400726</i>	
Permittee: <i>Gilmour</i>		
County: <i>Benton</i>	Report Date: <i>9/21/09</i>	Monitoring Year <i>4</i>
Date Removal-Fill Activity Completed:		
Date mitigation was completed Grading: <i>2/05</i> Planting: <i>5/06</i>

The purpose of this report is to summarize the progress of Phase 1 of the Mid-Valley Wetland Mitigation Bank (Bank). The Bank is located approximately one mile east of Independence Highway and one and one-half miles south of Springhill Drive in T10S, R4W, Sec. 15, Tax Lot 700. The letter of approval for the Bank was signed on September 27, 2005 and is permitted as ACOE permit #2004-000726. Phase 1 of the Bank consists of 33.1 acres.

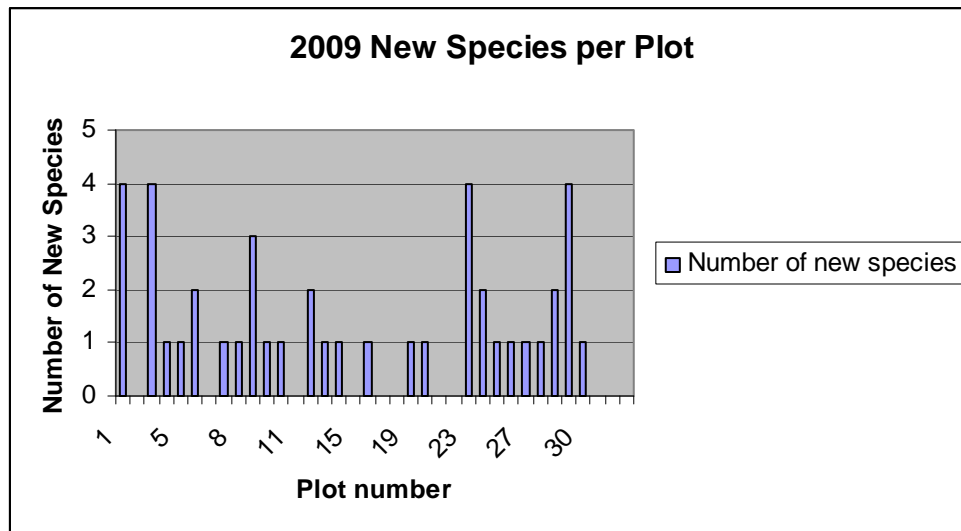
The sample plots were evaluated using a species area curve to show the incidence of new species found within each of the plots. The curve shows several spikes in the number of new species found as new wetland types are sampled. The last three plots showed no new species. All wetland types were included in the sample plots.
