Portland General Electric Harborton Restoration: Year 3 Monitoring Report

Portland General Electric

December 2023
Revised October 2024

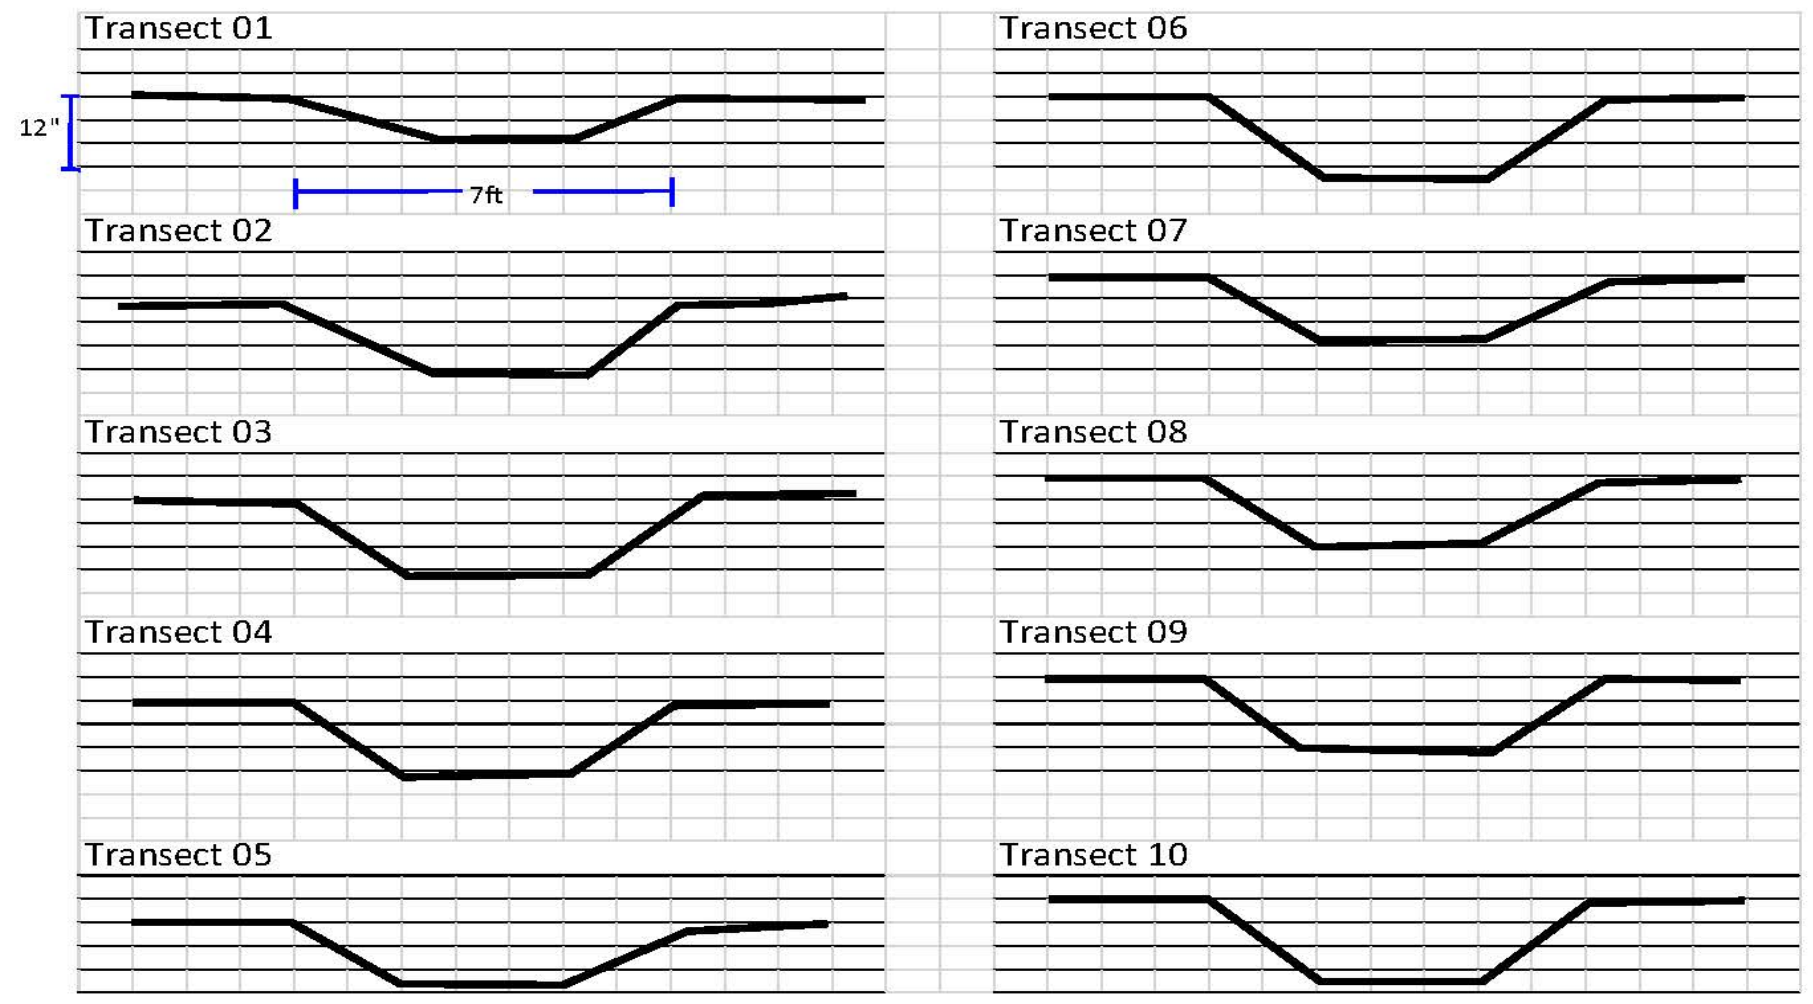
FIGURE 2K

Note:
Field topography was collected by PGE Survey crew using RTK GPS on 9/21/2023 and 10/04/2023.
Elevations shown in City of Portland vertical datum (NAVD88 - 2.1 feet)
Vertical accuracy approximately 1.5 centimeters.

Channel Cross-sections
2023 GPS Field Survey
PGE Environmental Services

PGE has observed no evidence of lateral migration, bank erosion, or downcutting, and no discernible change in longitudinal slope since channel construction in 2020. Differences from 2021 to

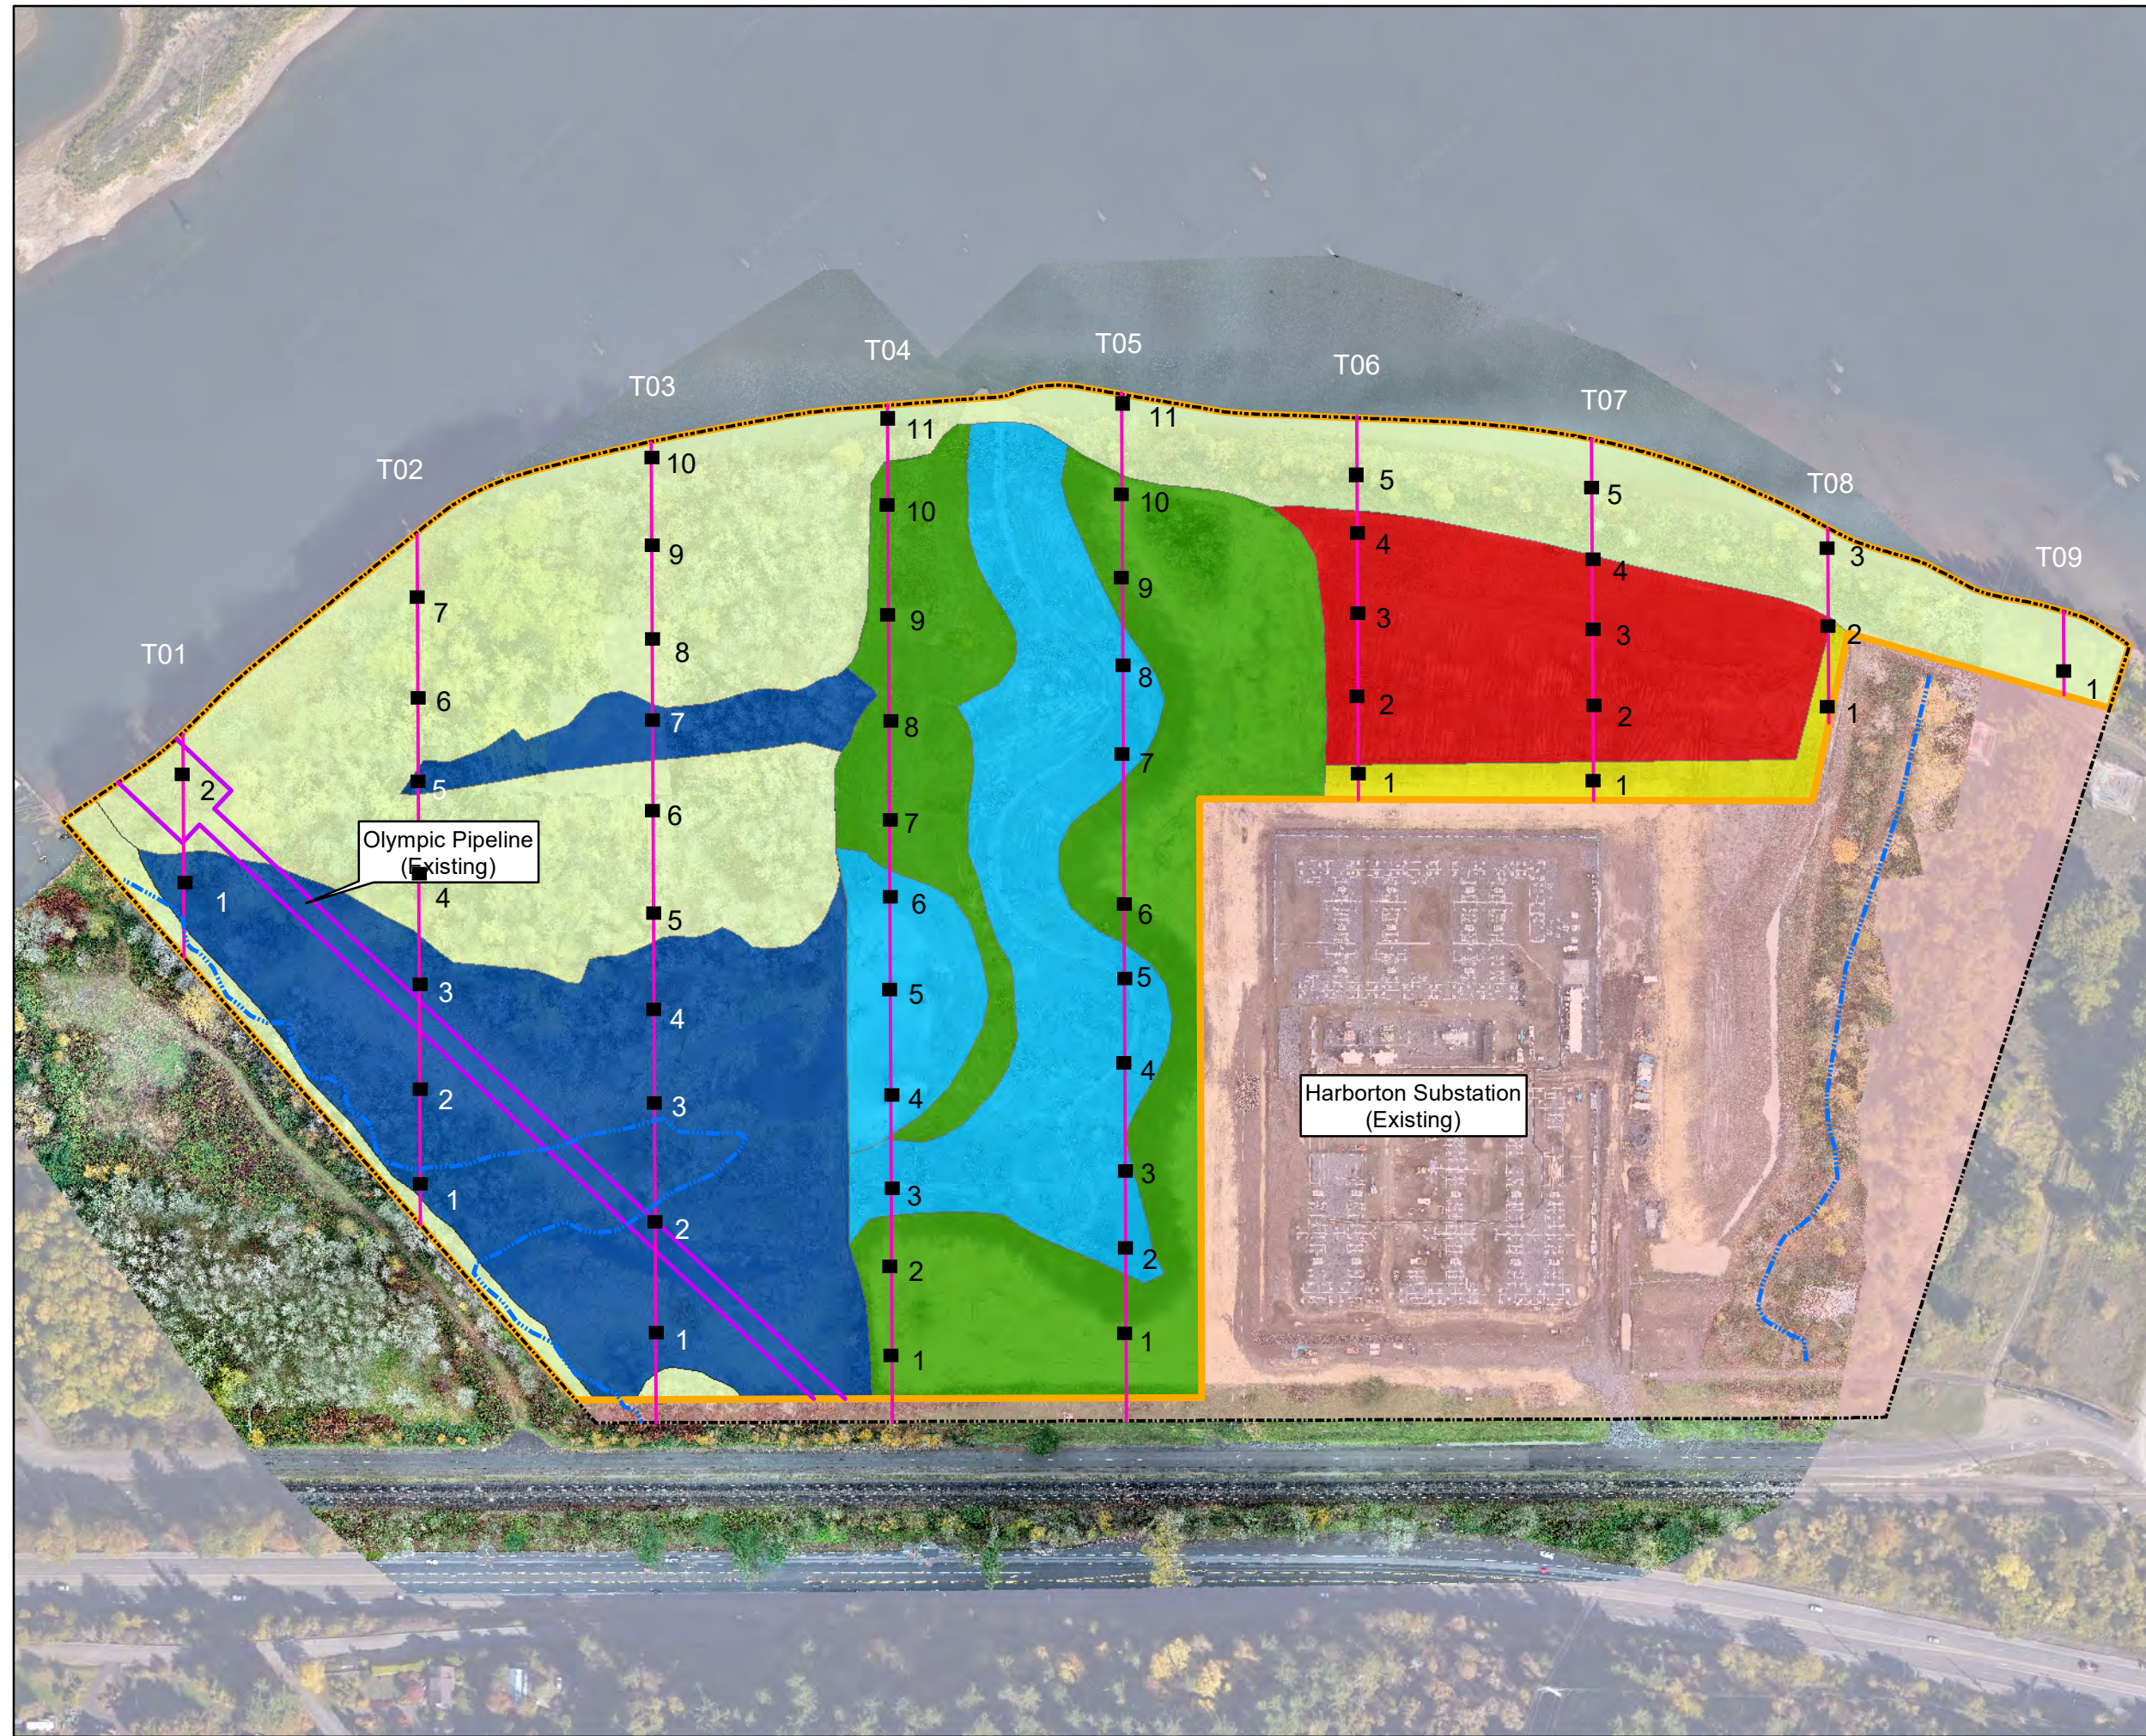
Figure 7
Sample Line-intercept
Vegetation Assessment Plots
PGE Environmental Services

RCG is the dominant plant cover with an average of 77 percent cover. Four of seven sample locations have 95 percent or greater RCG cover. Plot T02-2 is just outside of the area managed for RCG via solarization in 2023 (See Figure 7). Should solarization as a management tool be successful in this area, PGE may propose to the Trustee Council extension of this management tool to a limited area within the northern red-legged frog management area to see if the successes could be replicated. The long-term goal would be to replace RCG with native plants better suited to egg-mass anchoring compared to RCG, and plants that provide greater overall habitat functions.

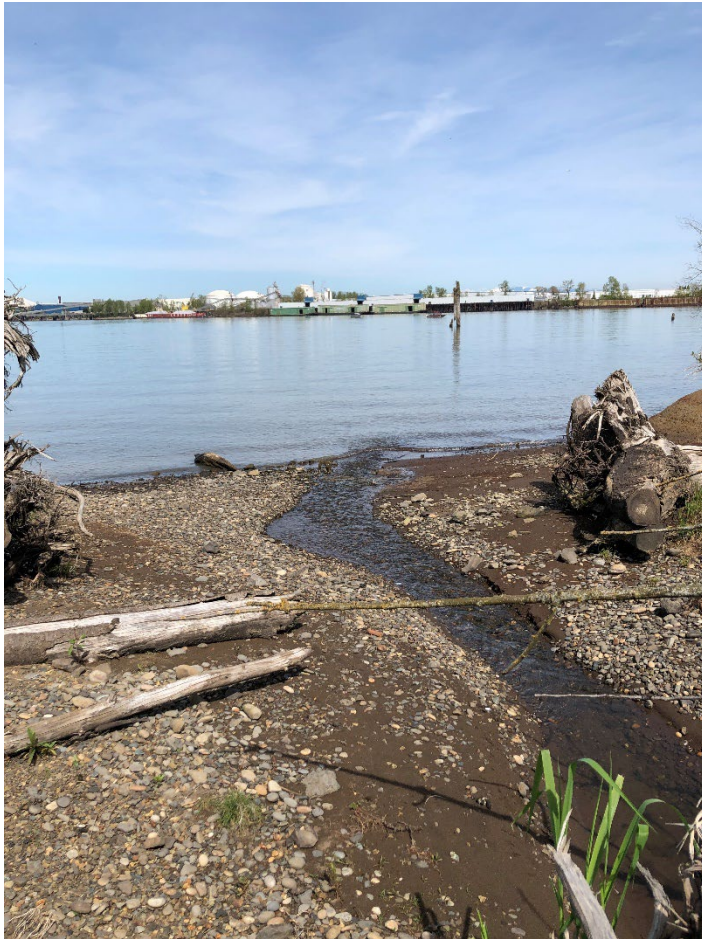
Photo 07 – Outlet, 4/26/23

Sediment deposited by the Willamette River at the mouth of North Channel observed in mid- to late summer is important when considering channel function. This bar creates a fish barrier, but occurs during periods when juvenile salmonids are not likely to be present, nor are conditions in the channel likely to attract outmigrating juvenile salmonids.

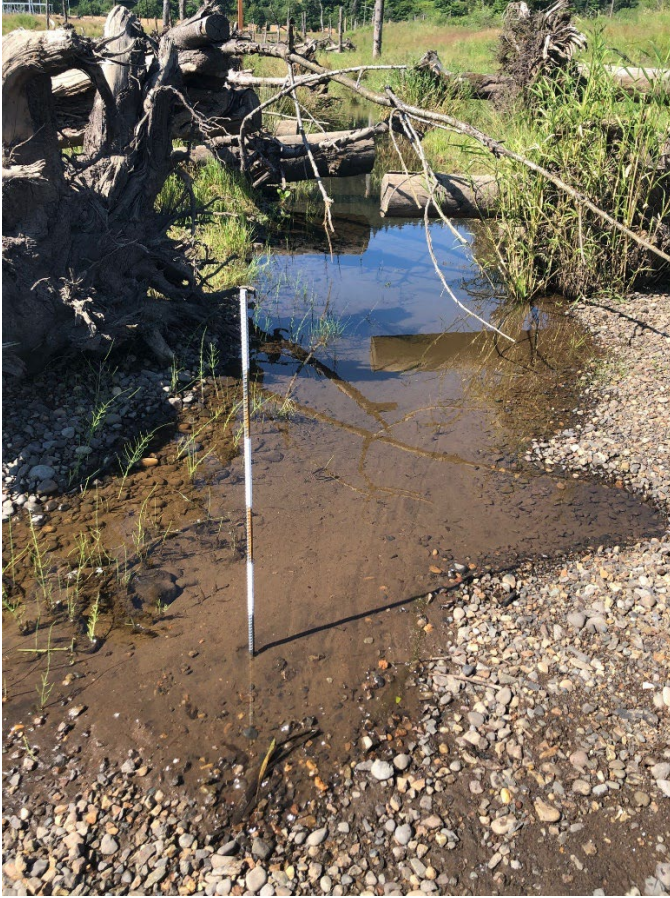
Photo 09 – Outlet at low tide, 6/22/23

The North Channel outfall to the Willamette River is the primary dynamic fluctuating channel feature. Interaction with Willamette lateral shoreline flow, tidal fluctuations, backwater flooding, and sediment loading create variations in outfall conditions throughout the year.
