i. MITIGATION MONITORING REPORT COVER SHEET
CORPS OF ENGINEERS

Corps Permit Number: 2011-100

2. WALN CREEK/BATTLE CREEK MITIGATION PLAN PURPOSE AND OVERVIEW

Wain Creek/Battle Creek riparian mitigation area in Salem, Oregon.

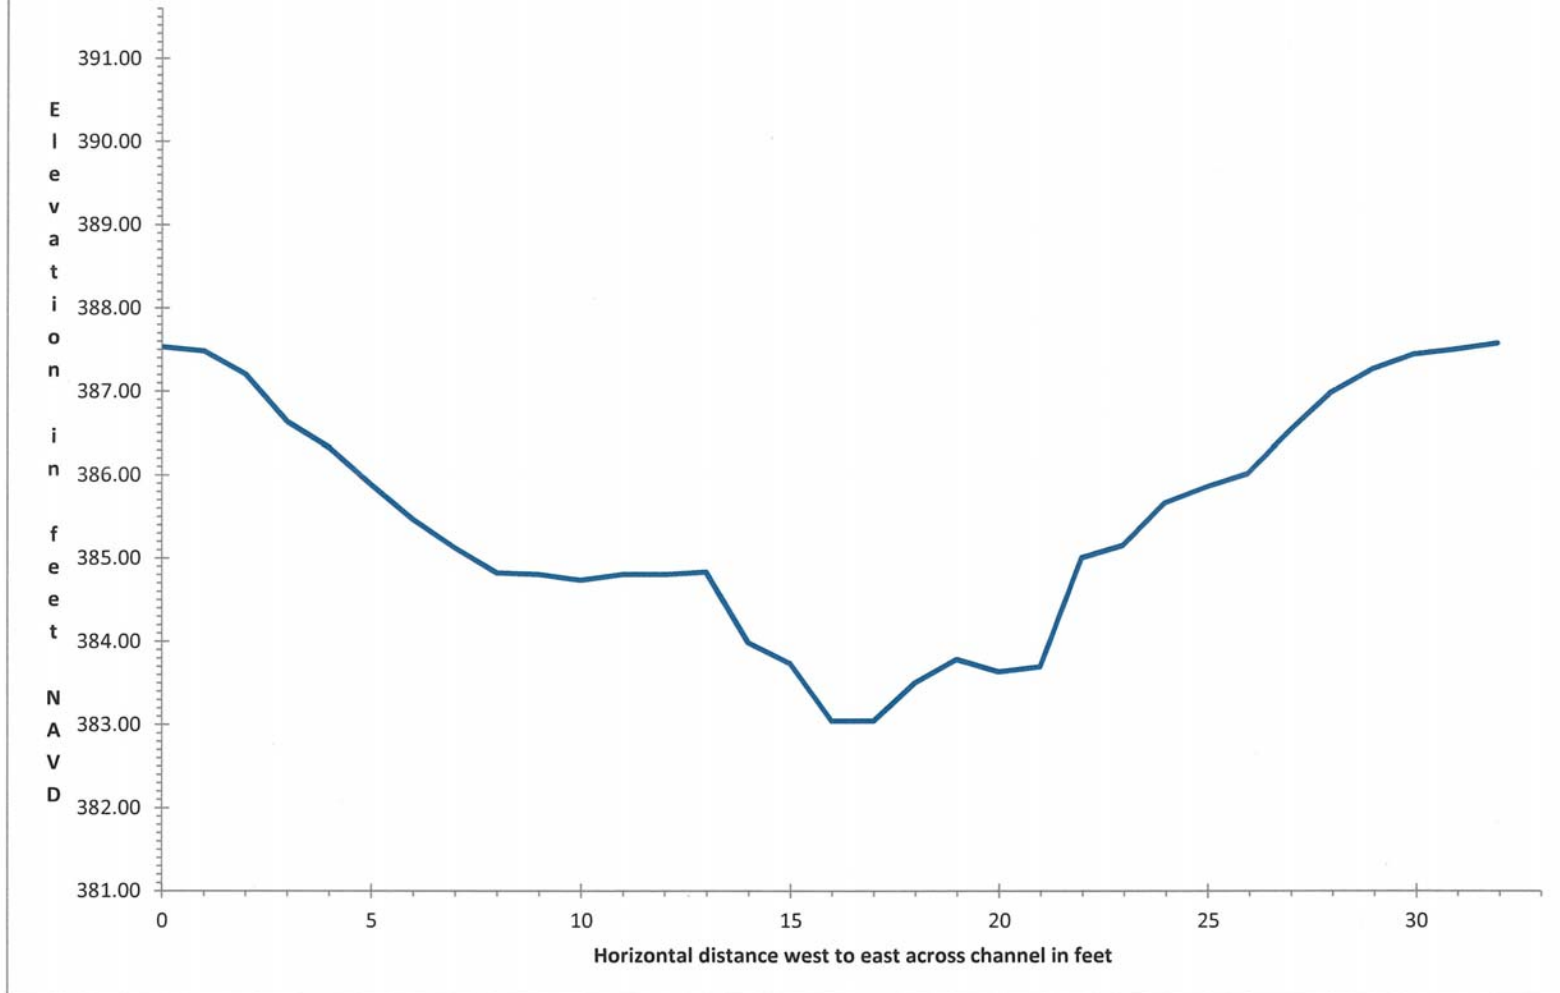
Channel section B vertical exaggeration x2

As mentioned above, the lack of comparative data from previous years precludes a current analysis of channel changes over time. Nevertheless, the calculations for the Bank Erosion Hazard Index (BEHI) at each cross section indicate that the stream channel currently has an overall low level of susceptibility to erosion (BEHI index ranges from 19 to 20.5). This measure is based on multiple factors, including bank height and angle, root depth and density, bank material, and surface protection. Given the relatively low gradient, low velocity channel as well as its relatively well vegetated banks, the BEHI index is unlikely to appreciably change over time.
