LINNTON MILL RESTORATION SITE (NWP-2014-477; 58909-RF; 59636-MBI)

YEAR 1 (2020) MONITORING REPORT

DECEMBER 18, 2020

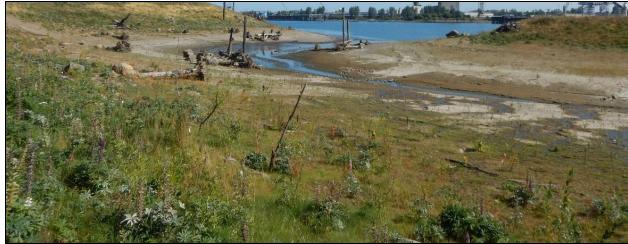
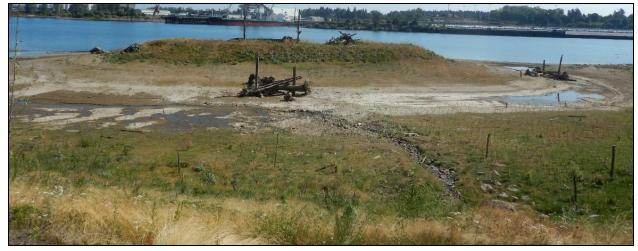
Based on a visual survey, no physical conditions exist that prevent fish access to the site. The photo series presented below (Photograph 1) illustrates that fish can access the site and leave the site freely, without impediments.

Photograph 1. Photo series: off-channel habitat fish access (river water level +6.2 ft)

Based on visual monitoring, the site contains no vertical jump heights greater than 6 inches. Photograph 1 above shows the off-channel habitat starting at the mouth and ending at the head, and illustrates the lack of vertical jumps.

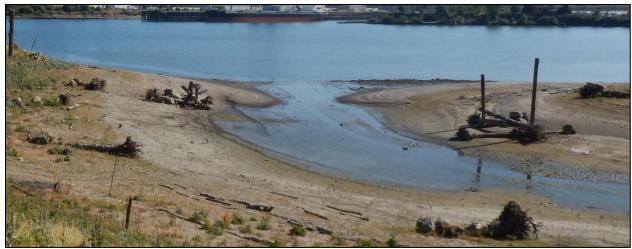
Additionally, sand appears to be accumulating at the mouth of the off-channel habitat, forming a small berm that extends a portion of the way across the channel (Photograph 3, Photograph 4). Though this does not constitute a stranding risk, if it continues to extend and connects across the mouth, this could cause an additional stranding risk. This is unlikely though, as continual outflow from the off-channel habitat due to year-round Linnton Creek flow as well as seeps from the hillside will likely keep this outlet open.

Photograph 4. Emerging berm on the downstream end of the off-channel habitat, facing northeast.

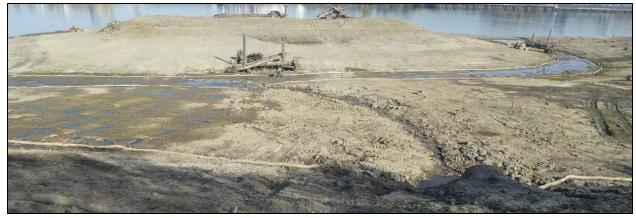
Performance Standard A9 requires that the Linnton Creek culvert be discharging from November 1 through June 30. Photographs depict flow on November 8, 2019 (Photograph 5), February 19 (Photograph 6), August 13 (Photograph 7), and October 29, 2020 (Photograph 8). During each of these site visits, flow is present from the Linnton Creek culvert. Though flow was not inspected daily during that period, it is presumed that flow was present between these dates as well.

Photograph 5. Flow from Linnton Creek November 8, 2019 (photo point 12, facing NE)

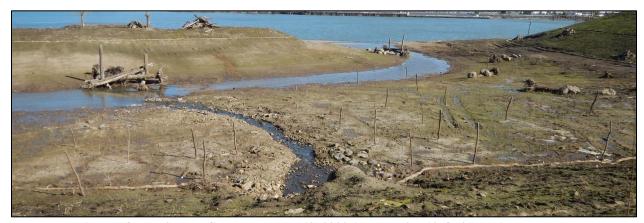
Photograph 6. Flow from Linnton Creek February 19, 2020 (photo point 12, facing NE)

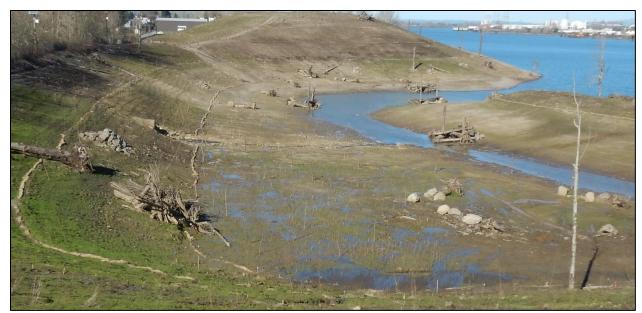
Visual monitoring of the thalweg of the off-channel habitat downstream of the outfall was conducted periodically. During every site visit, groundwater was observed seeping out of the southern hillside and collecting in the off-channel habitat. As anticipated, daylighting groundwater provides year-round freshwater inputs to the off-channel habitat, even during dry summer months.

Photograph 9. Freshwater inputs from Photo Point 21, 2/19/20

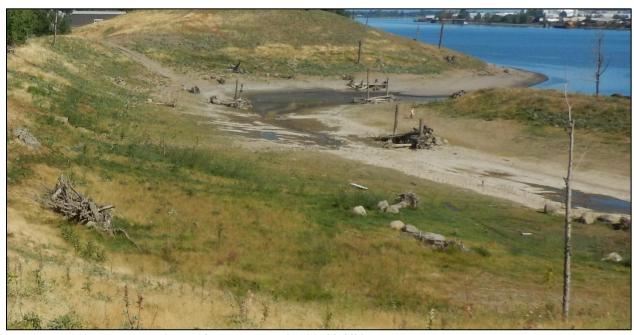
Photograph 10. Freshwater inputs from Photo Point 21, 8/13/20

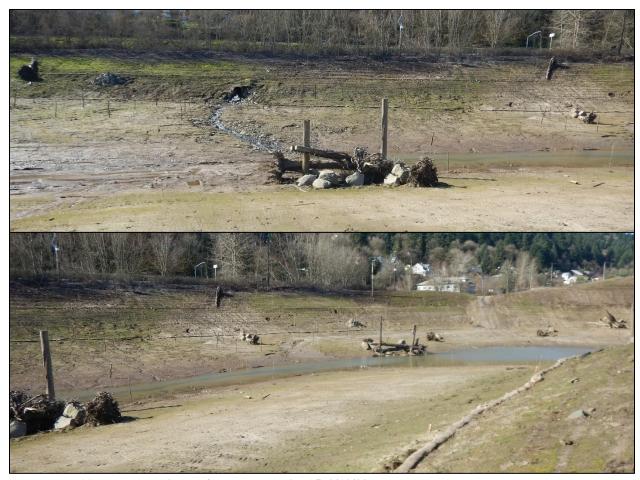
Photograph 11. Freshwater inputs from $\overline{\text{Photo Point 15, 2/19/20}}$

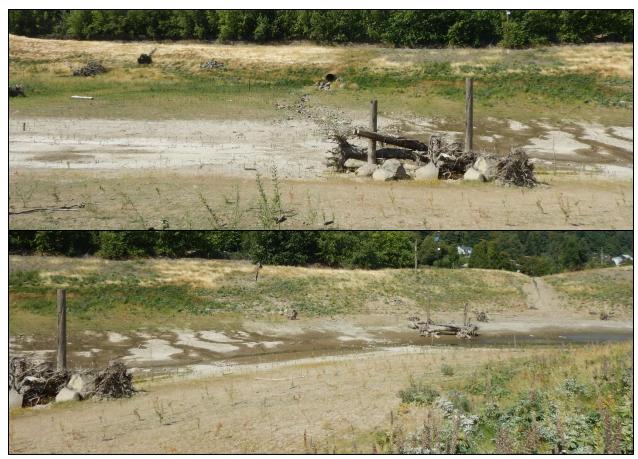
Photograph 12. Freshwater inputs from Photo Point 15, 8/13/20

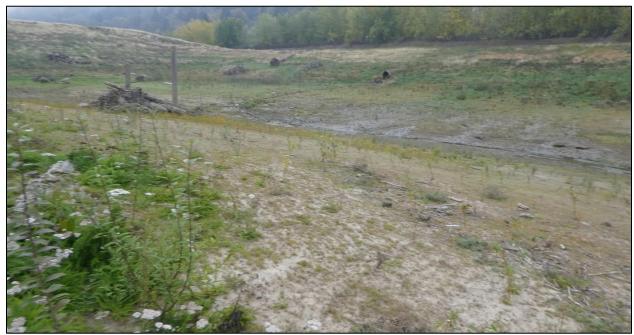
Photograph 13. Freshwater inputs from the riparian island, 10/29/20.

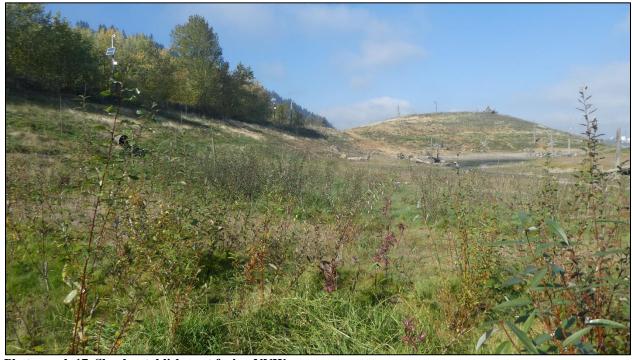
Photograph 17. Shrub establishment facing NNW

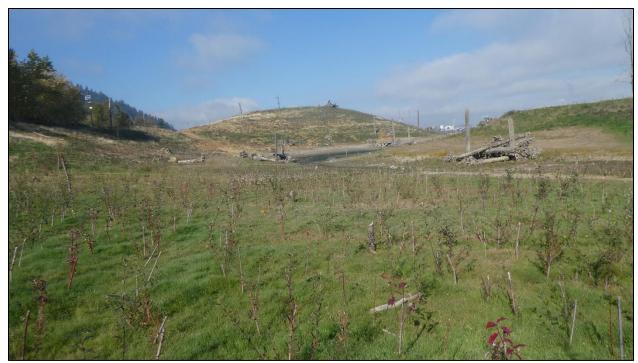
Photograph 18. Shrubs, facing NNW
